Zeitschrift: IABSE reports = Rapports AIPC = IVBH Berichte
Band: 57/1/57/2 (1989)

Rubrik: Workshop 3: Durability of suspended structures

Inspection Evaluation, and Rehabilitation of Suspension Bridge Cables

Inspection Program for the Lisbon Suspension Bridge
Programme d'inspection pour le pont suspendu de Lisbonne
Untersuchungsprogramm für die Hängebrücke in Lissabon

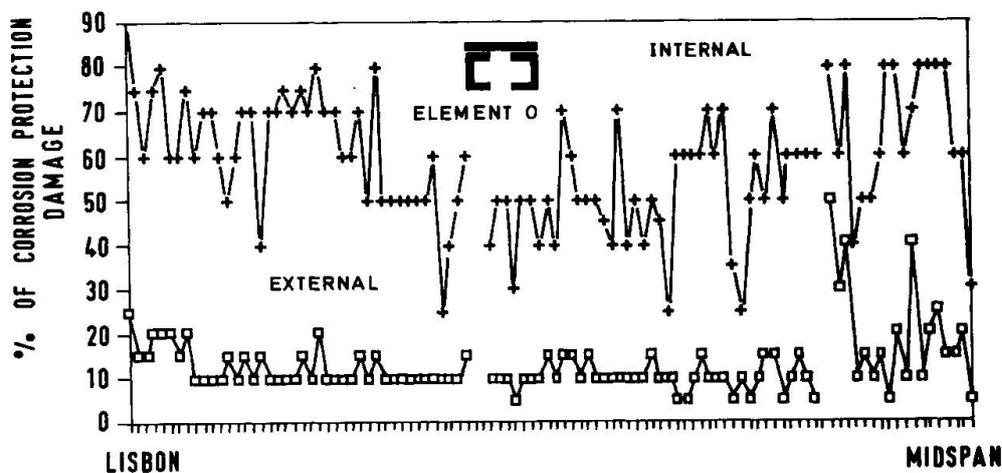
Fig. 3 - ANTICORROSION PROTECTION DAMAGE AT ELEMENT 0, ALONG THE SPAN.

At the first stage of the program, the corrosion inspection was implemented. At the columns only superficial corrosion was found, mostly at the interior of the base section. The concrete caissons were also observed and filmed under water to check for concrete degradation, but no relevant findings were obtained. At the cables hangers and cable bands, and with an external observation, only small spots of superficial corrosion were found. Due to the good external condition, an internal observation with electromagnetic techniques was not considered necessary at this stage. All the bars of the deck truss were also inspected and plots of the superficial corrosion along the bridge were drawn for each element (Fig. 3). Structural damage by corrosion was found only in a few nuts of the bolted connections which presented section reductions of more than 20%. It is estimated that about 2% of the deck bolts will need to be replaced shortly. During deck inspection some transversal bars located over the longitudinal girders (shown in Fig. 2 by A). It is estimated that 13% of the total number present this problems.

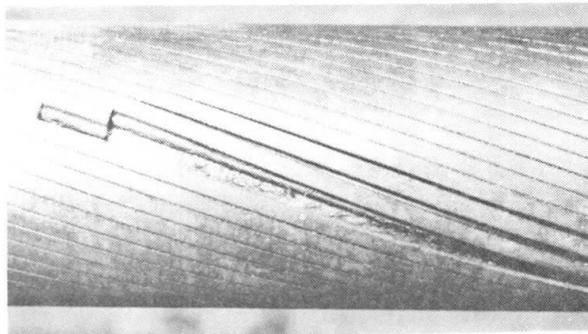
Um das zehn Meter lange verschlossene Tragseil, 63 mm Durchmesser, belasten zu können, wurde es an beiden Enden mit Vergußköpfen versehen. Die äußere Z-Drahtlage weist in Seilmitte zwei nebeneinander liegende Drahtbrüche auf. (Fig. 3)

Fig.3 Verschlossenes Tragseil, 63 mm Durchmesser, mit zwei nebeneinander liegenden gebrochenen Z-Drähten, Belastung des Seiles in der Seilreckanlage: 1430 kN

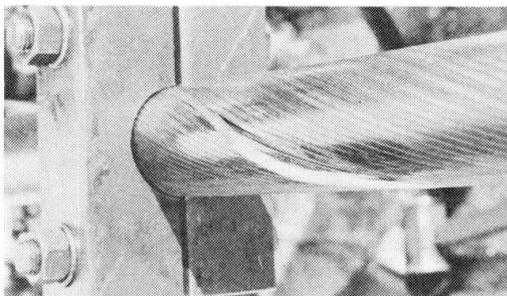
Fig. 6 Einpressen der Drahtüberlänge (Schleife) in den Seilverband mittels einer Schraubklemme

Im zweiten Arbeitsgang wurde der neue Z-Draht mittels einer gut passenden Schraubklemme in den Seilverband gepreßt und zwar vorerst bis zur ursprünglichen Schadensstelle. Im weiteren Verlauf der Sanierung wurde das zweite Bruchende des Z-Drahtes Nr.1 aus dem Seilverband gehoben und in Richtung Klemmenwagen, auf eine Länge von 2240 mm, aus dem Seilverband geschält. Anschließend wurde der neue Z-Draht von der ursprünglichen Schadensstelle mittels Schraubklemme in den Seilverband gepreßt. In einer Entfernung von 2800 mm von der ersten Lötung wurde die zweite Lötung mit kurzer Drahtüberlänge vorgenommen. (Fig.6) Nach Behandlung der Lötstelle mit Spezialwerkzeugen wurde im dritten Arbeitsgang die Drahtschleife mittels Schraubklemme bis zum Verschwinden in die Außenlage des verschlossenen Tragseiles gepreßt. (Fig.7) Hierzu war eine Wegstrecke von ein Meter Länge erforderlich. Die Gesamtlänge zur Sanierung eines gebrochenen Z-Drahtes beträgt in diesem Falle 3800 mm, das sind ca. sechs Seilschlaglängen. Mit der Sanierung des zweiten Drahtbruches wurde in gleicher Weise wie beim Drahtbruch Nr.1 verfahren.

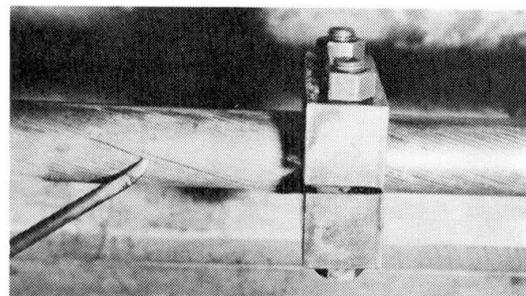
Fig. 7: Seilzustand nach dem Einpressen der Drahtüberlänge in den Seilverband, Entfernung von der sanierten Bruchstelle: 2800 mm

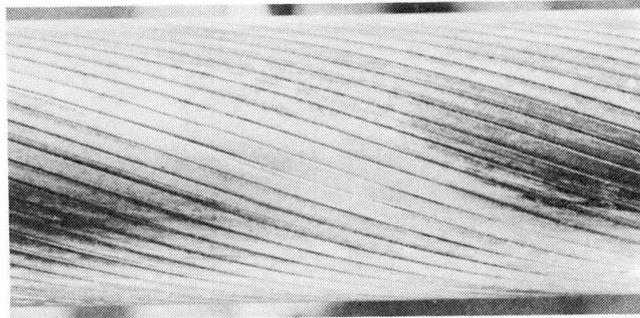
Aus Fig.8 ist der Seilverband im sanierten Bereich ersichtlich. 'Alle Z-Drähte der Außenanlage liegen fest im Seilverband. Unmittelbar nach der Sanierung tragen die eingepreßten und gelöteten Z-Drähte nicht voll mit. Ein weitgehender Spannungsausgleich zwischen den Z-Drähten tritt jedoch nach mehrmaliger Be- und Entlastung auf.

Fig.8 Verschlossenes Tragseil, 63 mm Durchmesser, Seilzustand im sanierten Bereich

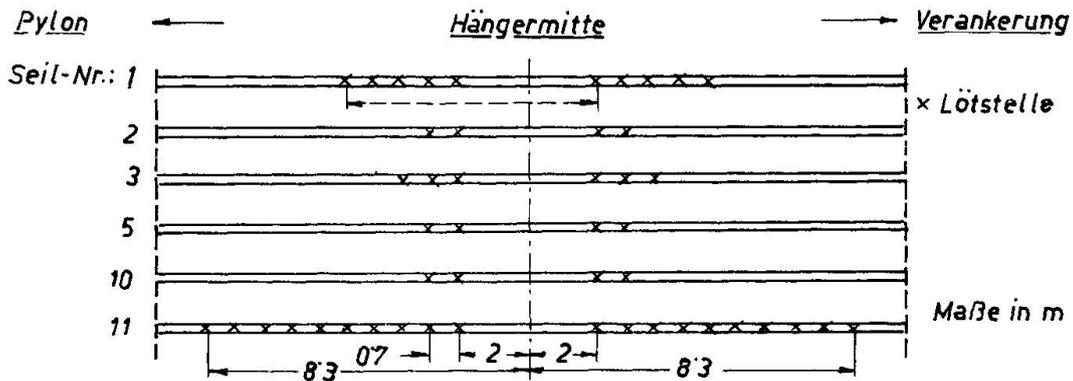
Im Bereich einer Hängerklemme wurden in 6 von 12 Tragseilen insgesamt 24 Drahtbrüche festgestellt. Die Lage der Drahtbrüche in den einzelnen Seilen ist aus dem Lötstellenplan ersichtlich. (Fig.9) Die Verteilung der Lötstellen wurde so festgelegt, daß der Abstand zwischen zwei benachbarten Lötstellen 700 mm beträgt. Im Bereich der Hängerklemme wurde eine lötstellenfreie Zone von 4 m geschaffen. Aufgrund der Drahtbruchverteilung ergaben sich im zu sanierenden Bereich folgende maximale Einziehlängen bzw. Sanierungslänge: Seil Nr. 11: Einziehlänge 10,3 m und Länge des sanierten Bereiches 16,6 m.

Fig.9 Lötstellenplan zur Sanierung der verschlossenen Tragseile im Bereich einer Hängerklemme
