**Zeitschrift:** IABSE reports = Rapports AIPC = IVBH Berichte  
**Band:** 57/1/57/2 (1989)

## Durability Assessment from the Design Phase to Execution

**Extending the Life of the Williamsburg Bridge**  
Prolongation de la durée de vie du pont de Williamsburg  
Verlängerung der Lebensdauer der Williamsburg-Brücke

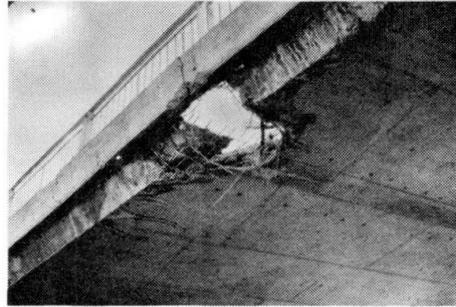
Fig. 1

- earthquakes;
- tropical cyclones;
- impacts due to road vehicles - Figure 1 or rail traffic, boats or even aircraft;
- fires and explosions;
- broken piping;
- slippage;
- landslides and avalanches;
- mining subsidence;
- local, general or regressive under mining;
- floods;
- human error....

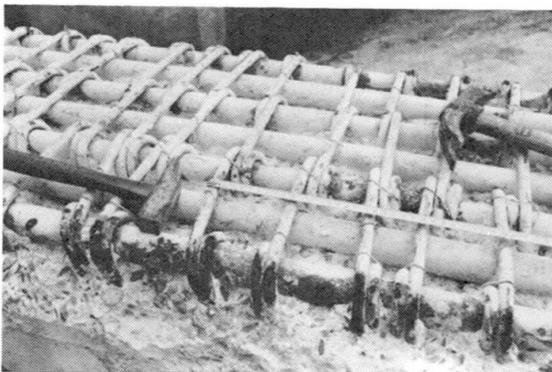
Fig.2

- electrochemical reactions (for instance in the presence of water containing salts which form an electrolyte, the richer sections of a steel part will take on the role of a soluble anode compared to the more heterogeneous parts which take on the function of the cathode. A corrosion will result - Figure 2).

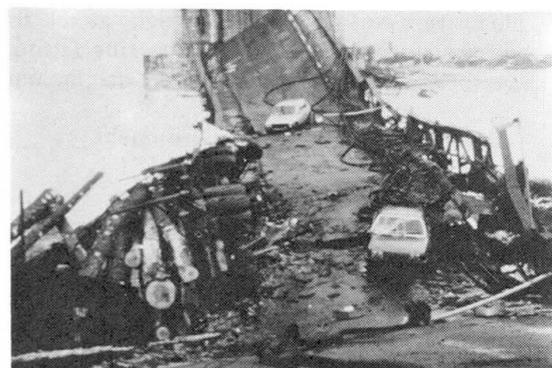
Fig.3

- physical reactions (for instance at low temperature metal materials have a reduced deformability which can lead to brittle phenomena in the case of impact or presence of nicks - Figure 3).

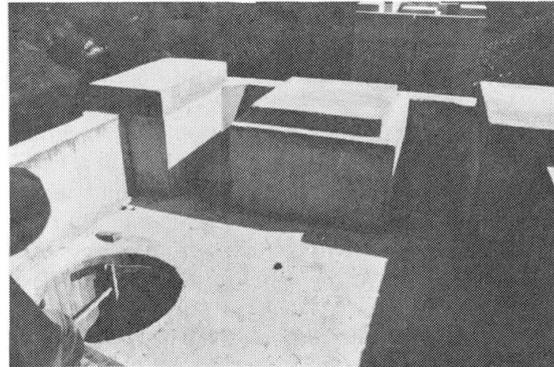
Fig.5

With regard to large size supports and all those located at a considerable height, the free height must be increased (by 0.40 m to 0.80 m or even more) to allow the workers to operate in the space located between the top of the deck and the bearing supports - Figure 5.

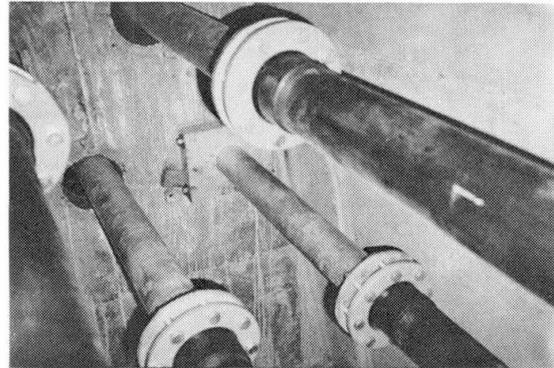
Fig.7

Currently, this external prestressing can be removed and replaced. For this purpose, the prestressing reinforcements are arranged under a double tubing in line with deflectors and fixtures - Figure 7.

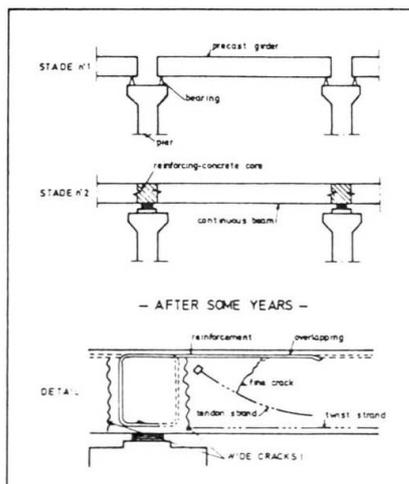
Fig.8

First example: we refer to reinforced concrete bridges composed of prefabricated contiguous beams linked by spacers poured in situ. The current state of decks, about forty years old, in relation to the very satisfactory state of bearings shows what can be achieved without top slab and waterproofing layer - Figure 8.

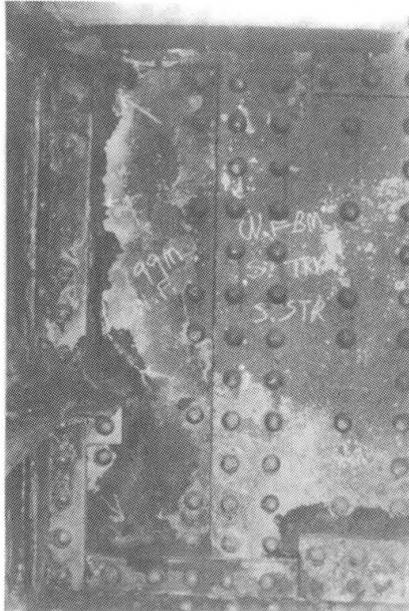
The first major areas of deterioration were found on the Brooklyn Bound outer roadway cantilever floorbeams on March 28, 1988. The webs of the floorbeams adjacent to the stiffening truss (at location of maximum moment and maximum shear) were severely deteriorated (many with through holes) in an "L-shaped" pattern vertically along the truss chord and horizontally along the floorbeam bottom flange angle. Upon being notified of this condition, the NYSDOT and NYCDOT decided to close the roadway to traffic. Considering the condition of the Brooklyn bound roadway, the cantilever floorbeams on the Manhattan bound roadway were then immediately inspected and similar conditions were found. This roadway was subsequently closed to traffic. In total, 46 out of 116 floorbeams required emergency repair.

The severity of the deterioration resulted from the fact that the roadway has no drainage system and water continually flows off the roadway onto the structural steel below. Modern design calls for a drainage collection system but frequently the discharge is not carried below structural members resulting in unnecessary corrosive conditions.

Fig. 3 Web Deterioration

PP99 was found to have its web completely deteriorated between the flange angles at the point of near maximum shear adjacent to the exterior stringer. Upon being notified of this condition the Transit Authority immediately suspended service across the Williamsburg Bridge.

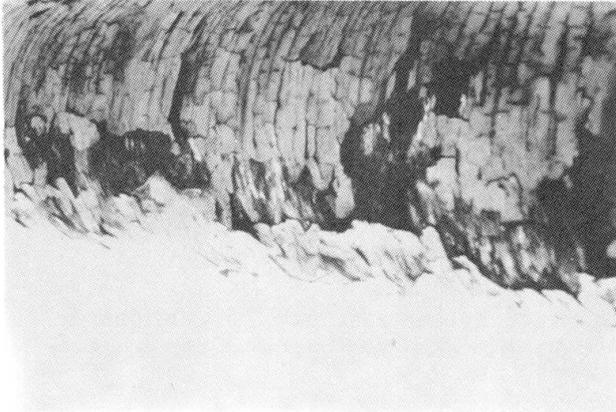
Our visual inspection of the wrapping found that the paint had peeled from the wrapping throughout most of its length but especially at the bottom of the cable. The wrapping had corroded at many locations and there were damaged

Fig. 4 Cable Paint Condition

sections of the wrapping that permitted water to penetrate to the cable. The locations of the worst situations plus a statistical approach led to the decision to pick five locations at which to unwrap cables and perform the sampling programs.

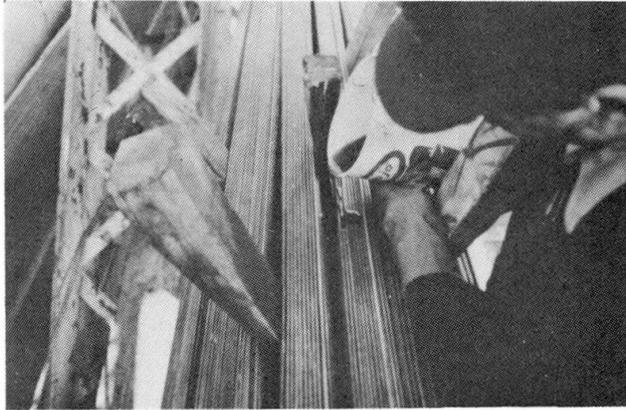
Fig. 7 Applying Protective Oil

The developed data was used to establish a corrosion rate and clamping length and various maintenance models were developed to forecast a cable life for the wrapped portion of the cable. A minimum maintenance model and a historic maintenance model indicated a safe minimum life of over fifty years. However, with rehabilitation and special maintenance there should be no further deterioration of the cable.
