**Zeitschrift:** IABSE reports = Rapports AIPC = IVBH Berichte  
**Band:** 57/1/57/2 (1989)  
**Rubrik:** Keynote lectures

## **Durability Assessment from the Design Phase to Execution**

Prolongation de la durée de vie du pont de Williamsburg  
Verlängerung der Lebensdauer der Williamsburg-Brücke

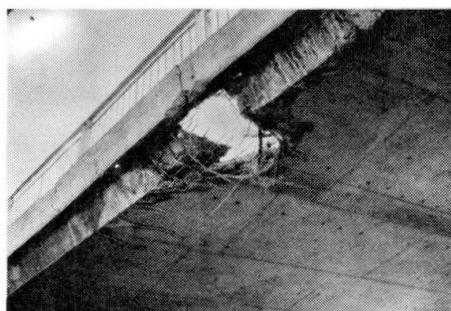
Fig. 1

- earthquakes;
- tropical cyclones;
- impacts due to road vehicles - Figure 1 or rail traffic, boats or even aircraft;
- fires and explosions;
- broken piping;
- slippage;
- landslides and avalanches;
- mining subsidence;
- local, general or regressive under mining;
- floods;
- human error....

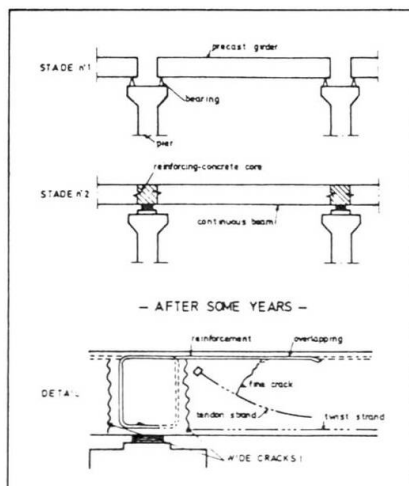
Fig.8

First example: we refer to reinforced concrete bridges composed of prefabricated contiguous beams linked by spacers poured in situ. The current state of decks, about forty years old, in relation to the very satisfactory state of bearings shows what can be achieved without top slab and waterproofing layer - Figure 8.

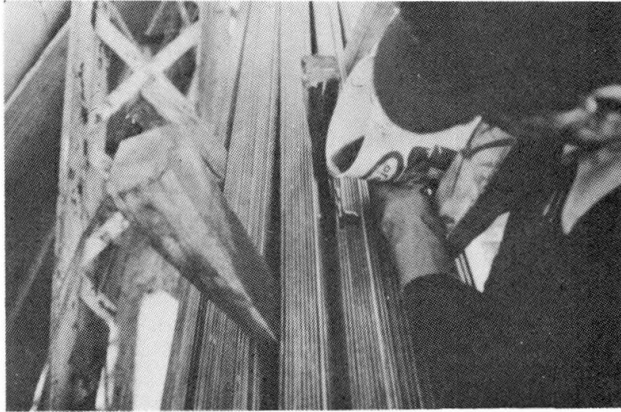
Fig. 7 Applying Protective Oil

The developed data was used to establish a corrosion rate and clamping length and various maintenance models were developed to forecast a cable life for the wrapped portion of the cable. A minimum maintenance model and a historic maintenance model indicated a safe minimum life of over fifty years. However, with rehabilitation and special maintenance there should be no further deterioration of the cable.
