Zeitschrift: IABSE reports = Rapports AIPC = IVBH Berichte
Band: 57/1/57/2 (1989)
Rubrik: Keynote lectures

Durability Assessment from the Design Phase to Execution

Prolongation de la durée de vie du pont de Williamsburg
Verlängerung der Lebensdauer der Williamsburg-Brücke

The decision to close the Williamsburg Bridge sent shock waves through transportation in New York City and brought the Williamsburg Bridge out from the shadows of the Brooklyn Bridge. The program to determine the present condition and the projected durability of the structure for possible rehabilitation rather than replacement is the subject of this paper.

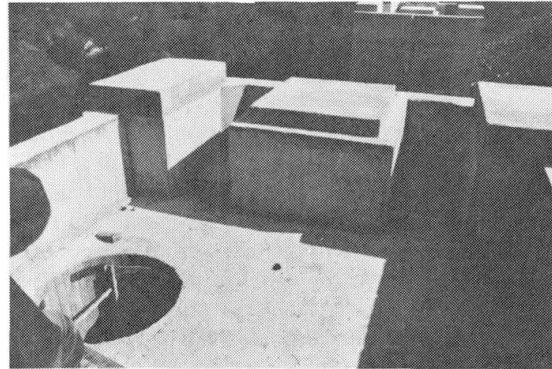
Fig.5

With regard to large size supports and all those located at a considerable height, the free height must be increased (by 0.40 m to 0.80 m or even more) to allow the workers to operate in the space located between the top of the deck and the bearing supports - Figure 5.

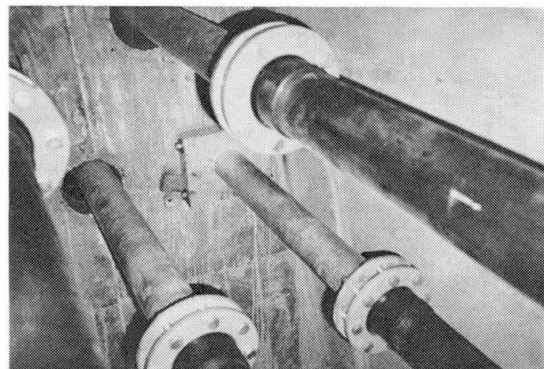
Fig.7

Currently, this external prestressing can be removed and replaced. For this purpose, the prestressing reinforcements are arranged under a double tubing in line with deflectors and fixtures - Figure 7.
