Extending the Life of the Williamsburg Bridge

William F. GEYER
Partner
Steinman
New York, NY, USA

The decision to close the Williamsburg Bridge sent shock waves through transportation in New York City and brought the Williamsburg Bridge out from the shadows of the Brooklyn Bridge. The program to determine the present condition and the projected durability of the structure for possible rehabilitation rather than replacement is the subject of this paper.

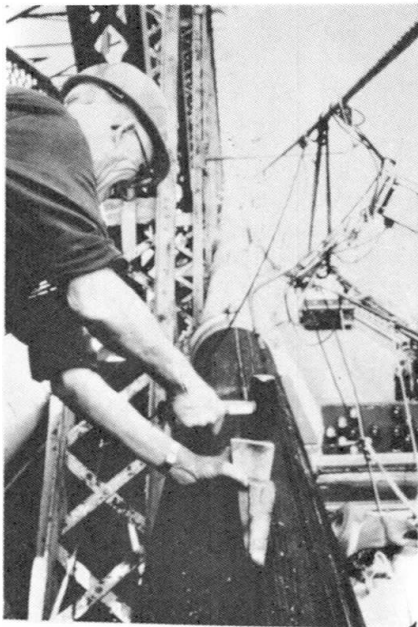
Fig. 5 Wedging the Cable

The procedure was to open a groove in the cable using wooden wedges and hydraulic jacks, visually inspect and take macro lens photographs, extract, coil and tag the sample for shipment to the laboratory. As the wire was cut the retraction of the wire was measured. The groove opening was then cleaned using a soft wire wheel brush or a cup wire brush. Samples of the corrosion and existing lubricant were then collected and sent to the laboratory for analysis. After cleaning photographs of the wire were taken at five foot intervals. One coat of protective oil (Vitalife 400) was then applied in the groove opening. After this procedure was completed at the eight groove openings, additional protective oil was applied liberally into the cable at that work location. The cable was then wrapped with Herculite and the inspection proceeded to the next work location.
