Extending the Life of the Williamsburg Bridge

William F. GEYER
Partner
Steinman
New York, NY, USA

The decision to close the Williamsburg Bridge sent shock waves through transportation in New York City and brought the Williamsburg Bridge out from the shadows of the Brooklyn Bridge. The program to determine the present condition and the projected durability of the structure for possible rehabilitation rather than replacement is the subject of this paper.

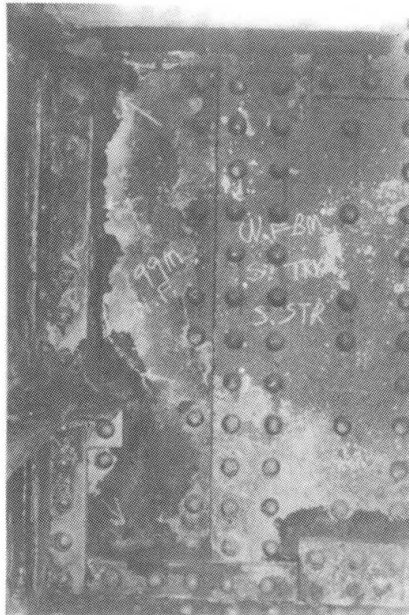
Fig. 3 Web Deterioration

The first major areas of deterioration were found on the Brooklyn Bound outer roadway cantilever floorbeams on March 28, 1988. The webs of the floorbeams adjacent to the stiffening truss (at location of maximum moment and maximum shear) were severely deteriorated (many with through holes) in an "L-shaped" pattern vertically along the truss chord and horizontally along the floorbeam bottom flange angle. Upon being notified of this condition, the NYSDOT and NYCDOT decided to close the roadway to traffic. Considering the condition of the Brooklyn bound roadway, the cantilever floorbeams on the Manhattan bound roadway were then immediately inspected and similar conditions were found. This roadway was subsequently closed to traffic. In total, 46 out of 116 floorbeams required emergency repair.

The severity of the deterioration resulted from the fact that the roadway has no drainage system and water continually flows off the roadway onto the structural steel below. Modern design calls for a drainage collection system but frequently the discharge is not carried below structural members resulting in unnecessary corrosive conditions.

PP99 was found to have its web completely deteriorated between the flange angles at the point of near maximum shear adjacent to the exterior stringer. Upon being notified of this condition the Transit Authority immediately suspended service across the Williamsburg Bridge.

The South inner roadway floorbeam at PP99 was also found to be completely deteriorated at its connection to the girder, except for about 9" of web. Fortunately, a knee bracket initially installed to provide rigidity was able to transmit the end reaction and thus avoid failure. At this point, with the concurrence of the Mayor, it was decided to completely close the bridge to expedite inspection and repair.

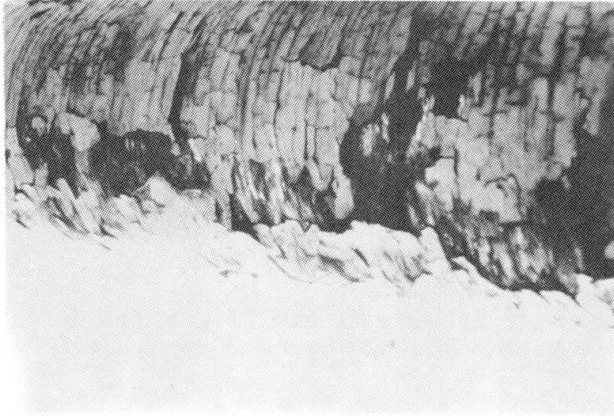
Fig. 4 Cable Paint Condition

Our visual inspection of the wrapping found that the paint had peeled from the wrapping throughout most of its length but especially at the bottom of the cable. The wrapping had corroded at many locations and there were damaged

sections of the wrapping that permitted water to penetrate to the cable. The locations of the worst situations plus a statistical approach led to the decision to pick five locations at which to unwrap cables and perform the sampling programs.
