Artikel: Extending the life of the Williamsburg Bridge
Autor: Geyer, William F.
DOI: <https://doi.org/10.5169/seals-44252>

Extending the Life of the Williamsburg Bridge
Prolongation de la durée de vie du pont de Williamsburg
Verlängerung der Lebensdauer der Williamsburg-Brücke

William F. GEYER
Partner
Steinman
New York, NY, USA

The decision to close the Williamsburg Bridge sent shock waves through transportation in New York City and brought the Williamsburg Bridge out from the shadows of the Brooklyn Bridge. The program to determine the present condition and the projected durability of the structure for possible rehabilitation rather than replacement is the subject of this paper.

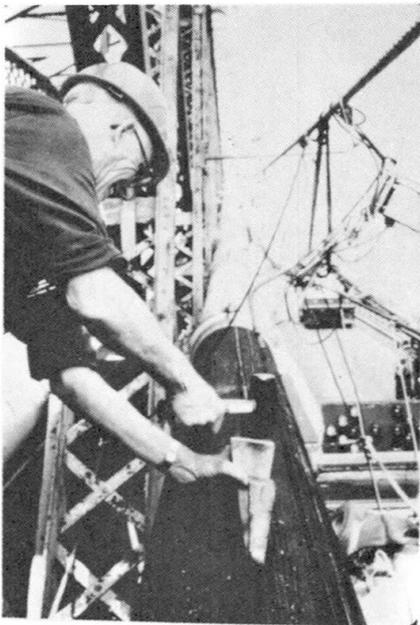
Fig. 5 Wedging the Cable

The procedure was to open a groove in the cable using wooden wedges and hydraulic jacks, visually inspect and take macro lens photographs, extract, coil and tag the sample for shipment to the laboratory. As the wire was cut the retraction of the wire was measured. The groove opening was then cleaned using a soft wire wheel brush or a cup wire brush. Samples of the corrosion and existing lubricant were then collected and sent to the laboratory for analysis. After cleaning photographs of the wire were taken at five foot intervals. One coat of protective oil (Vitalife 400) was then applied in the groove opening. After this procedure was completed at the eight groove openings, additional protective oil was applied liberally into the cable at that work location. The cable was then wrapped with Herculite and the inspection proceeded to the next work location.
