Zeitschrift: IABSE reports = Rapports AIPC = IVBH Berichte

Band: 57/1/57/2 (1989)

Rubrik: Presentation Session 4a: Case studies

Causes of Damages and Rehabilitation of the Pancevo Bridge

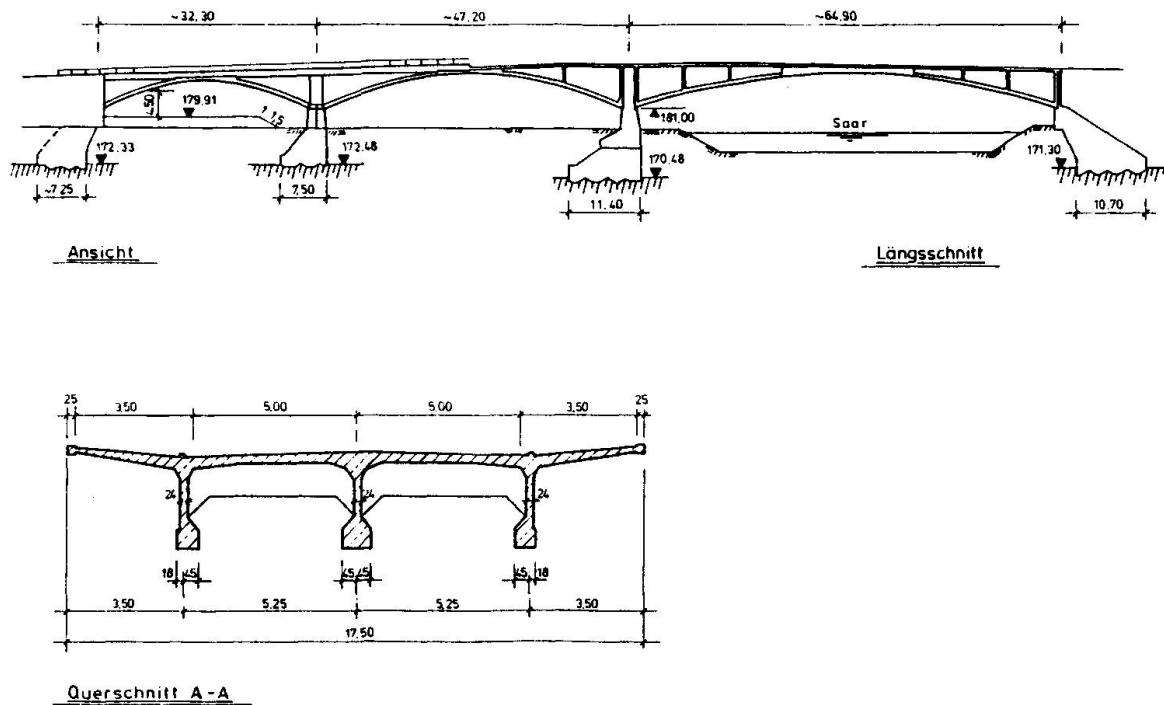
Bild 1 Von-Lettow-Vorbeck-Brücke in Saarlouis

In den Scheitelbereichen aller drei Bögen wurden bei einer routinemäßigen Brückenprüfung Risse festgestellt, deren Breite mit größer werdender Spannweite der Bögen zunahm. Während die Rißbreite im kleinen Landfeld nur bei 0,2 – 0,3 mm lag, erreichte sie im Mittelfeld schon 1,2 mm und wuchs im großen Saarfeld auf 2,5 mm an.

Eine Überprüfung des Verpreßgrades der Hüllrohre ergab, daß einige Spannglieder nicht oder nur teilweise verpreßt waren. Die Spanngliederoberfläche zeigte Korrosionsansätze, die nicht nur in den Bereichen mit Verpreßmängeln, sondern auch in vollständig verpreßten Strecken zu beobachten waren.

Eine Nachrechnung des Überbaus führte zu dem Ergebnis, daß in den Bereichen, wo die Risse beobachtet worden sind, hohe Zugspannungen im Beton vorhanden waren. Die Breite der Risse (max. $w = 2,5 \text{ mm}$) ist hauptsächlich auf den geringen inneren Hebelarm der Spannbewehrung und auf die sehr schwach ausgebildete schlaffe Bewehrung zurückzuführen. In den Untergurten der Bogenscheiben sind lediglich $6 \varnothing 8 = 3 \text{ cm}^2$ aus Stahl I vorhanden.

Unter diesen Umständen war es auch nicht weiter verwunderlich, daß die Bruchsicherheit im Scheitelbereich nicht im erforderlichen Rahmen nachgewiesen werden konnte.

Unter Abwägung der zu erwartenden Schwierigkeiten und der erforderlichen Kosten hat man sich nicht für eine Sanierung entschieden, sondern dem Abbruch und einem Neubau den Vorzug gegeben.

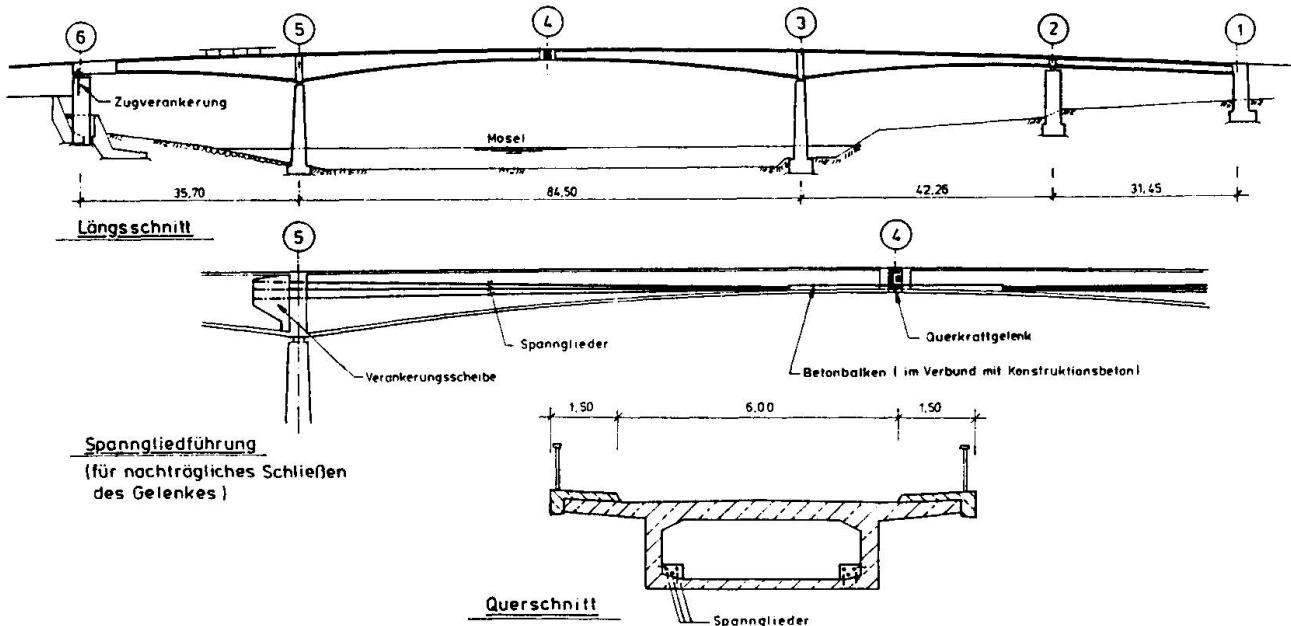
Bild 2: Moselbrücke bei Thörnich

Dieses Bauwerk wies nun Anfang der 80-er Jahre zwei schwerwiegende Schäden auf: die stark korrodierte, nicht mehr bewegliche Zugabspannung zur Kippsicherung des nördlichen Überbauabschnittes und die starke Durchbiegung im Gelenk des Stromfeldes.

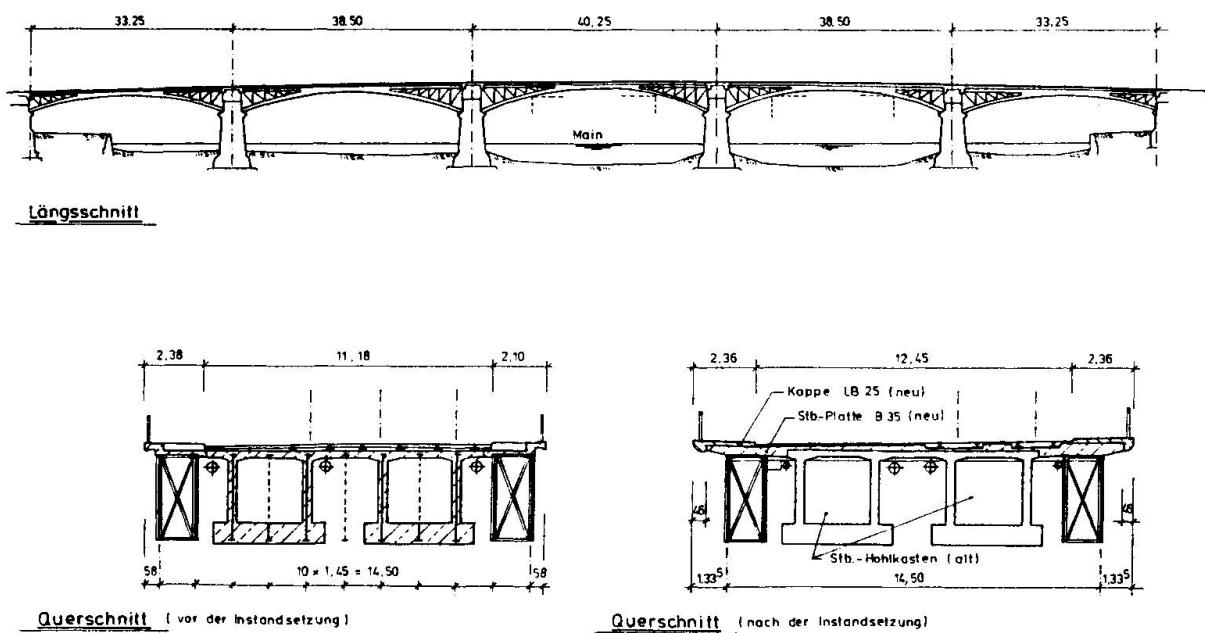
Bild 3: Obermainbrücke in Frankfurt a.M.

Dieses Bauwerk wies stärkere Schäden im Bereich der Fahrbahnplatte auf, die alle von Undichtigkeiten an den zahlreichen Fugen herrührten. An jedem Pfeiler waren 2 Querfugen und zwischen Massivteil und Stahlfachwerk war jeweils eine Längsfuge über die gesamte Bauwerkslänge vorhanden.

Das Instandsetzungskonzept sollte nicht nur zu einer Behebung der aufgetretenen Schäden, sondern auch zu einer weitgehenden Elimierung der Schwachpunkte führen. Zusätzlich sollte in der Vorplanung untersucht werden, ob nicht eine Verbreiterung der Fahrbahnplatte um ca. 1,50 m möglich sei, damit drei vollwertige Fahrstreifen gewonnen werden können.

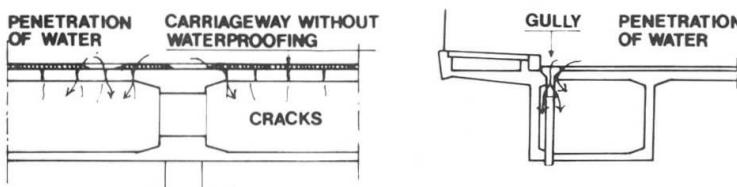
Fig. 3 - The penetration of water to the inside of the box

Beside the structures, the other elements of the bridges have also been examined: bearings, expansion joints, gullies, drainage system, carriageway, fence and the like. The expansion joints were incorrect and broken, Fig. 7, the bearings contained impurities and were corroded, some of them outside the bearing slab or turned out and the gullies were either blocked or out of operation due to some other reasons. The carriageway was unsMOOTH and wavy with a large number of impact holes, Fig. 3. The posts and the foundations were in a good state.

One of important design and execution failures is that waterproofing has not been planned. That has caused penetration of water and salt used for rubbing the bridge deck during the winter time. The penetration was to the inside

of the box, through the bridge deck, and especially through cracks appearing in the upper zone, above the medium supports, Fig. 3. Incorrect and damaged gullies were another way of water penetration to the inside of the main girder box. Their designed position in the middle of the span is very inconvenient as that is the place where the tendons are concentrated in the lower zone and the lower chord through which the drainage tubes penetrate, Fig. 6.

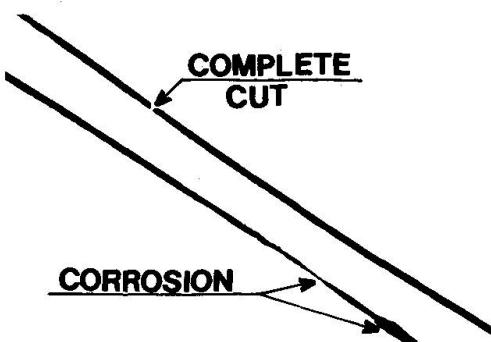
Fig. 4 - Corroded tendon

It has been found out that prestressing tendons were corroded on some of the places, from slight corrosion to complete cut, Fig. 4. Cement grout for injecting tendons was not of the required quality and on some of the places it did not exist, at all, Fig. 5. By measuring the existing force in the tendons, it was established that on a number of wires the designed prestressing force was not achieved. The results of measuring their own free oscillations and damping pointed to the decrease of general rigidity of the main girders.

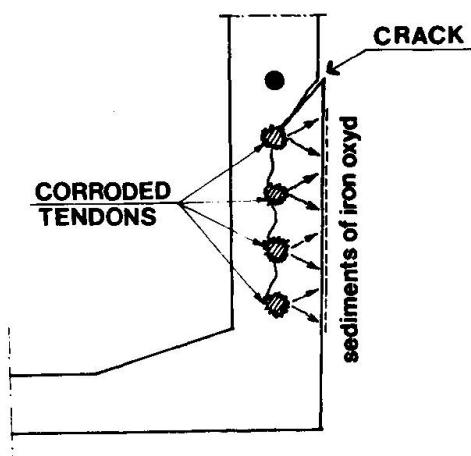
Fig. 5 - Irregular injected tendons

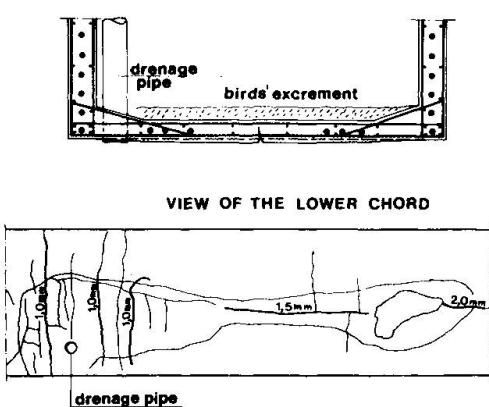
Fig. 6 - Damaged lower chord

Large damage and concrete deterioration zones have been tested and checked by ultrasonic, Fig. 6. The quality of the built in concrete and of the prestressing wires was examined, too.

Long presence of water in the inside of the box has also contributed to the corrosion of tendons as no openings on the lower chord for drainage of possibly penetrated water have been designed. No wire net was placed at the openings for entering the inside of the main girders and for aeration so the inside of the box made a good "home" for birds. In time, a thick layer (10 cm and more) of birds' excrement, eggs and similar impurities was formed which had extensively increased aggressivity of the environment, Fig. 6.

On one of the structures on which greater deterioration of the concrete, due to permanent wetting, and action of frost and salt took place, the whole damaged zone of the lower plate was replaced - several square metres, Fig. 6.

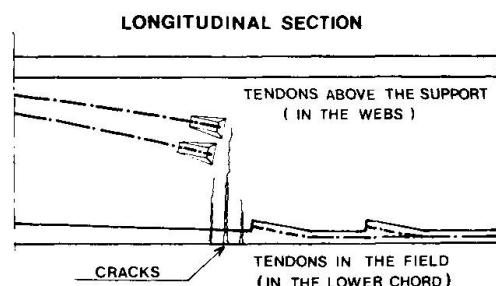
A certain number of cracks has appeared in the zones around 1/4 of the span due to incorrect anchoring of the tendons in the lower chord and webs as no care was taken of the necessary overlapping of the tendons at the places of anchorage, Fig. 8.

Fig. 8 - Irregular end of tendons

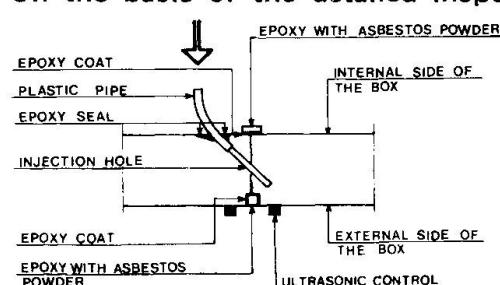
Fig. 9 - Cracks injecting

Within the rehabilitation of the structures, injecting of all cracks over 0.1 mm wide, by the application of special procedure, using low viscosity epoxy resin under pressure has been done. There was ultrasonic control of injecting, Fig. 9. During the execution of those works, the traffic on the bridge was

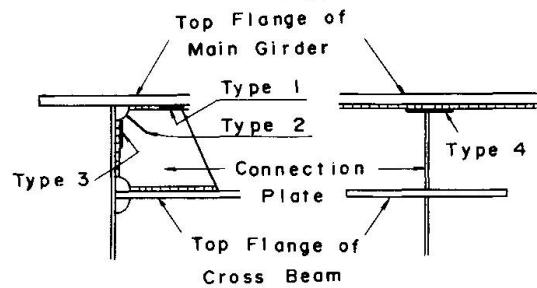
- (1) Defects are limited to bridges with reinforced concrete deck served more than 14 years. There is a tendency that the cracks are found for bridges,
 - 1) designed according to the specification edited in 1964 [1],
 - 2) with RC slab of span length more than 2.5 m long, and
 - 3) with relatively shallow slab depth.
- (2) Defects can be found for bridges with rigid cross beam, which was intended to secure good load distribution.
- (3) Most cracks are classified into Type 1 shown in Fig. 1. Type 2 cracks follows.

Fig. 1 Types of Fatigue Crack

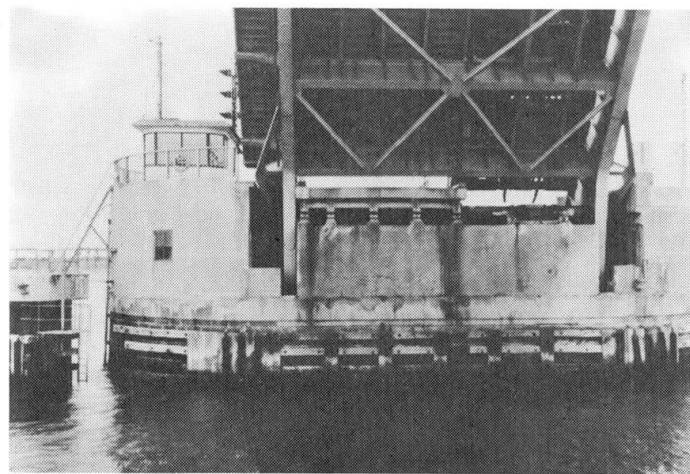
Fig. 2

Already shortly after the Oddesund bridge had been finished in 1937, settlements and cracks as well as deformations were found in the bascule pier (Fig. 2). Since then the bascule pier has been subjected to continued examinations, repairs and reinforcements. Likewise, it was the main object in connection with the work of the Danish Alkali-Silica Committee in the 1950's and the 1960's.

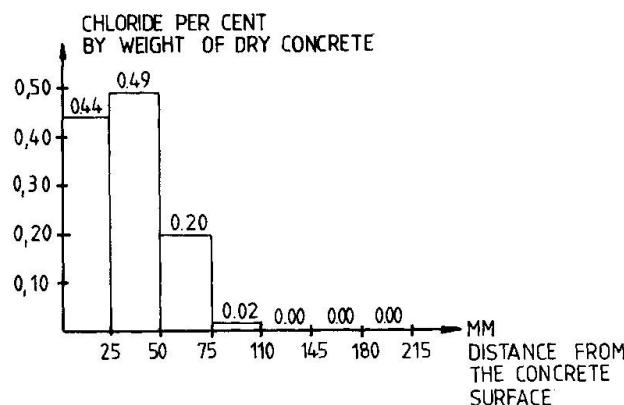
On the basis of these observations it was concluded that severe corrosion of the reinforcement located in the walls 0 to 0.5 m above ground level is caused by an excess of chloride in the concrete.

Fig. 2 Typical Chloride Profile at Ground Level

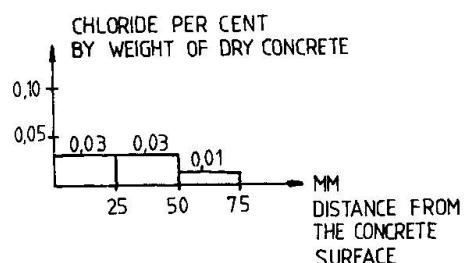
Fig. 3 Typical Chloride Profile approx. 0.7 m above Ground Level
