**Zeitschrift:** IABSE reports = Rapports AIPC = IVBH Berichte  
**Band:** 57/1/57/2 (1989)

**Rubrik:** Presentation Session 4a: Case studies

## Zweckässigkeit und Umfang von Instandsetzungen

## Causes of Damages and Rehabilitation of the Pancevo Bridge

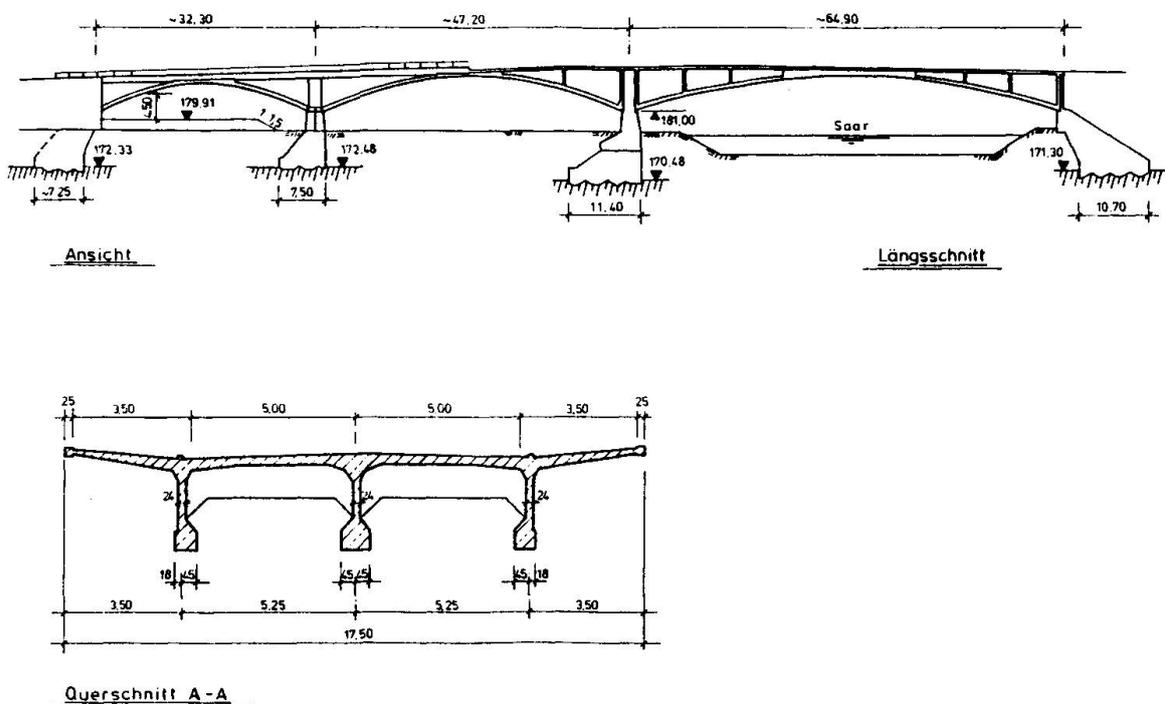
Bild 1. Von-Lettow-Vorbeck-Brücke in Saarlouis

In den Scheitelbereichen aller drei Bögen wurden bei einer routinemäßigen Brückenprüfung Risse festgestellt, deren Breite mit größer werdender Spannweite der Bögen zunahm. Während die Rißbreite im kleinen Landfeld nur bei 0,2 - 0,3 mm lag, erreichte sie im Mittelfeld schon 1,2 mm und wuchs im großen Saarfeld auf 2,5 mm an.

Eine Überprüfung des Verpreßgrades der Hüllrohre ergab, daß einige Spannglieder nicht oder nur teilweise verpreßt waren. Die Spanngliedoberfläche zeigte Korrosionsansätze, die nicht nur in den Bereichen mit Verpreßmängeln, sondern auch in vollständig verpreßten Strecken zu beobachten waren.

Eine Nachrechnung des Überbaus führte zu dem Ergebnis, daß in den Bereichen, wo die Risse beobachtet worden sind, hohe Zugspannungen im Beton vorhanden waren. Die Breite der Risse (max.  $w = 2,5$  mm) ist hauptsächlich auf den geringen inneren Hebelarm der Spannbewehrung und auf die sehr schwach ausgebildete schlaaffe Bewehrung zurückzuführen. In den Untergurten der Bogenscheiben sind lediglich  $6 \varnothing 8 = 3 \text{ cm}^2$  aus Stahl I vorhanden.

Unter diesen Umständen war es auch nicht weiter verwunderlich, daß die Bruchsicherheit im Scheitelbereich nicht im erforderlichen Rahmen nachgewiesen werden konnte.

Unter Abwägung der zu erwartenden Schwierigkeiten und der erforderlichen Kosten hat man sich nicht für eine Sanierung entschieden, sondern dem Abbruch und einem Neubau den Vorzug gegeben.

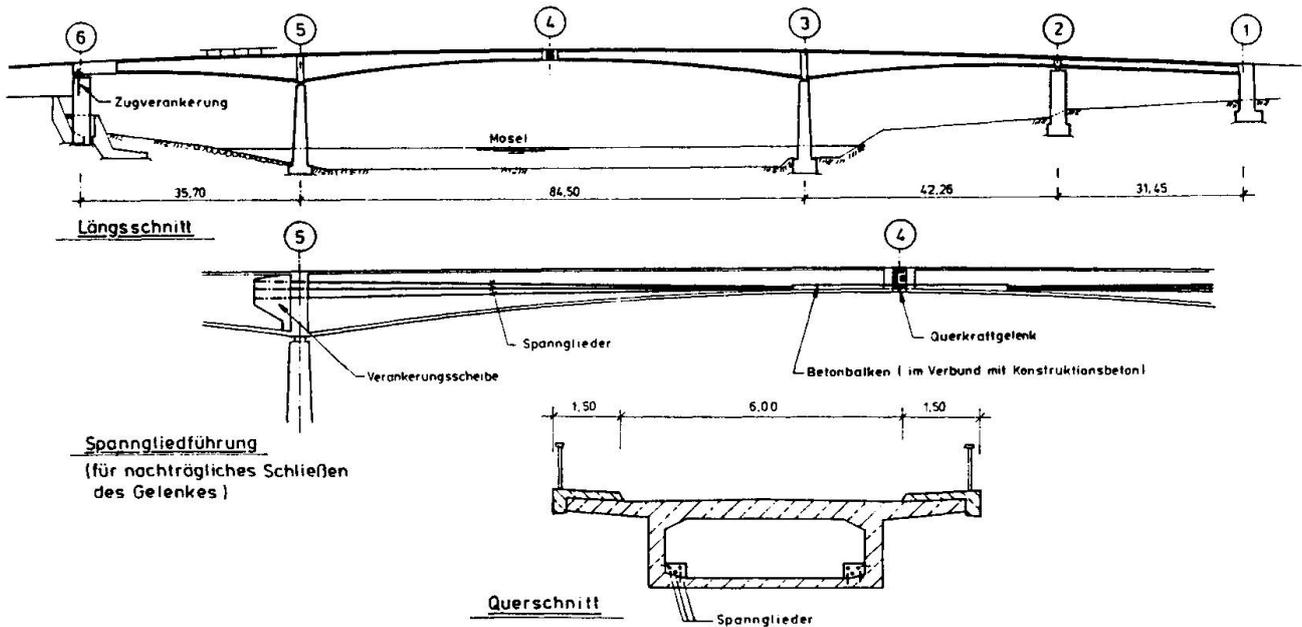
Bild 2: Moselbrücke bei Thörnich

Dieses Bauwerk wies nun Anfang der 80-er Jahre zwei schwerwiegende Schäden auf: die stark korrodierte, nicht mehr bewegliche Zugabspannung zur Kippsicherung des nördlichen Überbauabschnittes und die starke Durchbiegung im Gelenk des Stromfeldes.

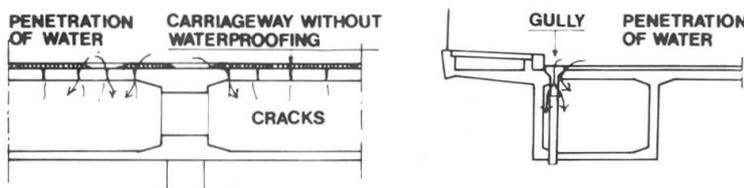
Fig. 3 - The penetration of water to the inside of the box

One of important design and execution failures is that waterproofing has not been planned. That has caused penetration of water and salt used for rubbing the bridge deck during the winter time. The penetration was to the inside

of the box, through the bridge deck, and especially through cracks appearing in the upper zone, above the medium supports, Fig. 3. Incorrect and damaged gullies were another way of water penetration to the inside of the main girder box. Their designed position in the middle of the span is very inconvenient as that is the place where the tendons are concentrated in the lower zone and the lower chord through which the drainage tubes penetrate, Fig. 6.

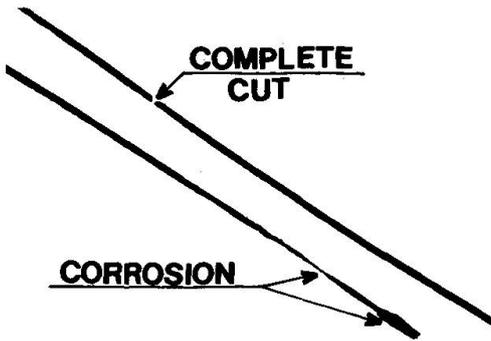
Fig. 4 - Corroded tendon

It has been found out that prestressing tendons were corroded on some of the places, from slight corrosion to complete cut, Fig. 4. Cement grout for injecting tendons was not of the required quality and on some of the places it did not exist, at all, Fig. 5. By measuring the existing force in the tendons, it was established that on a number of wires the designed prestressing force was not achieved. The results of measuring their own free oscillations and damping pointed to the decrease of general rigidity of the main girders.

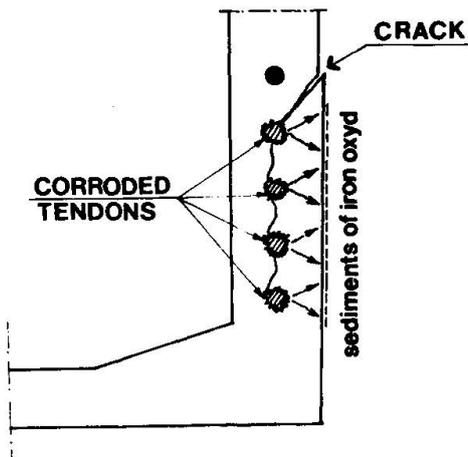
Fig. 5 - Irregular injected tendons

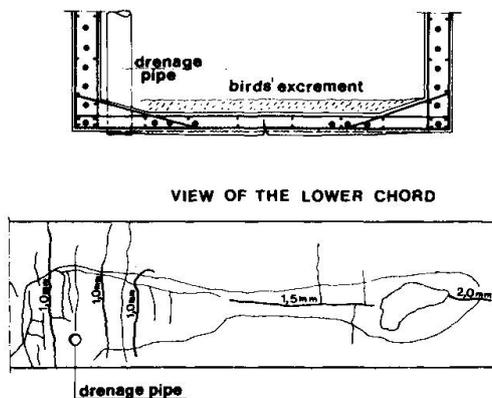
Fig. 6 - Damaged lower chord

Large damage and concrete deterioration zones have been tested and checked by ultrasonic, Fig. 6. The quality of the built in concrete and of the prestressing wires was examined, too.

Long presence of water in the inside of the box has also contributed to the corrosion of tendons as no openings on the lower chord for drainage of possibly penetrated water have been designed. No wire net was placed at the openings for entering the inside of the main girders and for aeration so the inside of the box made a good "home" for birds. In time, a thick layer (10 cm and more) of birds' excrement, eggs and similar impurities was formed which had extensively increased aggressivity of the environment, Fig. 6.

On one of the structures on which greater deterioration of the concrete, due to permanent wetting, and action of frost and salt took place, the whole damaged zone of the lower plate was replaced - several square metres, Fig. 6.

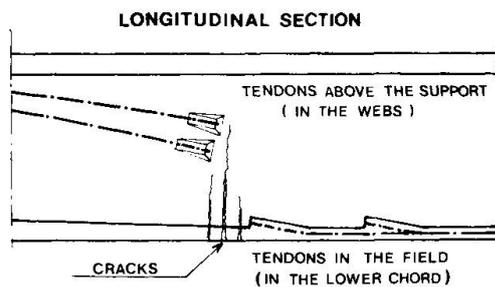
A certain number of cracks has appeared in the zones around 1/4 of the span due to incorrect anchoring of the tendons in the lower chord and webs as no care was taken of the necessary overlapping of the tendons at the places of anchorage, Fig. 8.

Fig. 8 - Irregular end of tendons

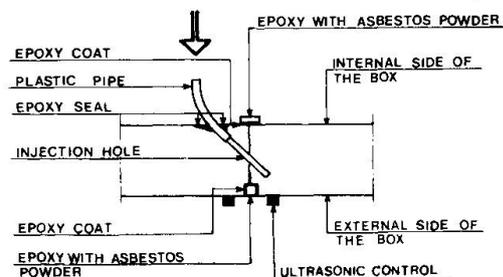
Fig. 9 - Cracks injecting

Within the rehabilitation of the structures, injecting of all cracks over 0.1 mm wide, by the application of special procedure, using low viscosity epoxy resin under pressure has been done. There was ultrasonic control of injecting, Fig. 9. During the execution of those works, the traffic on the bridge was

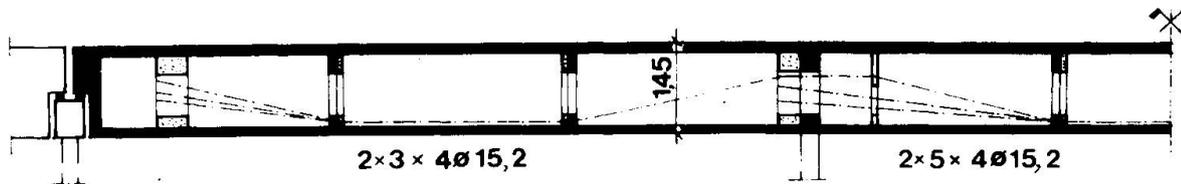
Fig. 10 - Disposition of additional tendons

For improving the state of stress and in order to achieve the required prestressing force, supplementary prestressing has been performed using new tendons of the IMS system. The tendons  $4\phi 15,2$  mm in polyethylene tubes are placed in the inside of the main girder boxes, Fig. 10. On the places on which the tendons

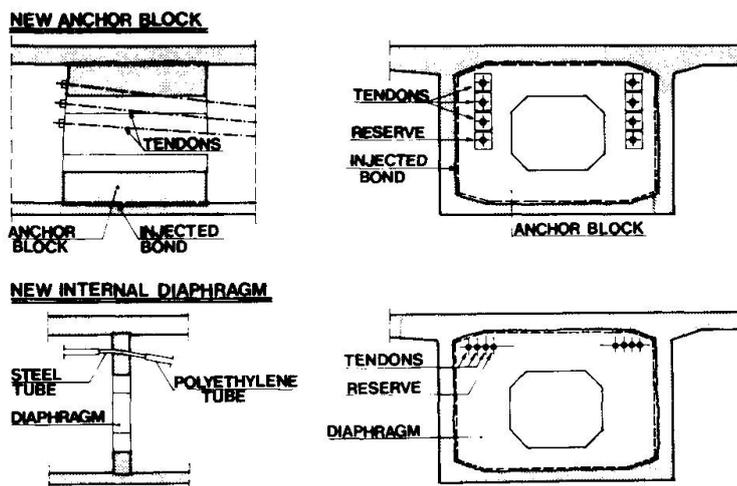
Fig. 11 - Details of the anchor block and diaphragm

are curved, correspondingly curved steel tubes have been placed instead of polyethylene tubes, Fig. 11. Such turnoff of the tendons has been executed on the places of the existing internal diaphragms whereat those diaphragms have

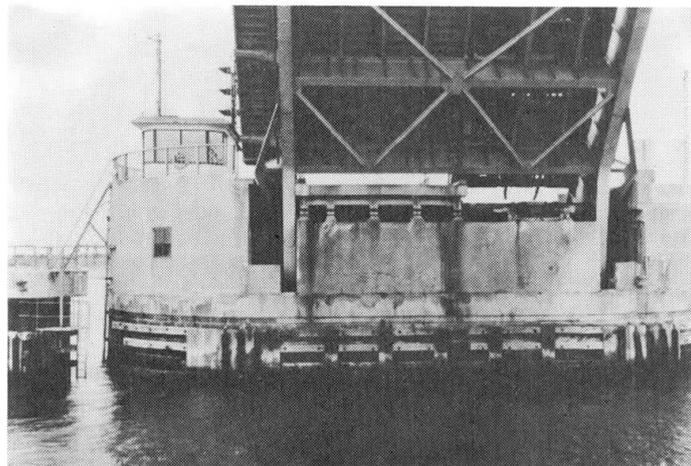
Fig. 2

Already shortly after the Odde Sund bridge had been finished in 1937, settlements and cracks as well as deformations were found in the bascule pier (Fig. 2). Since then the bascule pier has been subjected to continued examinations, repairs and reinforcements. Likewise, it was the main object in connection with the work of the Danish Alkali-Silica Committee in the 1950's and the 1960's.

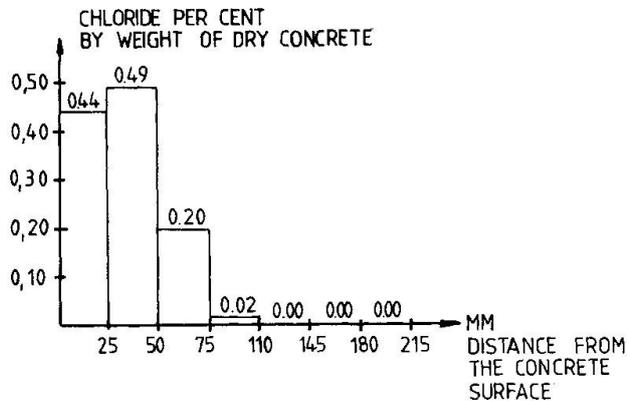
On the basis of these observations it was concluded that severe corrosion of the reinforcement located in the walls 0 to 0.5 m above ground level is caused by an excess of chloride in the concrete.

Fig. 2 Typical Chloride Profile at Ground Level
