**Zeitschrift:** IABSE reports = Rapports AIPC = IVBH Berichte  
**Band:** 57/1/57/2 (1989)

**Artikel:** Causes of damages and rehabilitation of the Pancevo Bridge  
**Autor:** Pakvor, Aleksandar / Djurdjevi, Mihajlo  
**DOI:** <https://doi.org/10.5169/seals-44282>

## Causes of Damages and Rehabilitation of the Pancevo Bridge

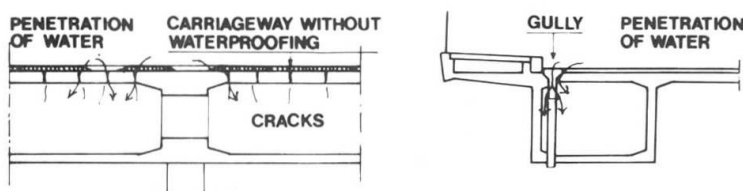
Fig. 3 - The penetration of water to the inside of the box

majority of structures. The cracks were mainly perpendicular to the main girders direction and distributed in the zones around the medium supports and about the middle of the span, Fig. 3. A detailed inspection of the structures has been made including the "survey" of cracks, both from the outside

One of important design and execution failures is that waterproofing has not been planned. That has caused penetration of water and salt used for rubbing the bridge deck during the winter time. The penetration was to the inside

of the box, through the bridge deck, and especially through cracks appearing in the upper zone, above the medium supports, Fig. 3. Incorrect and damaged gullies were another way of water penetration to the inside of the main girder box. Their designed position in the middle of the span is very inconvenient as that is the place where the tendons are concentrated in the lower zone and the lower chord through which the drainage tubes penetrate, Fig. 6.

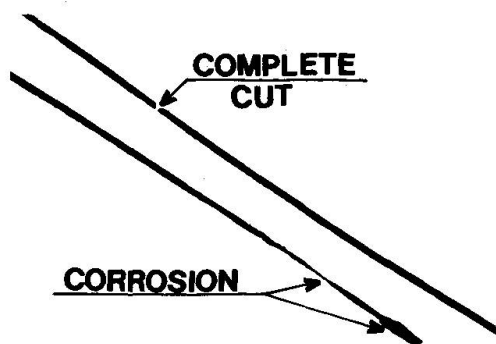
Fig. 4 - Corroded tendon

It has been found out that prestressing tendons were corroded on some of the places, from slight corrosion to complete cut, Fig. 4. Cement grout for injecting tendons was not of the required quality and on some of the places it did not exist, at all, Fig. 5. By measuring the existing force in the tendons, it was established that on a number of wires the designed prestressing force was not achieved. The results of measuring their own free oscillations and damping pointed to the decrease of general rigidity of the main girders.

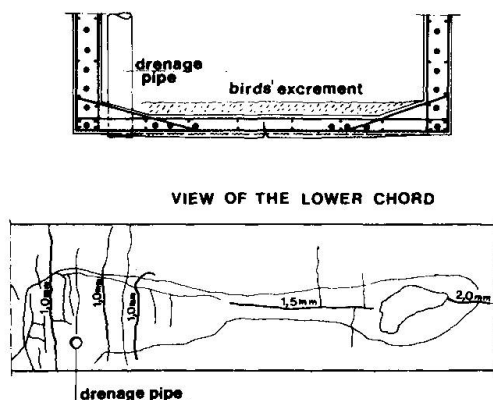
Fig. 6 - Damaged lower chord

Large damage and concrete deterioration zones have been tested and checked by ultrasonic, Fig. 6. The quality of the built in concrete and of the prestressing wires was examined, too.

Long presence of water in the inside of the box has also contributed to the corrosion of tendons as no openings on the lower chord for drainage of possibly penetrated water have been designed. No wire net was placed at the openings for entering the inside of the main girders and for aeration so the inside of the box made a good "home" for birds. In time, a thick layer (10 cm and more) of birds' excrement, eggs and similar impurities was formed which had extensively increased aggressivity of the environment, Fig. 6.

On one of the structures on which greater deterioration of the concrete, due to permanent wetting, and action of frost and salt took place, the whole damaged zone of the lower plate was replaced - several square metres, Fig. 6.

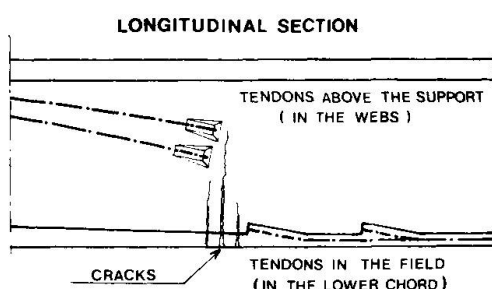
Fig. 8 - Irregular end of tendons

A certain number of cracks has appeared in the zones around  $1/4$  of the span due to incorrect anchoring of the tendons in the lower chord and webs as no care was taken of the necessary overlapping of the tendons at the places of anchorage, Fig. 8.
