Zeitschrift: IABSE reports = Rapports AIPC = IVBH Berichte
Band: 57/1/57/2 (1989)

Artikel: Causes of damages and rehabilitation of the Pancevo Bridge
Autor: Pakvor, Aleksandar / Djurdjevi, Mihajlo
DOI: <https://doi.org/10.5169/seals-44282>

Causes of Damages and Rehabilitation of the Pancevo Bridge

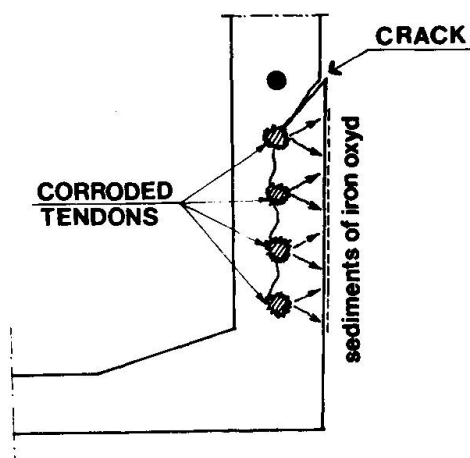
Fig. 5 - Irregular injected tendons

It has been found out that prestressing tendons were corroded on some of the places, from slight corrosion to complete cut, Fig. 4. Cement grout for injecting tendons was not of the required quality and on some of the places it did not exist, at all, Fig. 5. By measuring the existing force in the tendons, it was established that on a number of wires the designed prestressing force was not achieved. The results of measuring their own free oscillations and damping pointed to the decrease of general rigidity of the main girders.

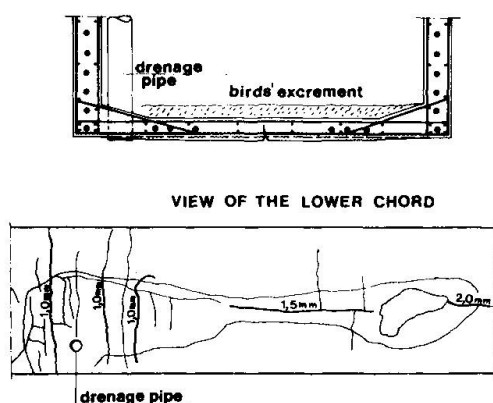
Fig. 6 - Damaged lower chord

Large damage and concrete deterioration zones have been tested and checked by ultrasonic, Fig. 6. The quality of the built in concrete and of the prestressing wires was examined, too.

of the box, through the bridge deck, and especially through cracks appearing in the upper zone, above the medium supports, Fig. 3. Incorrect and damaged gullies were another way of water penetration to the inside of the main girder box. Their designed position in the middle of the span is very inconvenient as that is the place where the tendons are concentrated in the lower zone and the lower chord through which the drainage tubes penetrate, Fig. 6.

Long presence of water in the inside of the box has also contributed to the corrosion of tendons as no openings on the lower chord for drainage of possibly penetrated water have been designed. No wire net was placed at the openings for entering the inside of the main girders and for aeration so the inside of the box made a good "home" for birds. In time, a thick layer (10 cm and more) of birds' excrement, eggs and similar impurities was formed which had extensively increased aggressivity of the environment, Fig. 6.

On one of the structures on which greater deterioration of the concrete, due to permanent wetting, and action of frost and salt took place, the whole damaged zone of the lower plate was replaced - several square metres, Fig. 6.

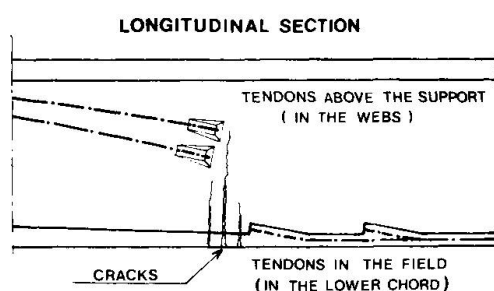
A certain number of cracks has appeared in the zones around $1/4$ of the span due to incorrect anchoring of the tendons in the lower chord and webs as no care was taken of the necessary overlapping of the tendons at the places of anchorage, Fig. 8.

Fig. 8 - Irregular end of tendons

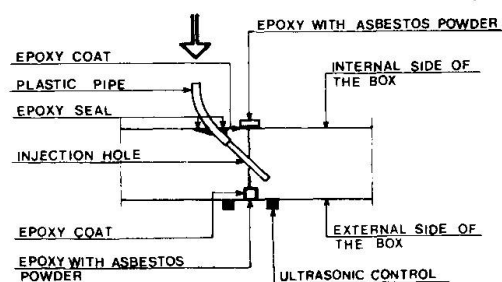
Fig. 9 - Cracks injecting

Within the rehabilitation of the structures, injecting of all cracks over 0.1 mm wide, by the application of special procedure, using low viscosity epoxy resin under pressure has been done. There was ultrasonic control of injecting, Fig. 9. During the execution of those works, the traffic on the bridge was

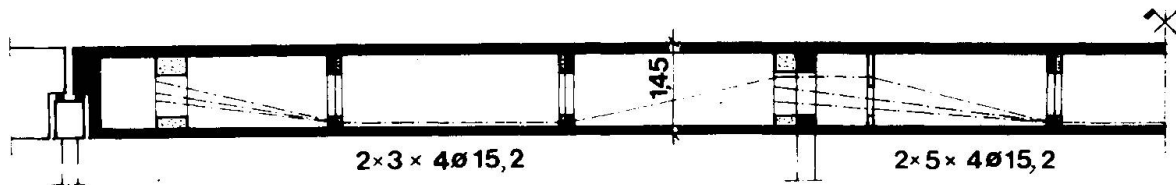
Fig. 10 - Disposition of additional tendons

For improving the state of stress and in order to achieve the required prestressing force, supplementary prestressing has been performed using new tendons of the IMS system. The tendons $4\phi 15,2$ mm in polyethylene tubes are placed in the inside of the main girder boxes, Fig. 10. On the places on which the tendons

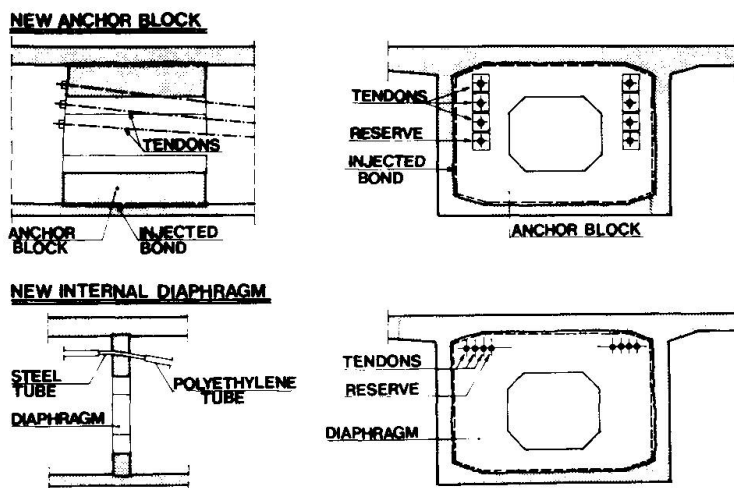
Fig. 11 - Details of the anchor block and diaphragm

are curved, correspondingly curved steel tubes have been placed instead of polyethylene tubes, Fig. 11. Such turnoff of the tendons has been executed on the places of the existing internal diaphragms whereat those diaphragms have

been reinforced. On the places on which the tendons should be turned off but on which there have been no diaphragms, the new ones are made. The tendons are anchored into the newly built anchor blocks positioned in the inside of the box at the ends of the structure, as the access from the front of the structure was not possible, Fig. 11.

eliminate negative effect of shrinkage and other factors, the existing contact concrete surfaces have been knocked off as deep as the protective layer and textured. Upon the concreting of anchor blocks and after the required strength has been acquired, the contact surfaces have been injected by low viscosity epoxy resin under pressure, with the ultrasonic control.
