**Artikel:** Causes of damages and rehabilitation of the Pancevo Bridge

**Autor:** Pakvor, Aleksandar / Djurdjevi, Mihajlo

## Causes of Damages and Rehabilitation of the Pancevo Bridge

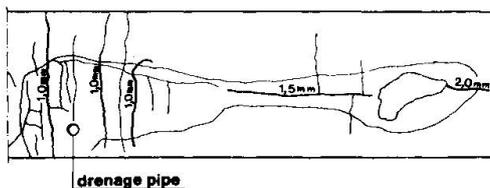
Fig. 6 - Damaged lower chord

Large damage and concrete deterioration zones have been tested and checked by ultrasonic, Fig. 6. The quality of the built in concrete and of the prestressing wires was examined, too.

Long presence of water in the inside of the box has also contributed to the corrosion of tendons as no openings on the lower chord for drainage of possibly penetrated water have been designed. No wire net was placed at the openings for entering the inside of the main girders and for aeration so the inside of the box made a good "home" for birds. In time, a thick layer (10 cm and more) of birds' excrement, eggs and similar impurities was formed which had extensively increased aggressivity of the environment, Fig. 6.

On one of the structures on which greater deterioration of the concrete, due to permanent wetting, and action of frost and salt took place, the whole damaged zone of the lower plate was replaced - several square metres, Fig. 6.
