**Artikel:** Repair of fatigue-cracked plate girders in highway bridges  
**Autor:** Nishimura, Akira / Horikawa, Kohsuke / Takayama, Hiromi  
**DOI:** <https://doi.org/10.5169/seals-44284>

**Repair of Fatigue-Cracked Plate Girders in Highway Bridges**  
**Réparation de poutres métalliques de ponts ayant des fissures de fatigue**  
**Reparatur von Blechträgern mit Ermüdungsrissen in Brücken**

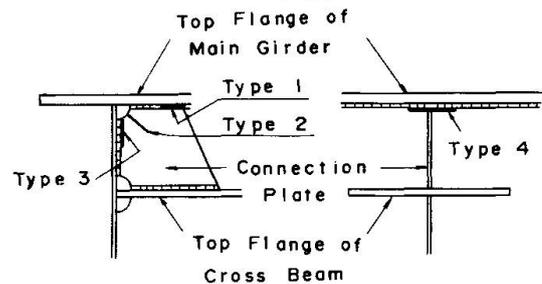
Fig. 1 Types of Fatigue Crack

(3) Most cracks are classified into Type 1 shown in Fig. 1. Type 2 cracks follows.

From the experiment, it was concluded that the rotational difference between the slab and the cross beam or the bracing is the main cause of the defects. Other inducements are to be welding defects caused by an excessive root-gap, or a notch of weld bead around a scallop.

As a result of the investigation shown above, the repairing method was decided as follows: replace the present 9 mm thick plate with 19 mm one by partial penetration welds. It is expected to secure strength and minimize the harmful influence at field welds.

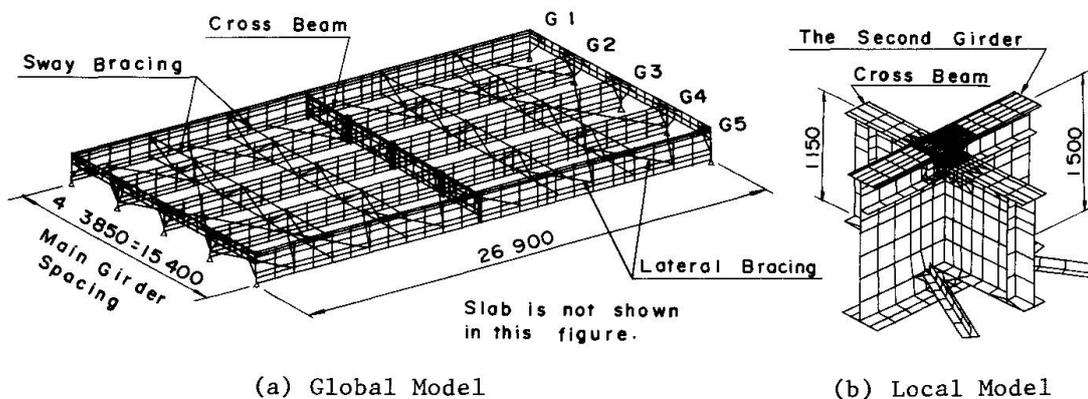
Fig. 2 Analysis Model

Finite Element Method was used to analyze stress distribution and its value. Phase-1 analysis was made on coarse three dimensional model shown in Fig. 2(a) to assess the global stress flow. A 20-ton-truck load, designated as T-20 loading in design specification [1](Fig. 3), was placed in the longitudinal

direction, two in the transverse direction so that those cause the most severe stress distribution at the place of concern. To make a detail investigation of stress distribution, Phase-2 analysis was made on a partial three dimensional model shown in Fig. 2(b) by applying the sectional force given by the Phase-1 analysis.

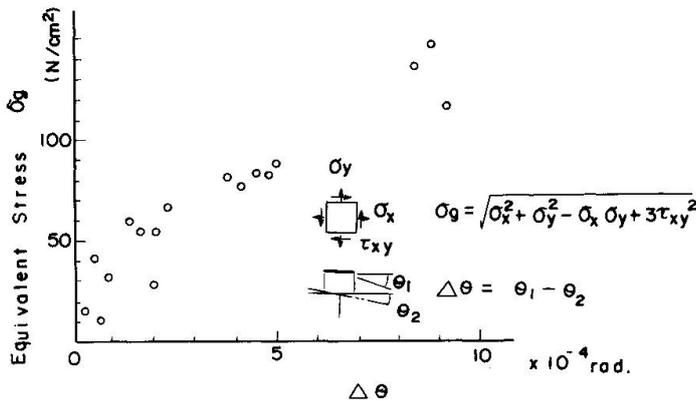
Fig. 4 Relation between  $\sigma_g$  and  $\Delta\theta$

From Phase-1 analysis, it was concluded there is a close correlation between the equivalent stress at the connection plate and the rotational difference between the slab and the cross beam as shown in Fig. 4.

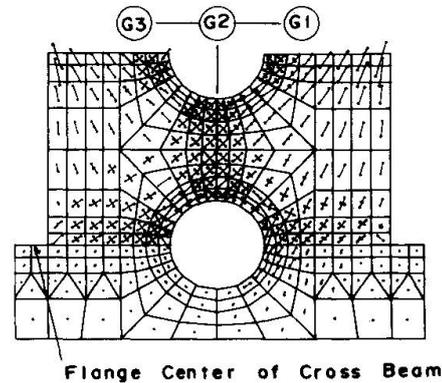
Fig. 5 Principal Stress Diagram

- 1) The Principal stress over 200 N/cm<sup>2</sup> is detected on the connection plate adjacent to the free edge of the top flange of the main girder. Due to shearing stress, the principal stress direction vary significantly as it comes closer to the web as shown in Fig. 5.
- 2) There is a stress turbulence due to scallop.

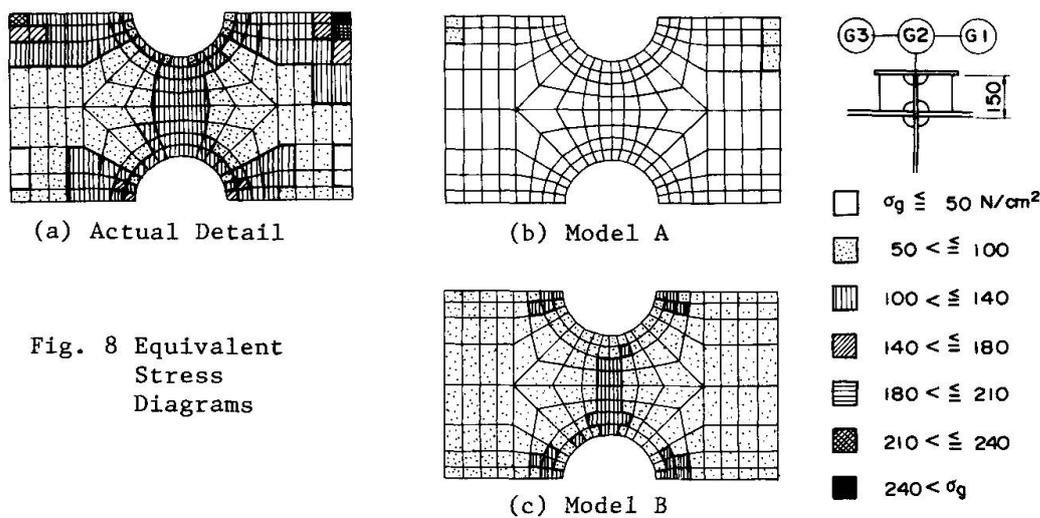
Fig. 8 Equivalent Stress Diagrams

Two prototypes shown in Fig. 7 are proposed as repairing prototypes. For Model A, Fig. 7(a), the thickness of the connection plate was tripled. For Model B, Fig. 7(b), a rib plate was attached along the edge of the connection plate. Analysis was performed in accordance with the method shown in 3.1. The results are shown in Fig. 8. Model A lessens stress to one third. Model B improves the stress distribution at the free edge of the connection plate, but stress distribution around the scallop remains almost the same.

From these results, Model A was expected as an effective repairing detail and its availability was confirmed by fatigue testing on the tested two-girder type specimen by replacing cracked connection plate with tripled thickness one.

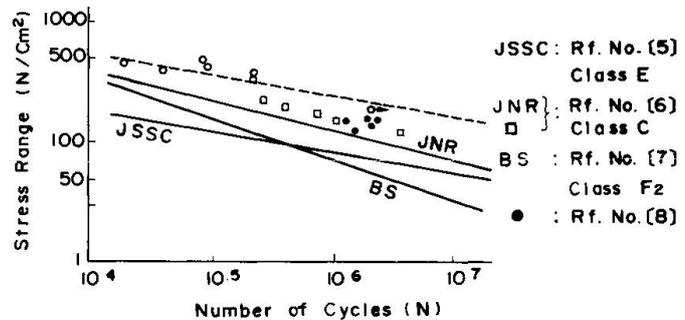
Fig. 10 Fatigue Test Result

The similar fatigue test as 3.3 was also performed for the structure designed by applying new specification. No cracks were detected. A series of the fatigue test was summarized as S-N relation in Fig. 10. The dotted line shows the S-N line given by the least square method. The slope is,

therefore the stress amplitude for 2,000,000 cycles is about 200 N/cm<sup>2</sup>.

Assuming that the bridges showed the defects are estimated to have experienced stress amplitude of 80 N/cm<sup>2</sup> for the past 14 years, we may conclude that bridges designed by new specification can sustain more than  $(80/25)^{5.4} \times 14$  years.

Slab span and the slab thickness have been improved from the stand point of fatigue. But in view of the increase of excessive truck loads, 12 mm thick connection plate is recommended to be applied in place of 9 mm one. And, no scallops are allowed in this portion, as it can be seen in 3.1.
