Zeitschrift: IABSE reports = Rapports AIPC = IVBH Berichte
Band: 57/1/57/2 (1989)

Artikel: Repair of fatigue-cracked plate girders in highway bridges
Autor: Nishimura, Akira / Horikawa, Kohsuke / Takayama, Hiromi
DOI: <https://doi.org/10.5169/seals-44284>

Repair of Fatigue-Cracked Plate Girders in Highway Bridges
Réparation de poutres métalliques de ponts ayant des fissures de fatigue
Reparatur von Blechträgern mit Ermüdungsrissen in Brücken

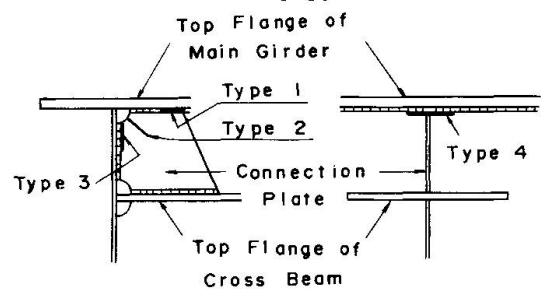
Fig. 1 Types of Fatigue Crack

(3) Most cracks are classified into Type 1 shown in Fig. 1. Type 2 cracks follows.

From the experiment, it was concluded that the rotational difference between the slab and the cross beam or the bracing is the main cause of the defects. Other inducements are to be welding defects caused by an excessive root-gap, or a notch of weld bead around a scallop.

As a result of the investigation shown above, the repairing method was decided as follows: replace the present 9 mm thick plate with 19 mm one by partial penetration welds. It is expected to secure strength and minimize the harmful influence at field welds.

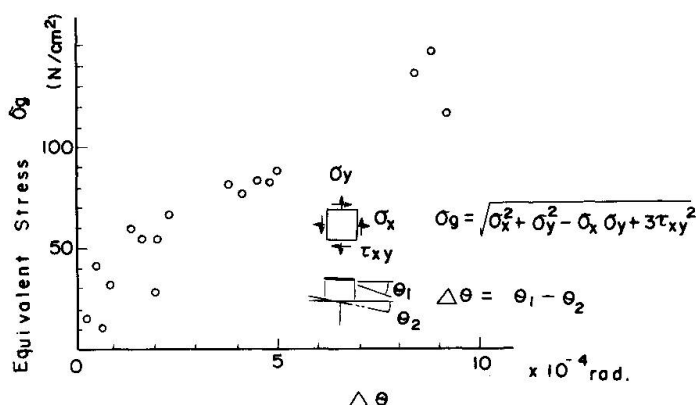
Fig. 4 Relation between σ_g and $\Delta\theta$

From Phase-1 analysis, it was concluded there is a close correlation between the equivalent stress at the connection plate and the rotational difference between the slab and the cross beam as shown in Fig. 4.

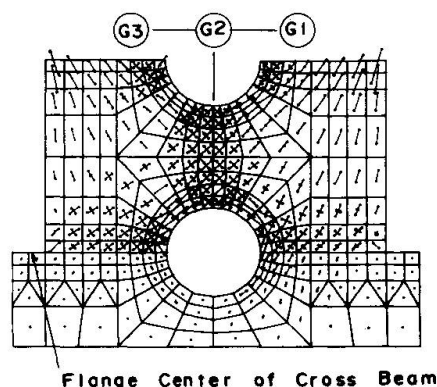
Fig. 5 Principal Stress Diagram

- 1) The Principal stress over 200 N/cm² is detected on the connection plate adjacent to the free edge of the top flange of the main girder. Due to shearing stress, the principal stress direction vary significantly as it comes closer to the web as shown in Fig. 5.
- 2) There is a stress turbulence due to scallop.

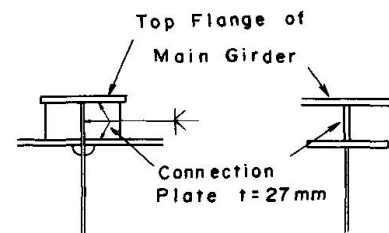
Fig. 7 Prototypes

Two prototypes shown in Fig. 7 are proposed as repairing prototypes. For Model A, Fig. 7(a), the thickness of the connection plate was tripled. For Model B, Fig. 7(b), a rib plate was attached along the edge of the connection plate. Analysis was performed in accordance with the method shown in 3.1. The results are shown in Fig. 8. Model A lessens stress to one third. Model B improves the stress distribution at the free edge of the connection plate, but stress distribution around the scallop remains almost the same.

From these results, Model A was expected as an effective repairing detail and its availability was confirmed by fatigue testing on the tested two-girder type specimen by replacing cracked connection plate with tripled thickness one.

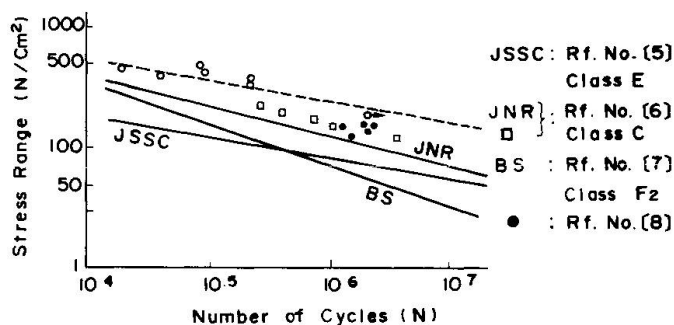
Fig. 10 Fatigue Test Result

A series of the fatigue test was summarized as S-N relation in Fig. 10. The dotted line shows the S-N line given by the least square method. The slope is,

therefore the stress amplitude for 2,000,000 cycles is about 200 N/cm^2 .

Assuming that the bridges showed the defects are estimated to have experienced stress amplitude of 80 N/cm^2 for the past 14 years, we may conclude that bridges designed by new specification can sustain more than $(80/25)^{5.4} \times 14$ years.

Slab span and the slab thickness have been improved from the stand point of fatigue. But in view of the increase of excessive truck loads, 12 mm thick connection plate is recommended to be applied in place of 9 mm one. And, no scallops are allowed in this portion, as it can be seen in 3.1.
