**Artikel:** Repair of fatigue-cracked plate girders in highway bridges  
**Autor:** Nishimura, Akira / Horikawa, Kohsuke / Takayama, Hiromi  
**DOI:** <https://doi.org/10.5169/seals-44284>

**Repair of Fatigue-Cracked Plate Girders in Highway Bridges**  
**Réparation de poutres métalliques de ponts ayant des fissures de fatigue**  
**Reparatur von Blechträgern mit Ermüdungsrissen in Brücken**

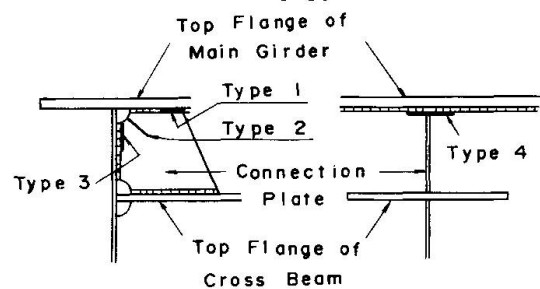
Fig. 1 Types of Fatigue Crack

(1) Defects are limited to bridges with reinforced concrete deck served more than 14 years. There is a tendency that the cracks are found for bridges,

- 1) designed according to the specification edited in 1964 [1],
- 2) with RC slab of span length more than 2.5 m long, and
- 3) with relatively shallow slab depth.

(2) Defects can be found for bridges with rigid cross beam, which was intended to secure good load distribution.

(3) Most cracks are classified into Type 1 shown in Fig. 1. Type 2 cracks follows.

From the experiment, it was concluded that the rotational difference between the slab and the cross beam or the bracing is the main cause of the defects. Other inducements are to be welding defects caused by an excessive root-gap, or a notch of weld bead around a scallop.

As a result of the investigation shown above, the repairing method was decided as follows: replace the present 9 mm thick plate with 19 mm one by partial penetration welds. It is expected to secure strength and minimize the harmful influence at field welds.

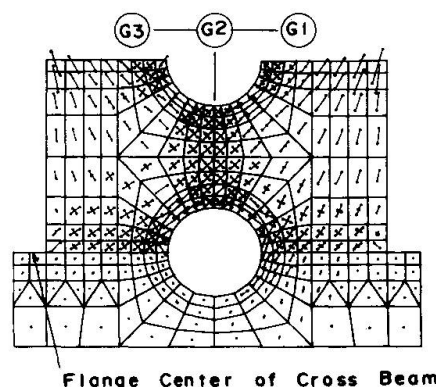
Fig. 5 Principal Stress Diagram

- 1) The Principal stress over 200 N/cm<sup>2</sup> is detected on the connection plate adjacent to the free edge of the top flange of the main girder. Due to shearing stress, the principal stress direction vary significantly as it comes closer to the web as shown in Fig. 5.
- 2) There is a stress turbulence due to scallop.

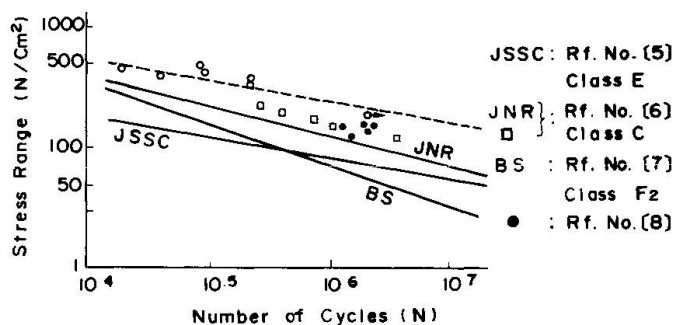
Fig. 10 Fatigue Test Result

A series of the fatigue test was summarized as S-N relation in Fig. 10. The dotted line shows the S-N line given by the least square method. The slope is,

therefore the stress amplitude for 2,000,000 cycles is about  $200 \text{ N/cm}^2$ .

Assuming that the bridges showed the defects are estimated to have experienced stress amplitude of  $80 \text{ N/cm}^2$  for the past 14 years, we may conclude that bridges designed by new specification can sustain more than  $(80/25)^{5.4} \times 14$  years.

Slab span and the slab thickness have been improved from the stand point of fatigue. But in view of the increase of excessive truck loads, 12 mm thick connection plate is recommended to be applied in place of 9 mm one. And, no scallops are allowed in this portion, as it can be seen in 3.1.
