Zeitschrift: IABSE reports = Rapports AIPC = IVBH Berichte
Band: 57/1/57/2 (1989)

Artikel: Aluminium curtain wall panel failure; assessment and repair
Autor: Cuoco, Daniel A. / Velivasakis, Emmanuel E.
DOI: <https://doi.org/10.5169/seals-44285>

Aluminum Curtain Wall Panel Failure, Assessment and Repair

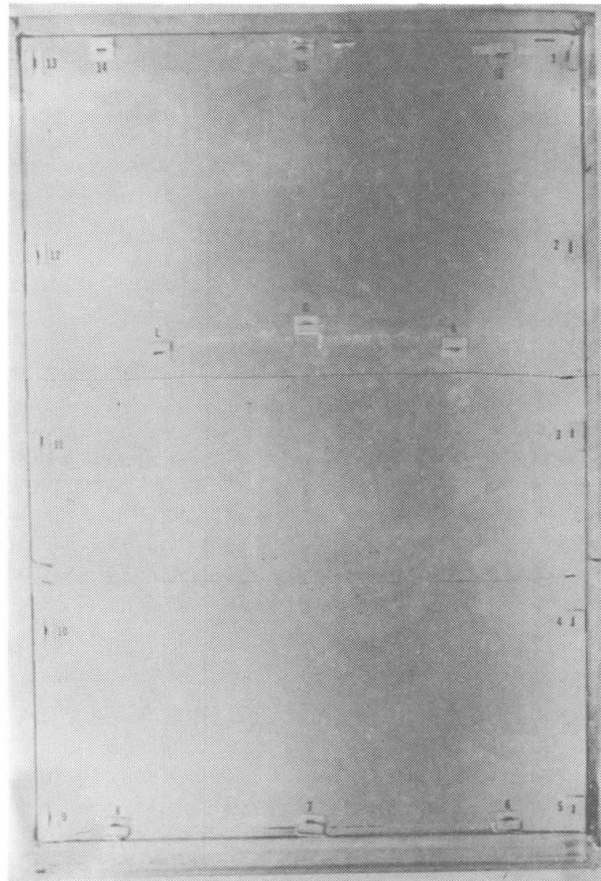
FIG. 1 Typical wall panel assembly

The typical wall panel assembly consists of a 1.42m x 2.13m x 4.76mm aluminum flat plate with 19 aluminum clips welded to the inside surface of the plate (Fig. 1). These clips attach the plate to the perimeter mullion system and an intermediate horizontal stiffener at the approximate mid-height of the panel. In addition, the top edge of the plate fits into a continuous groove formed into the upper horizontal mullion. Since the building has approximately 9,000 wall panels, there are almost 200,000 clips utilized on the building.

A metallurgical evaluation of the separated panel and its remaining clips was conducted. It was concluded that the fatigue-sensitive nature of the clip-to-panel weld detail, combined with poor welding, resulted in fatigue cracking of panel clip weldments which caused the panel to separate from the building.

Clips that were found to be missing or broken during the field inspection and survey were repaired by fastening either the existing clip or a new replacement clip to the panel using stainless steel screws.

In addition, stainless steel screws were installed along the bottom edge of all panels by drilling and tapping into the panels from the inside of the building. This, along with the existing continuous groove support at the top of the panel, provided basic stability for the panel independent of the clips, and was performed as an advance safety measure while the investigation was proceeding.

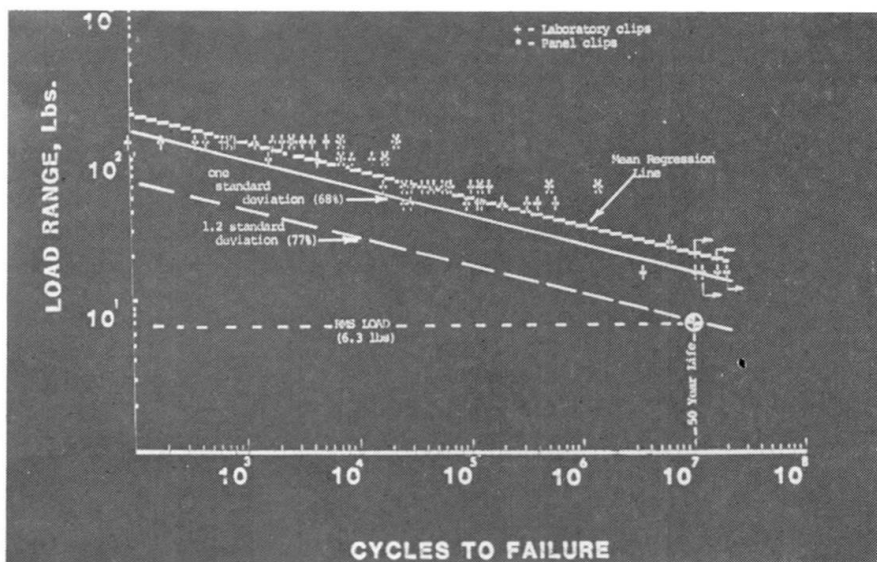
FIG. 2 Load vs. cycles to failure

In order to determine the expected fatigue life of existing panel clips, constant-amplitude cyclic testing of numerous panel clips was performed. These panel clips consisted of existing clips removed from the building, and also new clips fabricated with "imperfect" weldments simulating the existing weldments in the building. The test results were plotted to obtain a "load vs. cycles-to-failure" curve for the clips (Fig. 2).

Based upon the cyclic wind loading spectrum that was derived, a root-mean-square (rms) wind loading of 10.4 kg/m^2 at 10 million cycles, corresponding to a 50-year life, was computed. This translates to an rms load of 2.9 kg at 10 million cycles on the most highly loaded clip. Fig. 2 indicates that there is a 77% confidence level that a maximum-loaded clip weld will survive 50 years.
