Artikel: Aluminium curtain wall panel failure; assessment and repair
Autor: Cuoco, Daniel A. / Velivasakis, Emmanuel E.
DOI: <https://doi.org/10.5169/seals-44285>

Aluminum Curtain Wall Panel Failure, Assessment and Repair

This paper summarizes an investigation of the failure of an aluminum curtain wall panel of a high-rise building in New City. The investigation included a review of the original panel and fastening system design, metallurgical evaluation, field inspections, in-place testing, development of interim repairs, structural analysis, derivation of a cyclic wind loading spectrum, laboratory static and fatigue testing, and fatigue life analysis. A repair and monitoring program was developed which represents a prudent, yet not overly conservative, means of ensuring a very low probability of panel failure in the future.

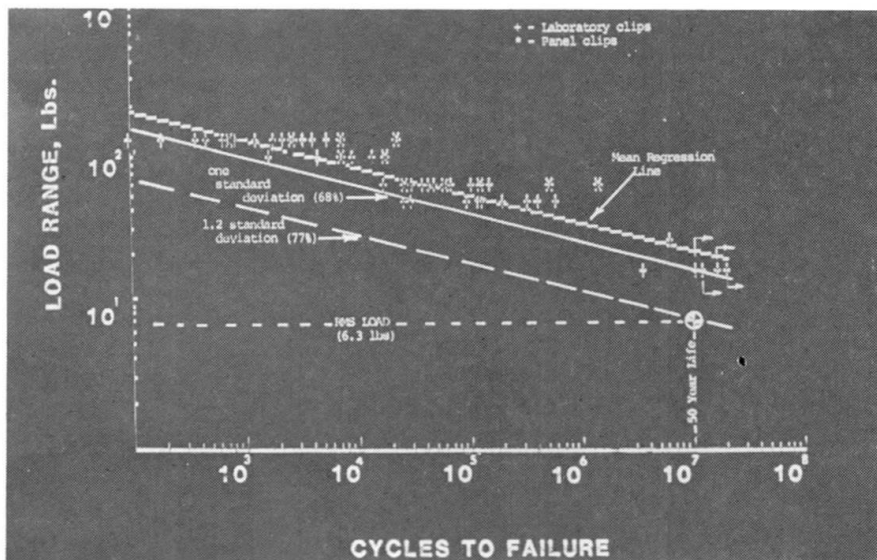
FIG. 2 Load vs. cycles to failure

In order to determine the expected fatigue life of existing panel clips, constant-amplitude cyclic testing of numerous panel clips was performed. These panel clips consisted of existing clips removed from the building, and also new clips fabricated with "imperfect" weldments simulating the existing weldments in the building. The test results were plotted to obtain a "load vs. cycles-to-failure" curve for the clips (Fig. 2).

Based upon the cyclic wind loading spectrum that was derived, a root-mean-square (rms) wind loading of 10.4 kg/m^2 at 10 million cycles, corresponding to a 50-year life, was computed. This translates to an rms load of 2.9 kg at 10 million cycles on the most highly loaded clip. Fig. 2 indicates that there is a 77% confidence level that a maximum-loaded clip weld will survive 50 years.
