**Artikel:** Aluminium curtain wall panel failure; assessment and repair  
**Autor:** Cuoco, Daniel A. / Velivasakis, Emmanuel E.  
**DOI:** <https://doi.org/10.5169/seals-44285>

## Aluminum Curtain Wall Panel Failure, Assessment and Repair

During a windstorm in December 1983, an aluminum curtain wall panel separated and fell from one of the upper floors of a high-rise building in New York City. The building was constructed in 1977 and its exterior contains more than 9,000 of these panels.

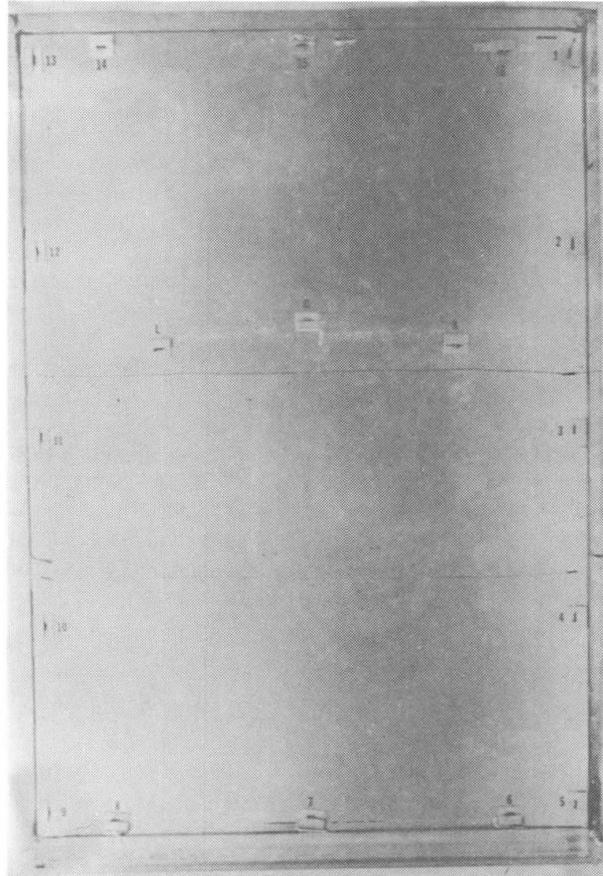
The typical wall panel assembly consists of a 1.42m x 2.13m x 4.76mm aluminum flat plate with 19 aluminum clips welded to the inside surface of the plate (Fig. 1). These clips attach the plate to the perimeter mullion system and an intermediate horizontal stiffener at the approximate mid-height of the panel. In addition, the top edge of the plate fits into a continuous groove formed into the upper horizontal mullion. Since the building has approximately 9,000 wall panels, there are almost 200,000 clips utilized on the building.

A metallurgical evaluation of the separated panel and its remaining clips was conducted. It was concluded that the fatigue-sensitive nature of the clip-to-panel weld detail, combined with poor welding, resulted in fatigue cracking of panel clip weldments which caused the panel to separate from the building.

FIG. 1 Typical wall panel assembly

Clips that were found to be missing or broken during the field inspection and survey were repaired by fastening either the existing clip or a new replacement clip to the panel using stainless steel screws.

In addition, stainless steel screws were installed along the bottom edge of all panels by drilling and tapping into the panels from the inside of the building. This, along with the existing continuous groove support at the top of the panel, provided basic stability for the panel independent of the clips, and was performed as an advance safety measure while the investigation was proceeding.

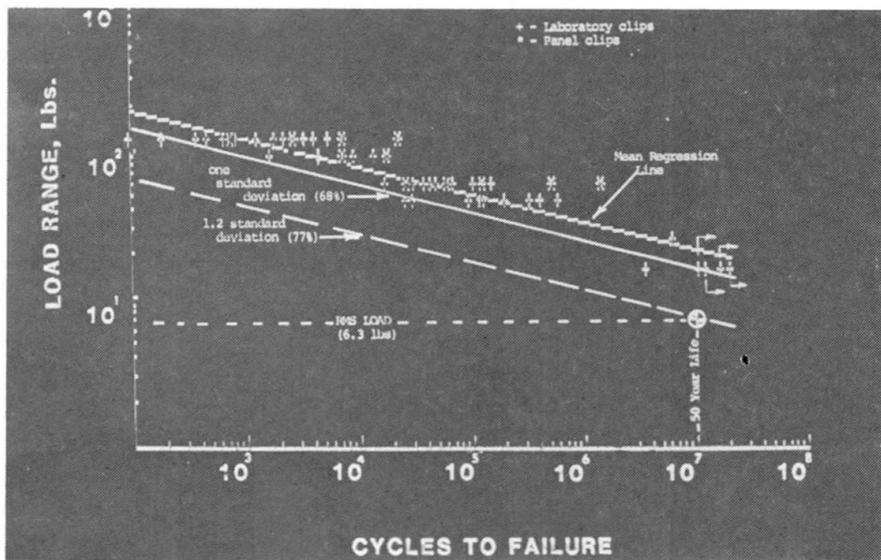
In order to determine the expected fatigue life of existing panel clips, constant-amplitude cyclic testing of numerous panel clips was performed. These panel clips consisted of existing clips removed from the building, and also new clips fabricated with "imperfect" weldments simulating the existing weldments in the building. The test results were plotted to obtain a "load vs. cycles-to-failure" curve for the clips (Fig. 2).

FIG. 2 Load vs. cycles to failure

Based upon the cyclic wind loading spectrum that was derived, a root-mean-square (rms) wind loading of  $10.4 \text{ kg/m}^2$  at 10 million cycles, corresponding to a 50-year life, was computed. This translates to an rms load of 2.9 kg at 10 million cycles on the most highly loaded clip. Fig. 2 indicates that there is a 77% confidence level that a maximum-loaded clip weld will survive 50 years.
