Repair of the Bascule Pier of the Oddesund Bridge

Hans TYCHSEN
Civil Engineer
Danish State Railways
Copenhagen, Denmark

Poul CHRISTENSEN
Civil Engineer
Rambøll & Hannemann
Aalborg, Denmark

Throughout its fifty-year life the bascule pier of the Oddesund Bridge has suffered both from alkali-silica reaction in the concrete and from a slanting pile foundation. These primary defects have in the course of the years resulted in movements and settlements. Attempts have been made to repair these primary defects and the resulting defects in various ways. However, these makeshift solutions have not fully been successful. After a final analysis in 1986 it was decided in 1987 that a total renovation of the bascule pier pile foundation and pier itself should be carried out. The field work was started in March, 1989.

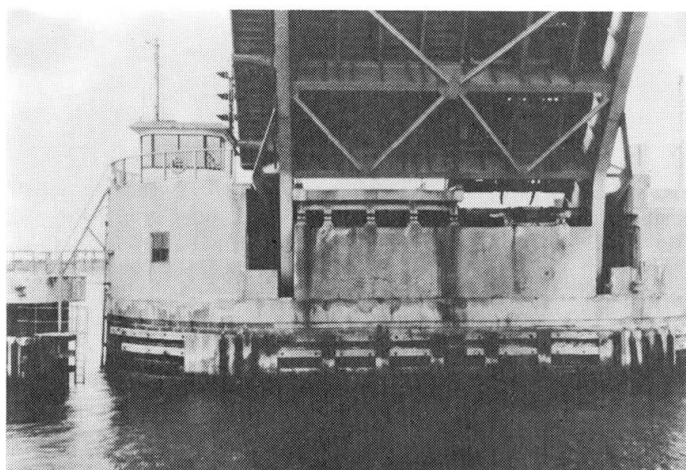
Fig. 2

Already shortly after the Odde Sund bridge had been finished in 1937, settlements and cracks as well as deformations were found in the bascule pier (Fig. 2). Since then the bascule pier has been subjected to continued examinations, repairs and reinforcements. Likewise, it was the main object in connection with the work of the Danish Alkali-Silica Committee in the 1950's and the 1960's.
