Zeitschrift: IABSE reports = Rapports AIPC = IVBH Berichte
Band: 57/1/57/2 (1989)

Artikel: Repair of the bascule pier of the Oddesund Bridge
Autor: Tychsen, Hans / Christensen, Poul
DOI: <https://doi.org/10.5169/seals-44286>

Repair of the Bascule Pier of the Oddesund Bridge

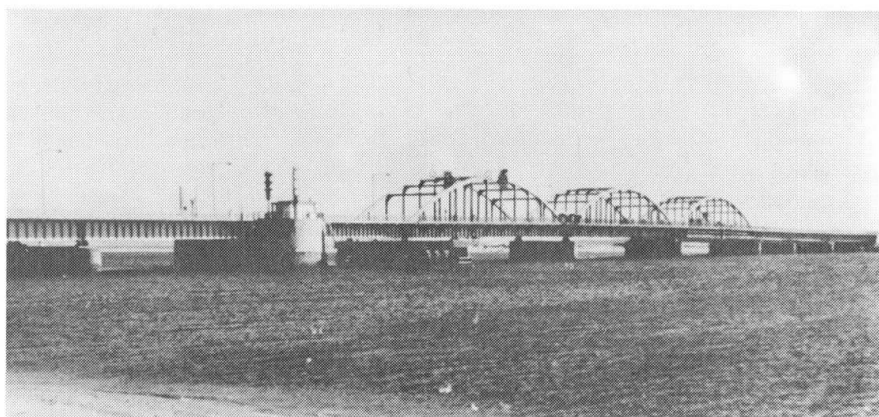
Fig. 1

The combined road and railway bridge over Odde Sund was built in the period 1934-37. Fig. 1.

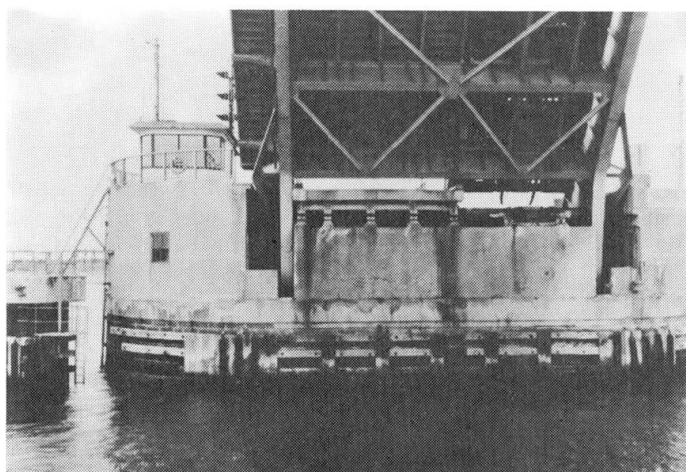
Fig. 2

Already shortly after the Odde Sund bridge had been finished in 1937, settlements and cracks as well as deformations were found in the bascule pier (Fig. 2). Since then the bascule pier has been subjected to continued examinations, repairs and reinforcements. Likewise, it was the main object in connection with the work of the Danish Alkali-Silica Committee in the 1950's and the 1960's.
