Artikel: Repair of chloride-contaminated concrete walls in a tunnel
Autor: Andersen, Ole Viggo / Thomsen, Jens Vejlbj / Sørensen, Egon A.
DOI: <https://doi.org/10.5169/seals-44287>

Repair of Chloride-Contaminated Concrete Walls in a Tunnel

The tunnel is situated in the northern suburbs of Copenhagen, and leads the southbound road traffic on Bernstorffsvej under and into Lyngbyvej - the motorway which is the main road link between Copenhagen and Elsinore.

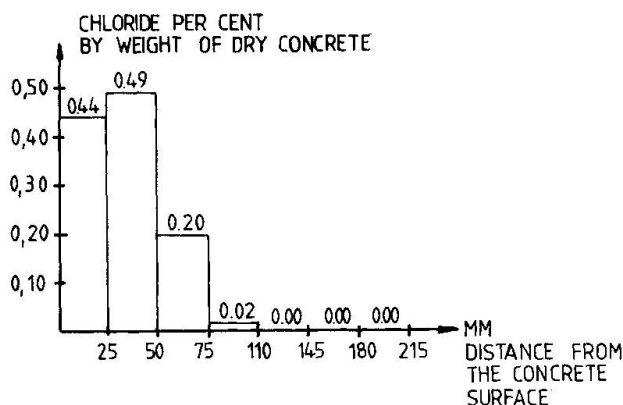
Fig. 2 Typical Chloride Profile at Ground Level

Ten concrete cores were sampled for laboratory tests. The locations of the cores were determined by the analysis of the half-cell potential survey. Tests of the cores included visual examination, petrographic analysis on thin sections, determination of the chloride and moisture contents and distribution: The concrete is mixed with a water-cement ratio between 0.45 and 0.50. Carbonation depth is approximately 15 mm (half the depth of the concrete cover). The sand fraction contains alkali-silica reactive aggregates. Severe alkali-silica reactions were observed locally in the lower parts of the wall, where the chloride content is very high throughout the length of the tunnel. Typical chloride profiles are shown in Figs. 2 and 3. The distribution of chloride content indicates that the chloride is permeating from outside sources - probably from de-icing salts. The moisture content is medium - but high enough to generate corrosion and alkali-silica reactions.

On the basis of these observations it was concluded that severe corrosion of the reinforcement located in the walls 0 to 0.5 m above ground level is caused by an excess of chloride in the concrete.

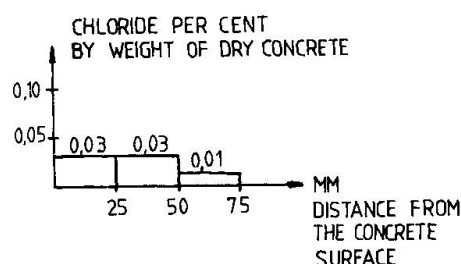
Fig. 3 Typical Chloride Profile approx. 0.7 m above Ground Level

On-site measurements were limited to a half-cell potential survey of the lower parts of the walls. The concrete cover was measured and parts of the reinforcement were exposed to visual examination. The half-cell potentials measured with a copper-coppersulphate electrode indicate a high risk of corrosion of the reinforcement, limited to the lower parts of the wall. Visual examinations of exposed reinforcement at these locations revealed severe pittings, while there were found no signs of corrosion on reinforcement located higher than 0.5 m above ground level in the tunnel. The concrete cover is 25-30 mm. The variation
