Artikel: Vibration fatigue of steel bridges of the bullet train system

Autor: Sakamoto, Kenji / Miki, Chitoshi / Ichikawa, Atushi

Vibration Fatigue of Steel Bridges of the Bullet Train System

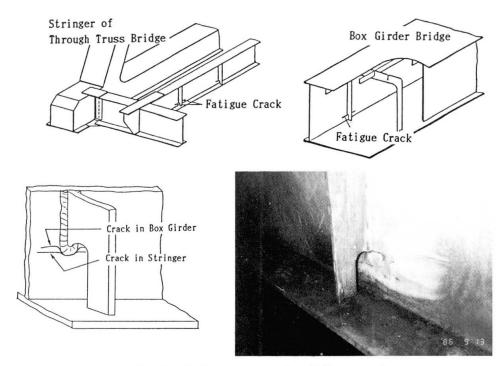
Fig.4 Fatigue crack at stiffener end

Fig. 4 shows cracked girder web. This type of fatigue cracks occurred at the lower end of the stiffener on girder webs of box girder bridges and stringer webs of through truss bridges. Characteristically, no crack has occurred at the end of the stiffener to which floor beams or sway bracings are connected. These fatigue cracks began to be observed in 1978. To date, cracks have been observed in about 10,000 details of about 200 box girder bridges and in about 100 details of five through type truss bridges. Countermeasures were taken against all parts of through type truss bridges which were considered to undergo cracking.

As a countermeasure against these fatigue cracks, it is most effective to stop local horizontal vibrations of lower flange which cause fatique cracks. In some truss bridge stringers, fatique cracks were removed by applying of arc air gouging and rewelded and then an additional plates were installed by highstrength bolts (Fig. 10). In some cases a sway bracing was also Another possible measure is to increase the fatigue strength of the detail. As it is costly to add plates to a slight fatigue crack, it was necessary to consider an economic method for raising fatigue strength. It is advisable to improve the fatigue strength of the toe of a fillet weld and prevent occurrence of additional crack in a part where occurrence of a fatigue crack is not confirmed as a preventive measure. Application of TIG (Tungsten Inert Gas) arc remelting has considered as an effective and economic method for repairing a fatigue crack at the toe of a fillet weld and improving fatigue strength.

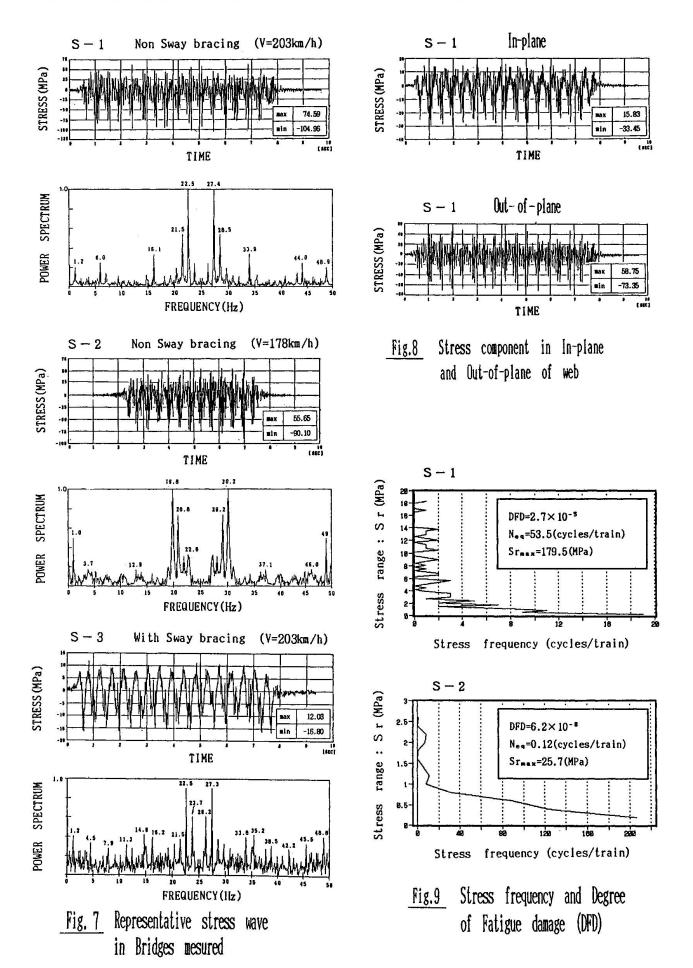
Fig. 7 shows a typical stress records on the stringer web and the results of frequency analysis. S-1 and S-2 are stress records at same point of stiffener end detail without sway bracing when a train passed away at a speed of 203 km/h and 178 km/h respectively. S-3 is a stress by train passing at a speed of 203 km/h at a position to which sway bracing is connected. Train speeds were obtained, using a strain gauge fitted to the track. Major results of this test can be summarized as follows; As obviously shown by the comparison between S-1 and S-3, at the detail where sway bracing exists, stress amplitude is smaller than where sway bracing does not exists, and the high-frequency component is also smaller. This is considered to be due to horizontal vibrations of the lower flange. Stresses in S-l is the largest measured value in this structure and its stress waveform exhibits a resonating behavior. However, S-2, the stress waveform of a low-speed train (v=178 km/h) does not produce as large stress as S-1 (v=203 km/h). Therefore, horizontal vibration of the lower flange was induced only by the passage of high speed trains. In order to examine this resonating behavior, a stress was separated into the in-plane component and the out-of-plane component as shown in Fig.8. Its results indicate that the stress at the lower end of the stiffener without sway bracing detail is mainly caused by out-of-plane distorsion of the web plate. From this, it seems possible to say that the source of a predominating stress which occurs at the lower end of a stiffener is horizontal vibrations of the lower flange. Fig.9 shows the stress histgram and the degree of fatigue damage of each stress component. The results suggest that fatigue cracks occurred in several years under S-1 stress history. However, S-2 shows not so high degree of damage.
