**Artikel:** Vibration fatigue of steel bridges of the bullet train system  
**Autor:** Sakamoto, Kenji / Miki, Chitoshi / Ichikawa, Atushi  
**DOI:** <https://doi.org/10.5169/seals-45713>

## **Vibration Fatigue of Steel Bridges of the Bullet Train System**

### **SUMMARY**

Fatigue cracks caused by out-of-plane vibration were observed in steel bridges of the Tokaido Shinkansen. Crack growth behaviour, measured cyclic stresses, evaluation of fatigue damage, and retrofitting methods are described.

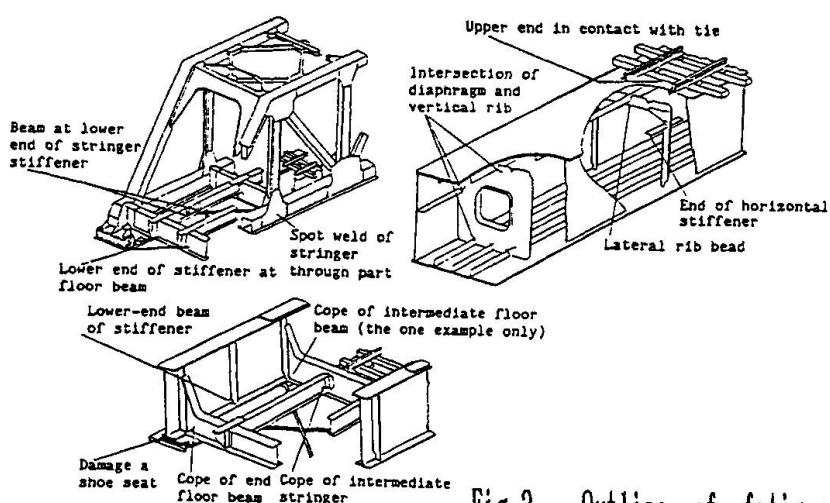
Fig.3 Outline of fatigue damage

In the process of their service, however, some types of fatigue damage have been observed as shown in fig.3. No fatigue damage due to low fatigue strength has not observed in main members where fatigue was assessed in the design stage. However, fatigue cracks which are the result of secondary stresses and displacement induced stresses are often discovered in such various structural elements as girder webs, stringer webs, floor beam webs, side walks, connections of attached facilities and diaphragms. One of these fatigue crackings which occurs relatively frequently and whose cause has not been made much clear is a fatigue crack which occurs on a web plate at the lower end of a stiffener (hereinafter referred to as the "lower end of a stiffener"). This fatigue cracks is in parallel with the lower flange.

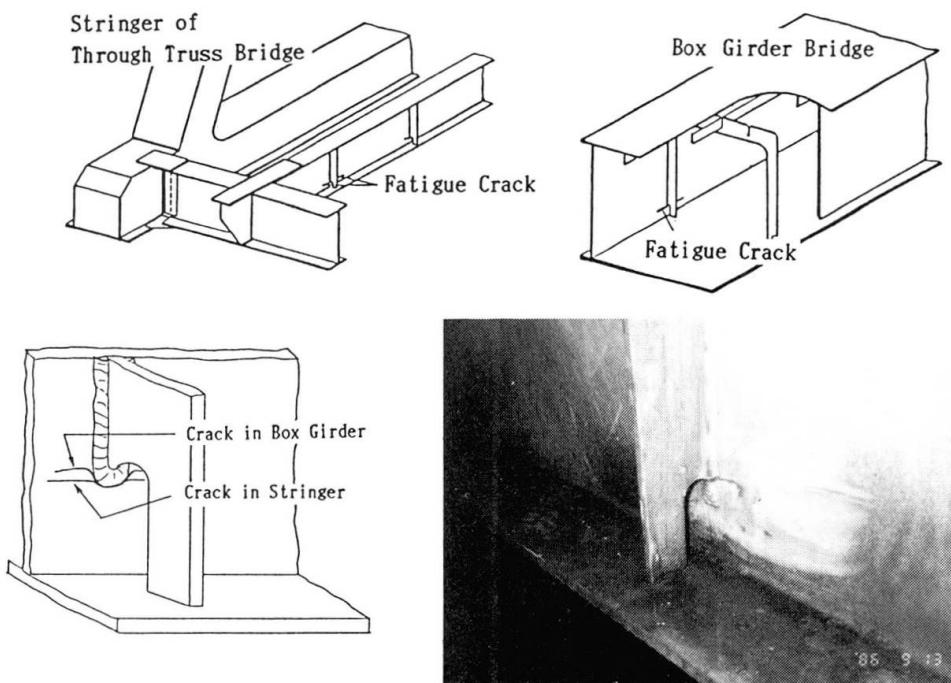
Fig.4 Fatigue crack at stiffener end

Fig. 4 shows cracked girder web. This type of fatigue cracks occurred at the lower end of the stiffener on girder webs of box girder bridges and stringer webs of through truss bridges. Characteristically, no crack has occurred at the end of the stiffener to which floor beams or sway bracings are connected. These fatigue cracks began to be observed in 1978. To date, cracks have been observed in about 10,000 details of about 200 box girder bridges and in about 100 details of five through type truss bridges. Countermeasures were taken against all parts of through type truss bridges which were considered to undergo cracking.

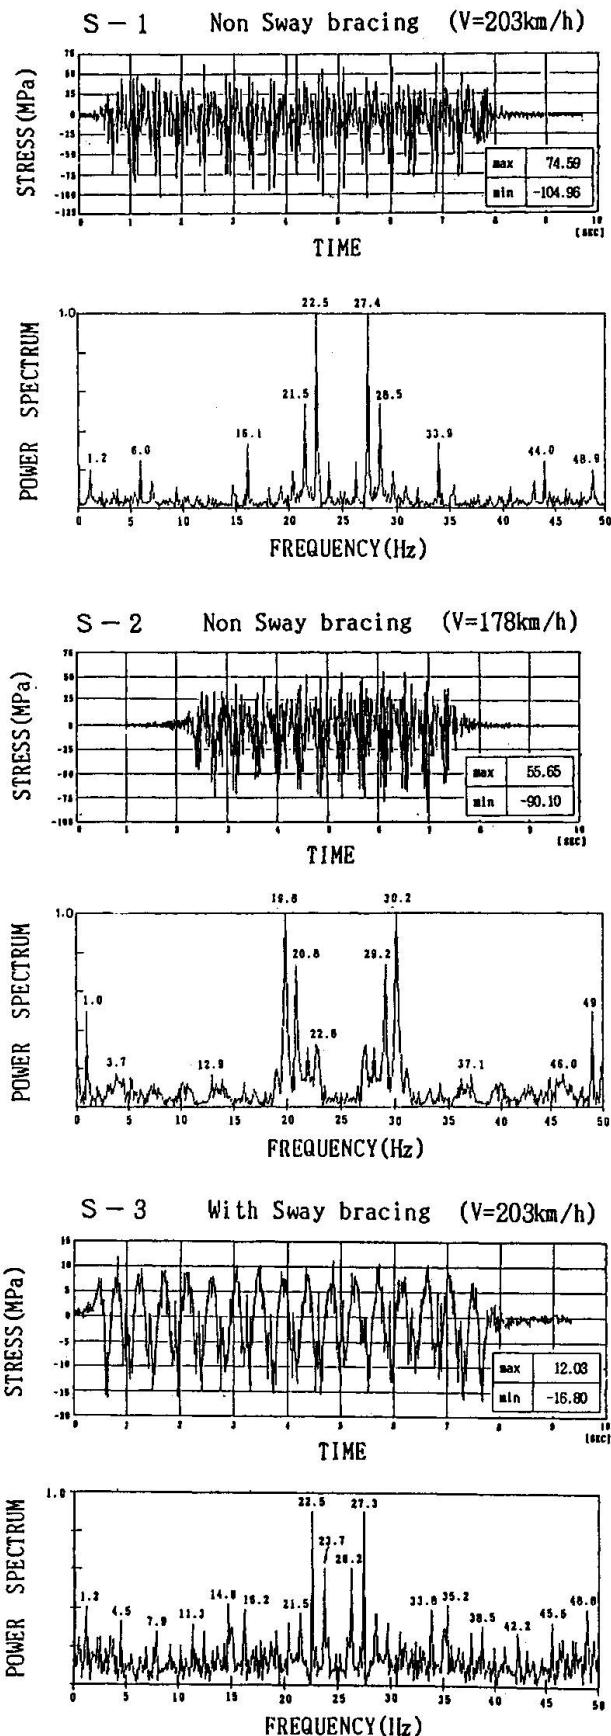
Fig. 7 Representative stress wave in Bridges measured

Fig.7 shows a typical stress records on the stringer web and the results of frequency analysis. S-1 and S-2 are stress records at same point of stiffener end detail without sway bracing when a train passed away at a speed of 203 km/h and 178 km/h respectively. S-3 is a stress by train passing at a speed of 203 km/h at a position to which sway bracing is connected. Train speeds were obtained, using a strain gauge fitted to the track. Major results of this test can be summarized as follows;

As obviously shown by the comparison between S-1 and S-3, at the detail where sway bracing exists, stress amplitude is smaller than where sway bracing does not exists, and the high-frequency component is also smaller. This is considered to be due to horizontal vibrations of the lower flange.

Stresses in S-1 is the largest measured value in this structure and its stress waveform exhibits a resonating behavior. However, S-2, the stress waveform of a low-speed train ( $v=178$  km/h) does not produce as large stress as S-1 ( $v=203$  km/h). Therefore, horizontal vibration of the lower flange was induced only by the passage of high speed trains. In order to examine this resonating behavior, a stress was separated into the in-plane component and the out-of-plane component as shown in Fig.8. Its results indicate that the stress at the lower end of the stiffener without sway bracing detail is mainly caused by out-of-plane distortion of the web plate. From this, it seems possible to say that the source of a predominating stress which occurs at the lower end of a stiffener is horizontal vibrations of the lower flange.

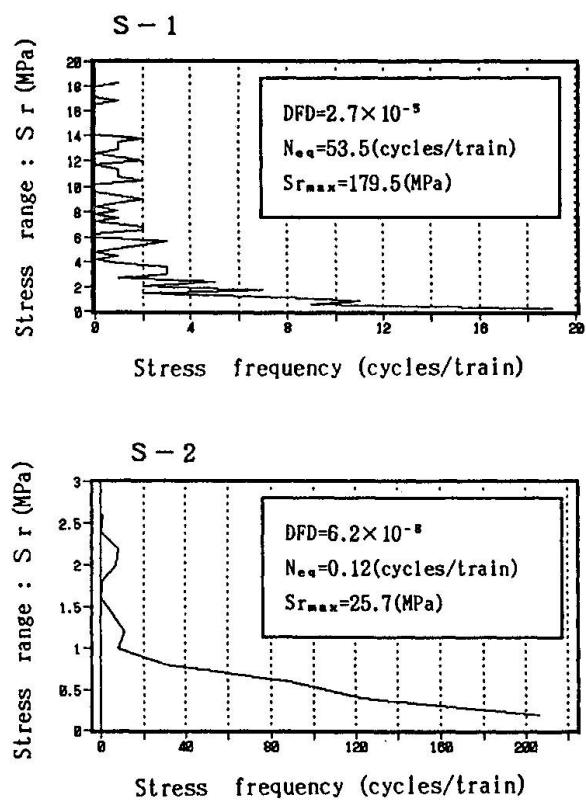
Fig.9 Stress frequency and Degree of Fatigue damage (DFD)

Fig.9 shows the stress histogram and the degree of fatigue damage of each stress component. The results suggest that fatigue cracks occurred in several years under S-1 stress history. However, S-2 shows not so high degree of damage.

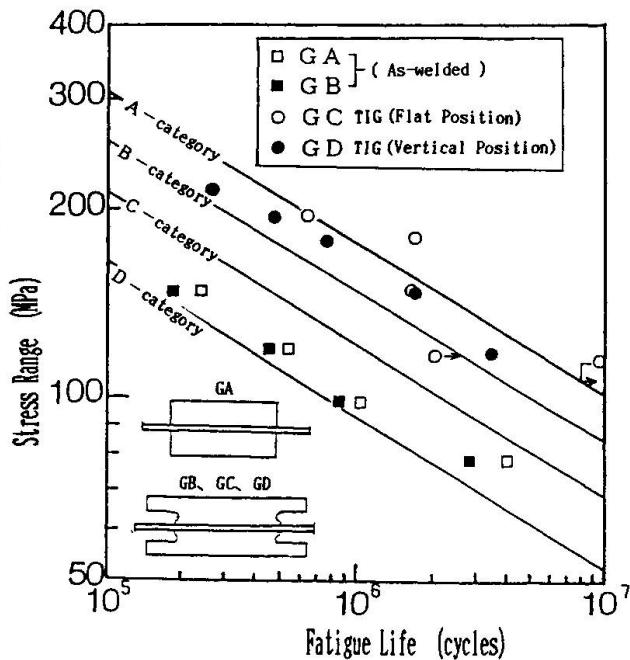
Fig.11 Results of fatigue test

The result of fatigue testing is shown in Fig. 11. It was found that the fatigue strength of as-welded specimens slightly exceeded the category D of the design curve, while the fatigue strength of TIG dressed specimens exceeded the category B curve. The TIG dressing improved the shape of the toe of weld which affects occurrence of a crack and reduces stress concentration, thus improving fatigue strength.

In order to confirm the effect of the TIG dressing on this stiffener end detail, fatigue testing was conducted on specimens simulating this detail and applying conditions in actual bridges. Two type of specimens (GC and GD) were TIG dressed under the conditions as given in Table 3. Specimens GC were treated by TIG arc remelting in a face-down position and specimens GD were TIG dressed in a stand-up position, considering actual application conditions.
