Vibration Fatigue of Steel Bridges of the Bullet Train System

Kenji SAKAMOTO

Fatigue cracks caused by out-of-plane vibration were observed in steel bridges of the Tokaido Shinkansen. Crack growth behaviour, measured cyclic stresses, evaluation of fatigue damage, and retrofitting methods are described.

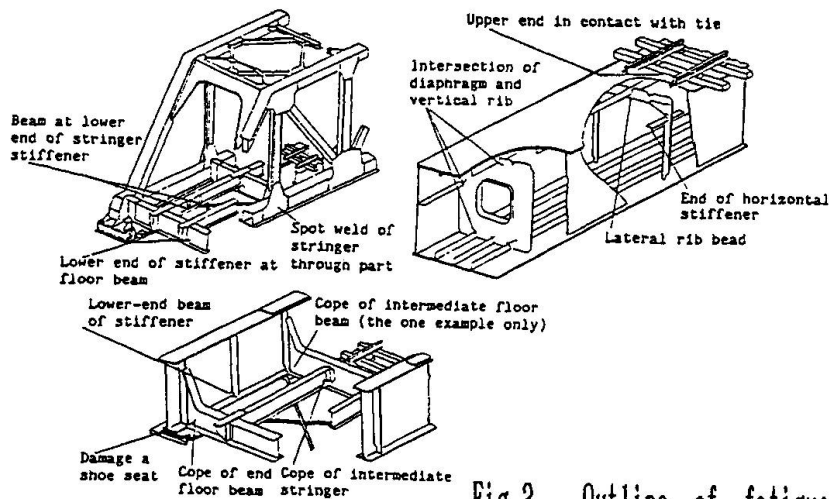
Fig.3 Outline of fatigue damage

In the process of their service, however, some types of fatigue damage have been observed as shown in fig.3. No fatigue damage due to low fatigue strength has not observed in main members where fatigue was assessed in the design stage. However, fatigue cracks which are the result of secondary stresses and displacement induced stresses are often discovered in such various structural elements as girder webs, stringer webs, floor beam webs, side walks, connections of attached facilities and diaphragms. One of these fatigue crackings which occurs relatively frequently and whose cause has not been made much clear is a fatigue crack which occurs on a web plate at the lower end of a stiffener (hereinafter referred to as the "lower end of a stiffener"). This fatigue cracks is in parallel with the lower flange.
