Artikel: Vibration fatigue of steel bridges of the bullet train system

Autor: Sakamoto, Kenji / Miki, Chitoshi / Ichikawa, Atushi

Vibration Fatigue of Steel Bridges of the Bullet Train System

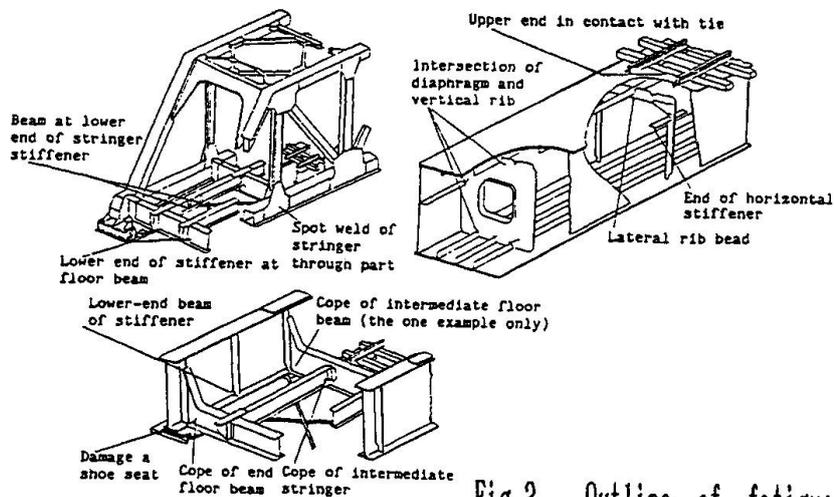
Fig.3 Outline of fatigue damage

In the process of their service, however, some types of fatigue damage have been observed as shown in fig.3. No fatigue damage due to low fatigue strength has not observed in main members where fatigue was assessed in the design stage. However, fatigue cracks which are the result of secondary stresses and displacement induced stresses are often discovered in such various structural elements as girder webs, stringer webs, floor beam webs, side walks, connections of attached facilities and diaphragms. One of these fatigue crackings which occurs relatively frequently and whose cause has not been made much clear is a fatigue crack which occurs on a web plate at the lower end of a stiffener (hereinafter referred to as the "lower end of a stiffener"). This fatigue cracks is in parallel with the lower flange.

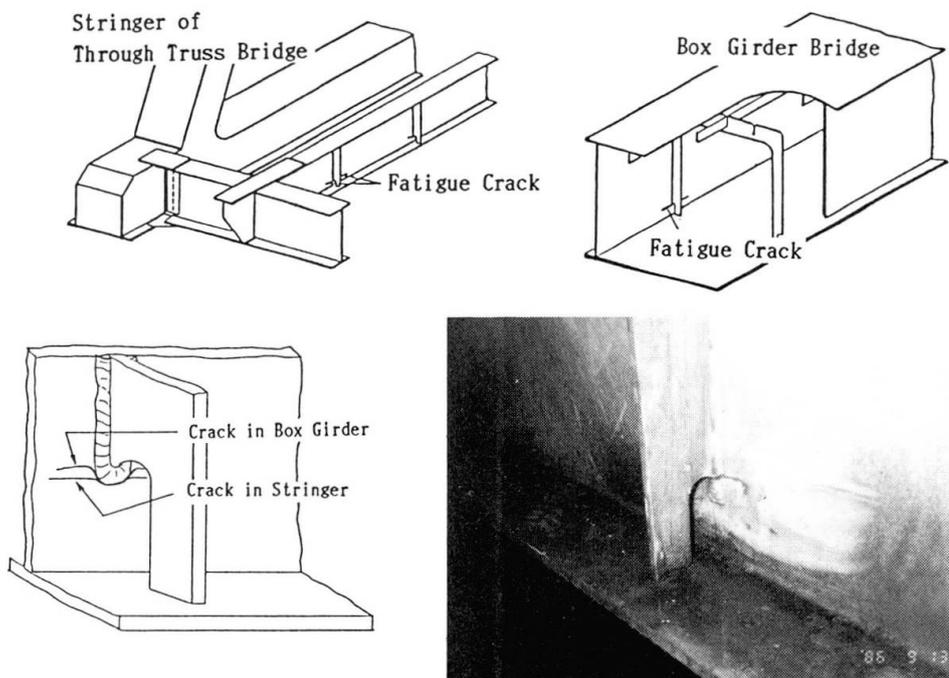
Fig.4 Fatigue crack at stiffener end

Fig. 4 shows cracked girder web. This type of fatigue cracks occurred at the lower end of the stiffener on girder webs of box girder bridges and stringer webs of through truss bridges. Characteristically, no crack has occurred at the end of the stiffener to which floor beams or sway bracings are connected. These fatigue cracks began to be observed in 1978. To date, cracks have been observed in about 10,000 details of about 200 box girder bridges and in about 100 details of five through type truss bridges. Countermeasures were taken against all parts of through type truss bridges which were considered to undergo cracking.

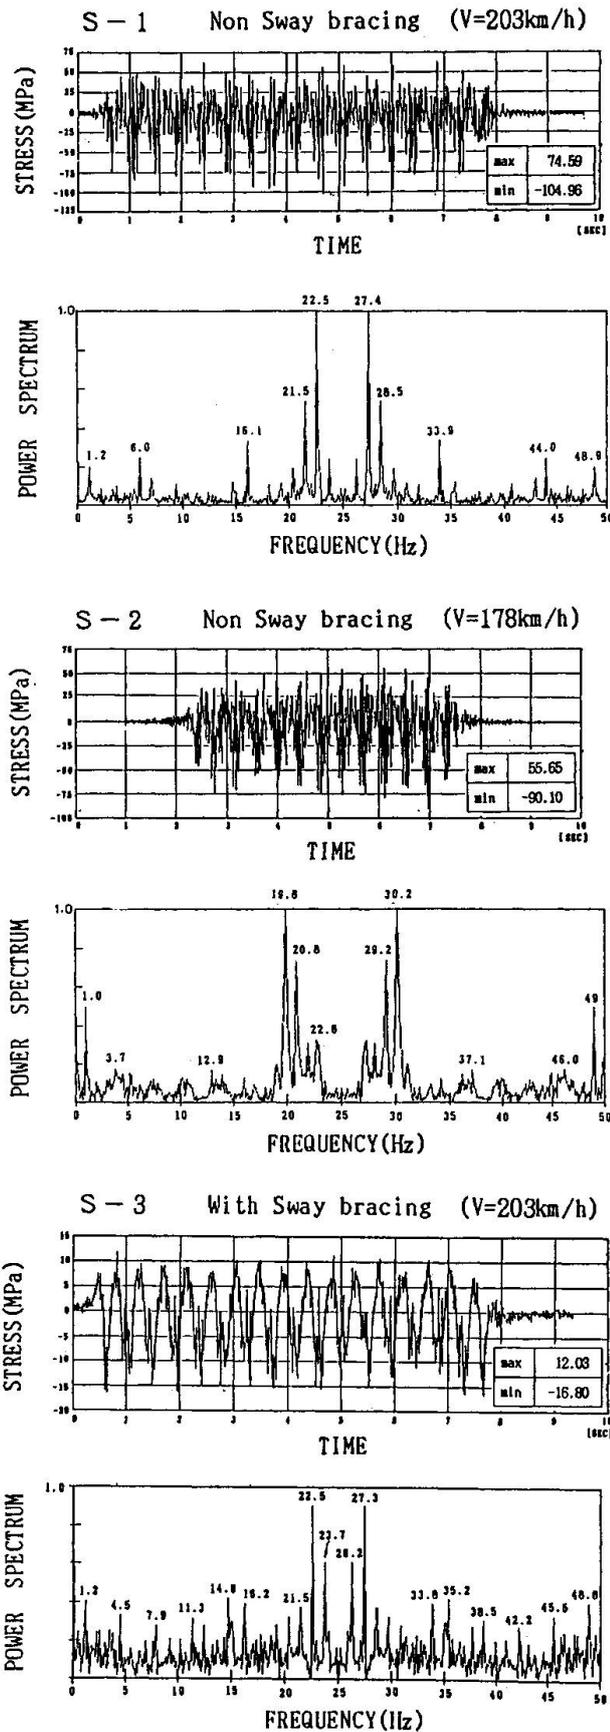
Fig. 7 Representative stress wave in Bridges measured

Fig.7 shows a typical stress records on the stringer web and the results of frequency analysis. S-1 and S-2 are stress records at same point of stiffener end detail without sway bracing when a train passed away at a speed of 203 km/h and 178 km/h respectively. S-3 is a stress by train passing at a speed of 203 km/h at a position to which sway bracing is connected. Train speeds were obtained, using a strain gauge fitted to the track. Major results of this test can be summarized as follows;

As obviously shown by the comparison between S-1 and S-3, at the detail where sway bracing exists, stress amplitude is smaller than where sway bracing does not exist, and the high-frequency component is also smaller. This is considered to be due to horizontal vibrations of the lower flange.

Stresses in S-1 is the largest measured value in this structure and its stress waveform exhibits a resonating behavior. However, S-2, the stress waveform of a low-speed train ($v=178$ km/h) does not produce as large stress as S-1 ($v=203$ km/h). Therefore, horizontal vibration of the lower flange was induced only by the passage of high speed trains. In order to examine this resonating behavior, a stress was separated into the in-plane component and the out-of-plane component as shown in Fig.8. Its results indicate that the stress at the lower end of the stiffener without sway bracing detail is mainly caused by out-of-plane distortion of the web plate. From this, it seems possible to say that the source of a predominating stress which occurs at the lower end of a stiffener is horizontal vibrations of the lower flange.

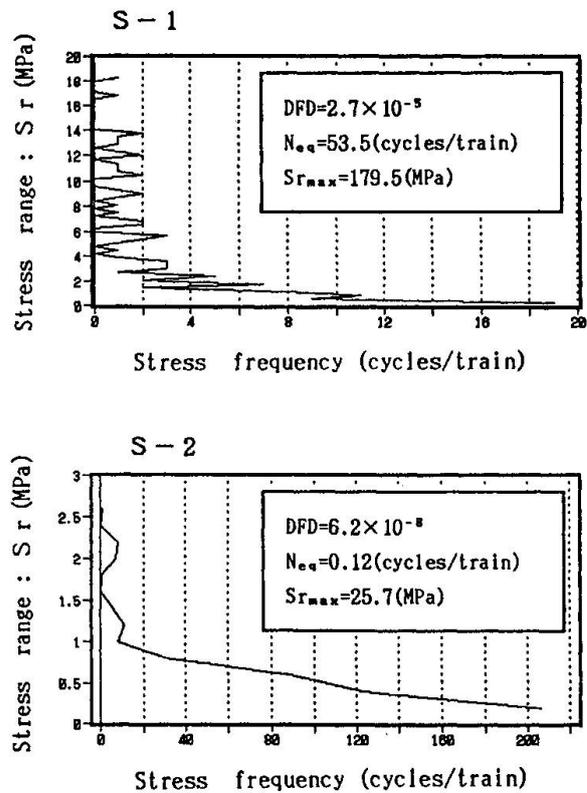
Fig. 9 Stress frequency and Degree of Fatigue damage (DFD)

Fig.9 shows the stress histogram and the degree of fatigue damage of each stress component. The results suggest that fatigue cracks occurred in several years under S-1 stress history.

However, S-2 shows not so high degree of damage.

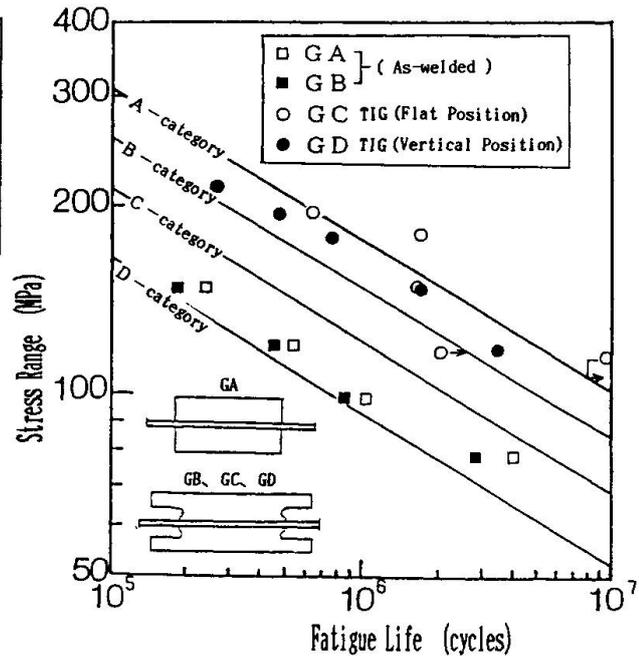
Fig.11 Results of fatigue test

The result of fatigue testing is shown in Fig. 11. It was found that the fatigue strength of as-welded specimens slightly exceeded the category D of the design curve, while the fatigue strength of TIG dressed specimens exceeded the category B curve. The TIG dressing improved the shape of the toe of weld which affects occurrence of a crack and reduces stress concentration, thus improving fatigue strength.
