Artikel: Vibration fatigue of steel bridges of the bullet train system
Autor: Sakamoto, Kenji / Miki, Chitoshi / Ichikawa, Atushi
DOI: <https://doi.org/10.5169/seals-45713>

Vibration Fatigue of Steel Bridges of the Bullet Train System

Fatigue cracks caused by out-of-plane vibration were observed in steel bridges of the Tokaido Shinkansen. Crack growth behaviour, measured cyclic stresses, evaluation of fatigue damage, and retrofitting methods are described.

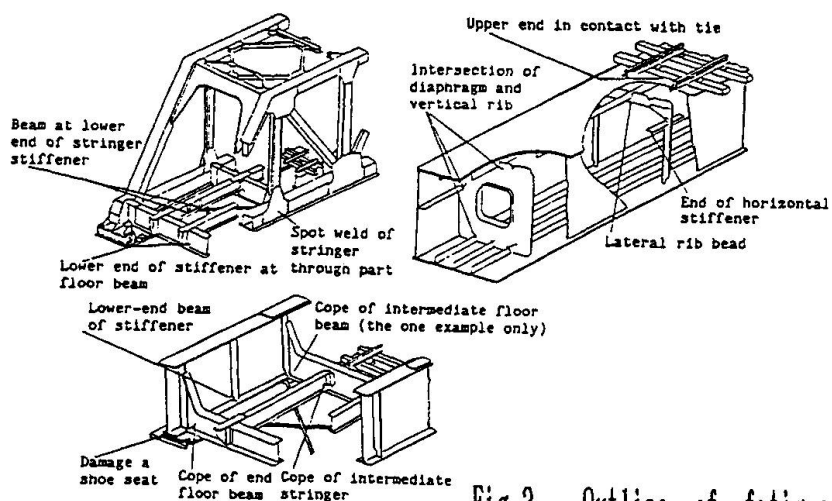
Fig.3 Outline of fatigue damage

In the process of their service, however, some types of fatigue damage have been observed as shown in fig.3. No fatigue damage due to low fatigue strength has not observed in main members where fatigue was assessed in the design stage. However, fatigue cracks which are the result of secondary stresses and displacement induced stresses are often discovered in such various structural elements as girder webs, stringer webs, floor beam webs, side walks, connections of attached facilities and diaphragms. One of these fatigue crackings which occurs relatively frequently and whose cause has not been made much clear is a fatigue crack which occurs on a web plate at the lower end of a stiffener (hereinafter referred to as the "lower end of a stiffener"). This fatigue cracks is in parallel with the lower flange.

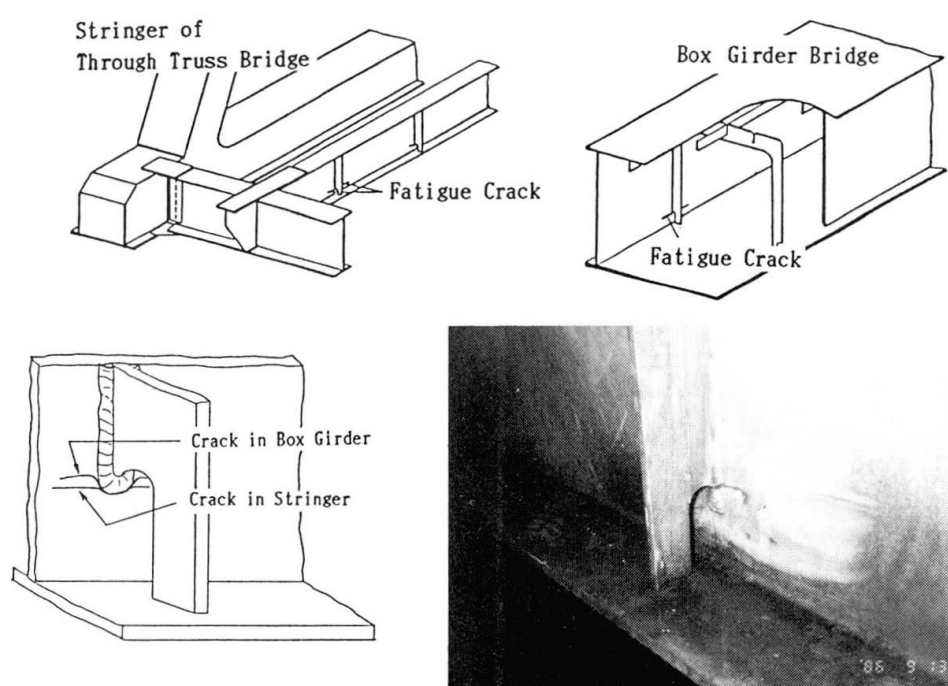
Fig.4 Fatigue crack at stiffener end

Fig. 4 shows cracked girder web. This type of fatigue cracks occurred at the lower end of the stiffener on girder webs of box girder bridges and stringer webs of through truss bridges. Characteristically, no crack has occurred at the end of the stiffener to which floor beams or sway bracings are connected. These fatigue cracks began to be observed in 1978. To date, cracks have been observed in about 10,000 details of about 200 box girder bridges and in about 100 details of five through type truss bridges. Countermeasures were taken against all parts of through type truss bridges which were considered to undergo cracking.

As a countermeasure against these fatigue cracks, it is most effective to stop local horizontal vibrations of lower flange which cause fatigue cracks. In some truss bridge stringers, fatigue cracks were removed by applying of arc air gouging and rewelded and then an additional plates were installed by high-strength bolts (Fig. 10). In some cases a sway bracing was also added. Another possible measure is to increase the fatigue strength of the detail. As it is costly to add plates to a slight fatigue crack, it was necessary to consider an economic method for raising fatigue strength. It is advisable to improve the fatigue strength of the toe of a fillet weld and prevent occurrence of additional crack in a part where occurrence of a fatigue crack is not confirmed as a preventive measure. Application of TIG (Tungsten Inert Gas) arc remelting has considered as an effective and economic method for repairing a fatigue crack at the toe of a fillet weld and improving fatigue strength.

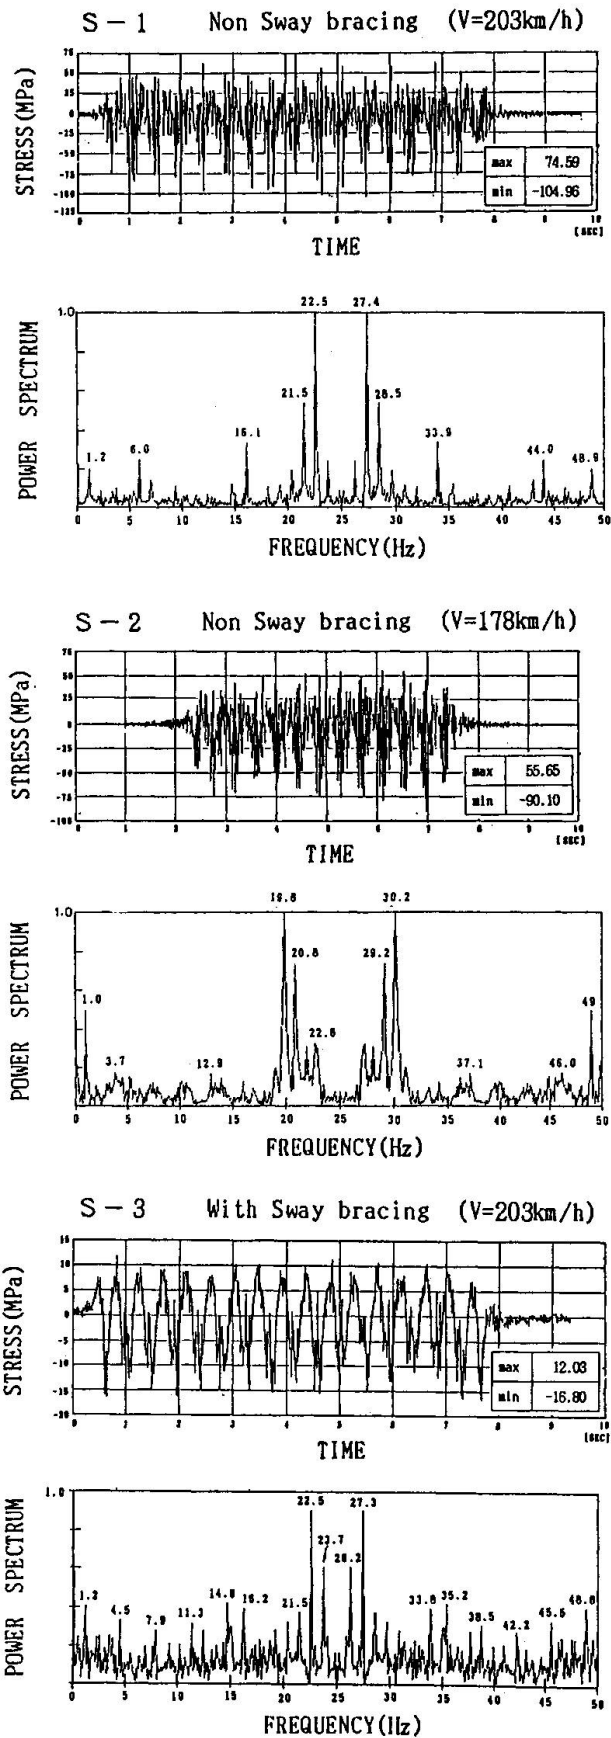
Fig. 7 Representative stress wave in Bridges measured

Fig.7 shows a typical stress records on the stringer web and the results of frequency analysis. S-1 and S-2 are stress records at same point of stiffener end detail without sway bracing when a train passed away at a speed of 203 km/h and 178 km/h respectively. S-3 is a stress by train passing at a speed of 203 km/h at a position to which sway bracing is connected. Train speeds were obtained, using a strain gauge fitted to the track. Major results of this test can be summarized as follows;

As obviously shown by the comparison between S-1 and S-3, at the detail where sway bracing exists, stress amplitude is smaller than where sway bracing does not exist, and the high-frequency component is also smaller. This is considered to be due to horizontal vibrations of the lower flange.

Stresses in S-1 is the largest measured value in this structure and its stress waveform exhibits a resonating behavior. However, S-2, the stress waveform of a low-speed train ($v=178$ km/h) does not produce as large stress as S-1 ($v=203$ km/h). Therefore, horizontal vibration of the lower flange was induced only by the passage of high speed trains. In order to examine this resonating behavior, a stress was separated into the in-plane component and the out-of-plane component as shown in Fig.8. Its results indicate that the stress at the lower end of the stiffener without sway bracing detail is mainly caused by out-of-plane distortion of the web plate. From this, it seems possible to say that the source of a predominating stress which occurs at the lower end of a stiffener is horizontal vibrations of the lower flange.

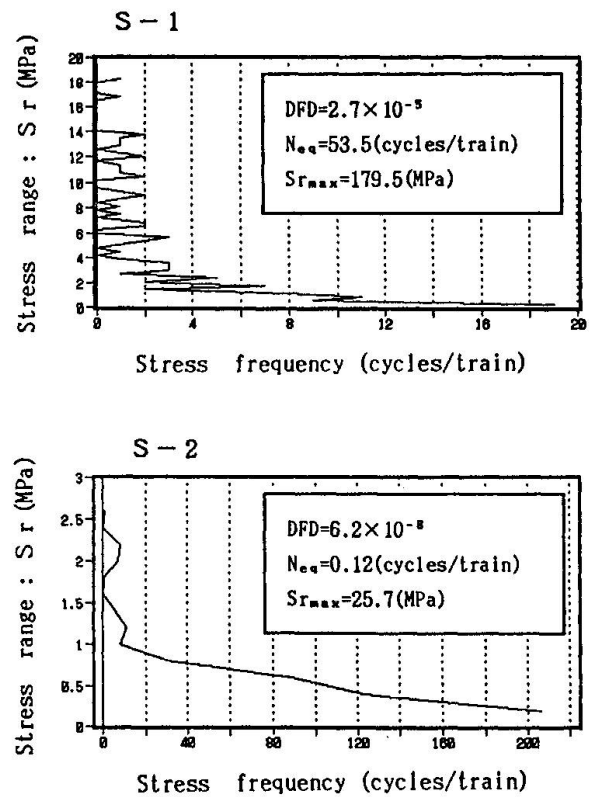
Fig. 9 Stress frequency and Degree of Fatigue damage (DFD)

Fig.9 shows the stress histogram and the degree of fatigue damage of each stress component. The results suggest that fatigue cracks occurred in several years under S-1 stress history. However, S-2 shows not so high degree of damage.

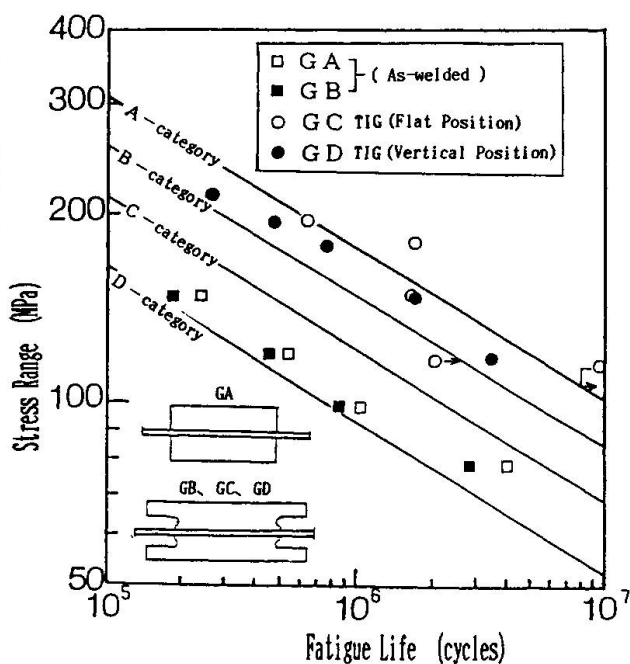
Fig.11 Results of fatigue test

The result of fatigue testing is shown in Fig. 11. It was found that the fatigue strength of as-welded specimens slightly exceeded the category D of the design curve, while the fatigue strength of TIG dressed specimens exceeded the category B curve. The TIG dressing improved the shape of the toe of weld which affects occurrence of a crack and reduces stress concentration, thus improving fatigue strength.
