Zeitschrift: IABSE reports = Rapports AIPC = IVBH Berichte

Artikel: Fatigue crack detection and repair of steel bridge structures

Autor: Fisher, John W. / Menzemer, Craig C. / Yen, Ben T.

Fatigue Crack Detection and Repair of Steel Bridge Structures

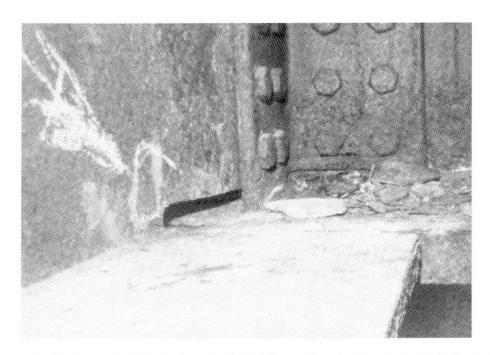
Inspection of the structure revealed several areas which contained fatigue cracks. In addition, lateral displacement of several longitudinal girder bottom flanges was also observed. Fatigue cracks were found along the longitudinal girder web to flange weld at the flange terminations and vertical cracks were observed in the longitudinal girder webs at the reentrant corner of the bottom copes (Fig. 5). Cracking was occasionally observed along the bolt fixity line of the connection angles (Fig. 6).

Fig. 5 Vertical and Horizontal Fatigue Cracks at Bottom Web Cope

Coping by flame cutting the longitudinal girder and floorbeam webs resulted in high tensile residual stresses along the cut edge as well as at reentrant corner. In addition, coping greatly reduced the section modulus for in-plane bending and left an unstiffened segment of girder web between the flange terminations and the bolt fixity line of the longitudinal girders. At locations where the longitudinal girders were not bolted full depth to the connection angles, the girder web could rotate in plane without developing significant compressive forces in the lower portion of the girder. This resulted in no bottom flange lateral displacement, no web gap distortion, and no fatigue cracking in the web cope or connection angles. In locations where the girder was bolted full depth to the connection angles of the transverse beam, connection restraint resulted in lateral displacement of the bottom flange and web gap distortion from the compressive stresses in the web. Hence, fatigue cracks along the bottom edges of the connection angles were all displacement induced.

Retrofits recommended for fatigue cracking in the longitudinal girders included the drilling of holes to blunt the crack tips. Further retrofit was required to prevent the lateral displacement of the bottom flange and minimize web gap distortion. Otherwise, fatigue crack reinitiation from the retrofit holes and continued crack propagation along the bolt fixity line would result. Several rows of bolts were removed from the girder to transverse beam connection to reduce the compression in the web and help move the flange toward normal alignment. Angles were then bolted to the inside longitudinal girder web and flange and to the connection angle to prevent lateral motion of the bottom flange (Fig. 10) and to provide greater resistance to the end restraint.

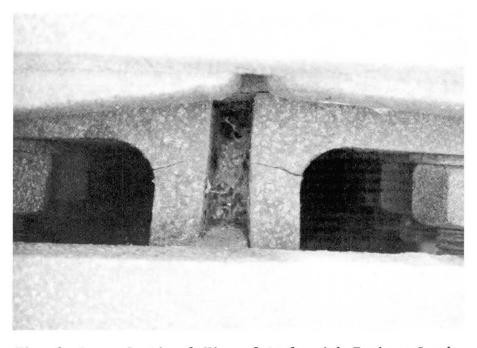
Fig. 6 Cross-Sectional View of Angle with Fatigue Cracks

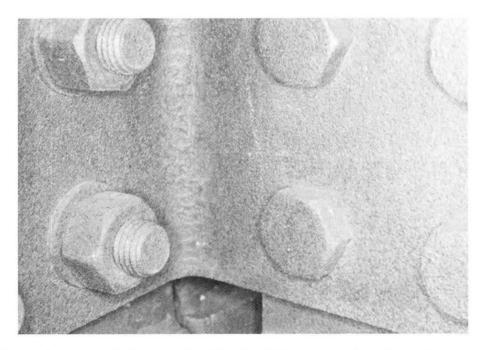
Figure 7 shows cracks which extended several inches along the bottom end of the angle fillet, between the girder web and the transverse beam of the bents. The cracks were found only at locations where the longitudinal girder web was bolted full depth to the connection angles. Other locations where the girder web was not bolted full depth exhibited no evidence of cracking (Fig. 8).

Fig. 7 Fatigue Crack in Longitudinal Girder-Beam (Bent) Angle Connection

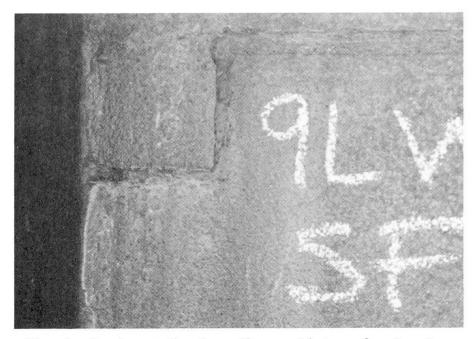
groove weld connecting the top flange of transverse beam to the column. Further grinding exposed the crack which extended from the back-up bar halfway through the groove weld thickness. Other bents revealed cracks at the web cope closure plates of the transverse box beam (Fig. 9). Grinding the fillet weld throat into the beam flange exposed cracks extending from the back-up bar into the groove weld thickness.

Fig. 9 Cracks at the Cope Closure Plates of a Box Beam

Connection geometry at the corner joints of the bent transverse beams produced a fabricated lack-of-fusion defect perpendicular to the primary stress field. Large initial defects and cracks are low fatigue resistant details, and with field measured stress range values exceeding the Category E fatigue limit of 31 MPa, crack growth would be expected. Measured differences in stress range between corners on the same transverse beam flange were observed and attributed to biaxial bending. Biaxial bending resulted from a combination of the vertical loading and longitudinal reaction and braking forces. Current design provisions do not take account of the longitudinal forces when evaluating fatigue resistance in these bent structures.

Transfer of the live load forces from the beam top flange to the bent column had to be assured for an effective retrofit of the beam column connection of the bent. Short sections of wide flange shapes were modified by partial removal of the web and were bolted to the top flange of the lower beam and webs of the column (Fig. 11). If the fatigue cracks in the groove welds continued to propagate and eventually led to fracture of the top beam flange to column connection, the live load forces would be transferred via the bolted splice. In addition, the reinforcement provided more resistance to the longitudinal forces.

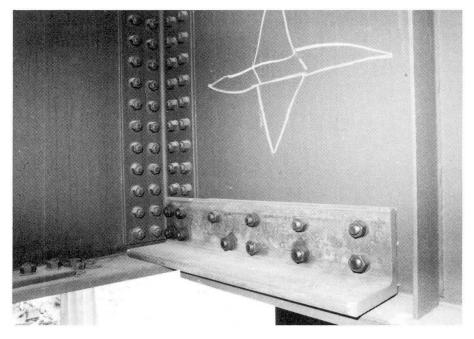
Fig. 10 Retrofit of a Longitudinal Girder Bottom Web Gap

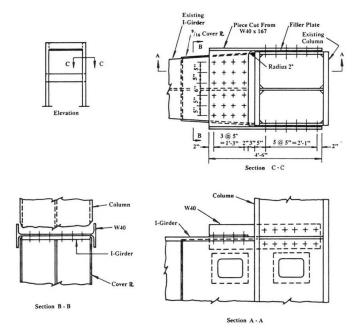
Fig. 11 Retrofit for an I Section Beam Column Connection

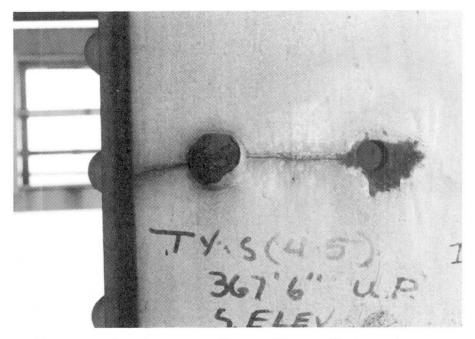
Inspections of the structure revealed fatigue cracks emanating from the rivet holes in several hanger box sections (Fig. 13). In addition to the fatigue cracks, significant amounts of corrosion product was found between the corner angles and both web and flange plates of the hanger sections (Fig. 13). Environmental corrosion was also found between the gusset and hanger plate as well as on the gusset at the elevation of the pin connection (Fig. 14).

Fig. 13 Corrosion Between a Hanger Flange Plate and Interior Connection Angle and Web Crack from Rivet Hole

The hanger connections are located directly below open roadway expansion joints which allows salt, water, and debris to fall and collect on the pin and hangers, thereby assisting and accelerating the corrosion process. Field inspections and strain measurements demonstrated that the development of corrosion caused pin restraint which, in turn, led to bending in the hangers. When the bending moment at the hanger joint was high enough to overcome the restraint, sudden release of the pin connection produced the dynamic action. Lubrication of the pins was effective in minimizing hanger bending and dynamic effects by reducing pin restraint and as such, was recommended as a routine maintenance practice. A longer term correction will require the redesign of the pin connection as well as effective control of water and debris by the elimination of open expansion joints.

Cracked hanger plates were temporarily retrofitted by the drilling of holes to blunt the crack tips. For the cracked hanger flange plates, the maximum measured stress range of 55 MPa exceeded the fatigue limit of 48 MPa for riveted members. Fatigue crack propagation is expected to continue in the flange plates. As a result, twice a year inspection of the hangers will be required, until the eventual replacement of the damaged hangers.

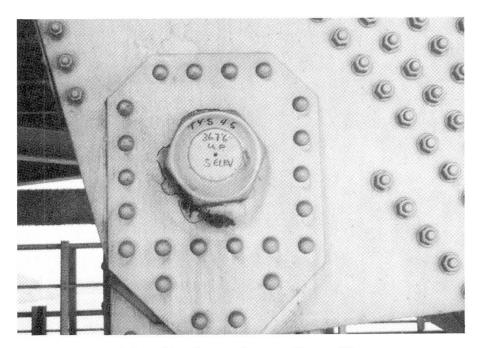
Fig. 14 Corrosion at Upper Pin
