**Zeitschrift:** IABSE reports = Rapports AIPC = IVBH Berichte  
**Band:** 59 (1990)

**Artikel:** Fatigue crack detection and repair of steel bridge structures  
**Autor:** Fisher, John W. / Menzemer, Craig C. / Yen, Ben T.  
**DOI:** <https://doi.org/10.5169/seals-45726>

## **Fatigue Crack Detection and Repair of Steel Bridge Structures**

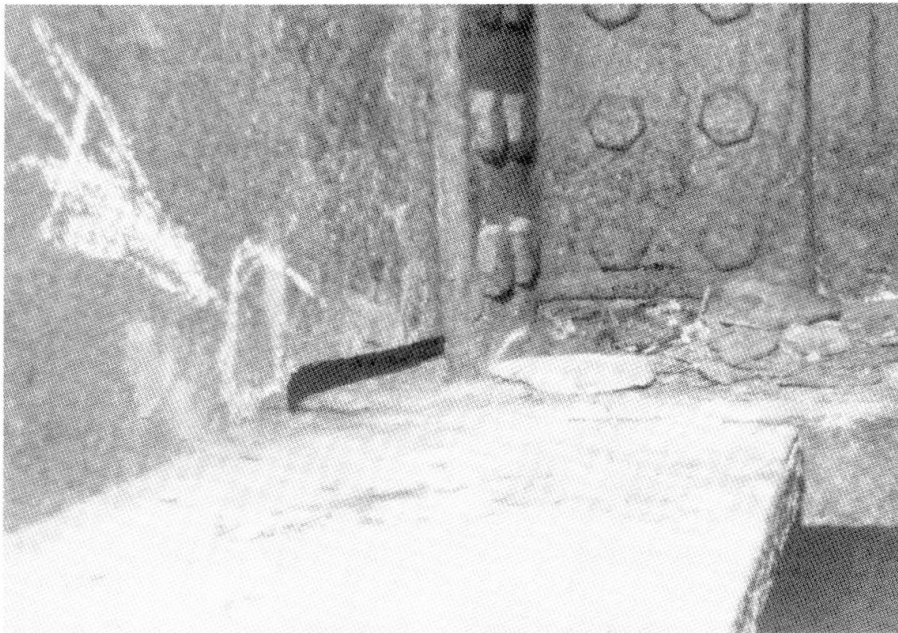
Inspection of the structure revealed several areas which contained fatigue cracks. In addition, lateral displacement of several longitudinal girder bottom flanges was also observed. Fatigue cracks were found along the longitudinal girder web to flange weld at the flange terminations and vertical cracks were observed in the longitudinal girder webs at the reentrant corner of the bottom copes (Fig. 5). Cracking was occasionally observed along the bolt fixity line of the connection angles (Fig. 6).

Fig. 5 Vertical and Horizontal Fatigue Cracks at Bottom Web Cope

Coping by flame cutting the longitudinal girder and floorbeam webs resulted in high tensile residual stresses along the cut edge as well as at reentrant corner. In addition, coping greatly reduced the section modulus for in-plane bending and left an unstiffened segment of girder web between the flange terminations and the bolt fixity line of the longitudinal girders. At locations where the longitudinal girders were not bolted full depth to the connection angles, the girder web could rotate in plane without developing significant compressive forces in the lower portion of the girder. This resulted in no bottom flange lateral displacement, no web gap distortion, and no fatigue cracking in the web cope or connection angles. In locations where the girder was bolted full depth to the connection angles of the transverse beam, connection restraint resulted in lateral displacement of the bottom flange and web gap distortion from the compressive stresses in the web. Hence, fatigue cracks along the bottom edges of the connection angles were all displacement induced.

Retrofits recommended for fatigue cracking in the longitudinal girders included the drilling of holes to blunt the crack tips. Further retrofit was required to prevent the lateral displacement of the bottom flange and minimize web gap distortion. Otherwise, fatigue crack reinitiation from the retrofit holes and continued crack propagation along the bolt fixity line would result. Several rows of bolts were removed from the girder to transverse beam connection to reduce the compression in the web and help move the flange toward normal alignment. Angles were then bolted to the inside longitudinal girder web and flange and to the connection angle to prevent lateral motion of the bottom flange (Fig. 10) and to provide greater resistance to the end restraint.

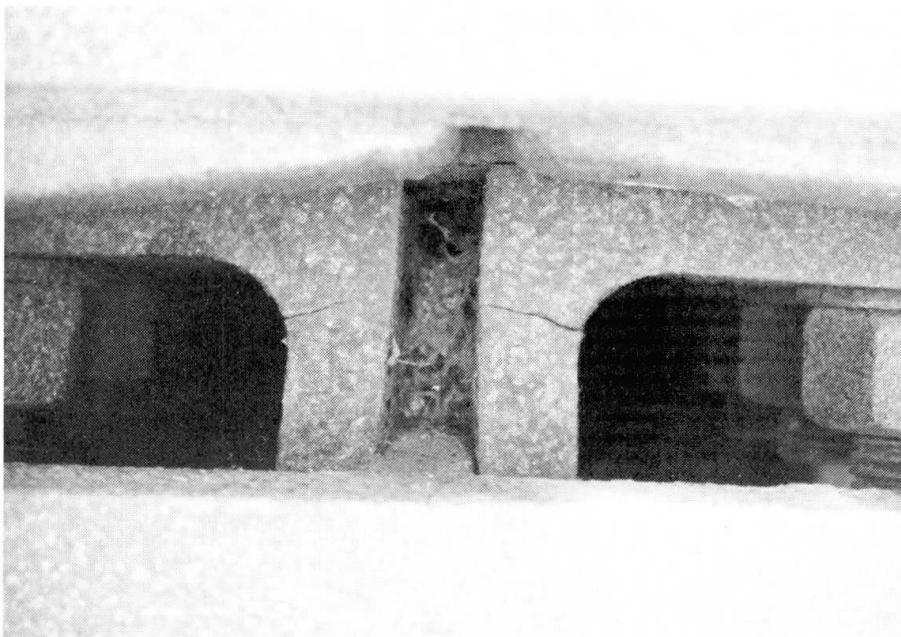
Fig. 6 Cross-Sectional View of Angle with Fatigue Cracks

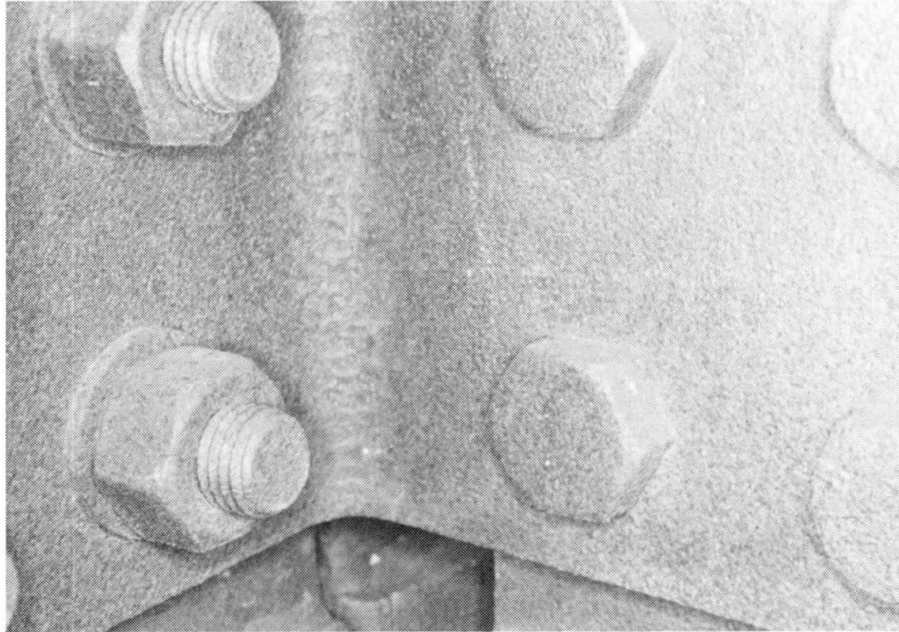
Figure 7 shows cracks which extended several inches along the bottom end of the angle fillet, between the girder web and the transverse beam of the bents. The cracks were found only at locations where the longitudinal girder web was bolted full depth to the connection angles. Other locations where the girder web was not bolted full depth exhibited no evidence of cracking (Fig. 8).

Fig. 7 Fatigue Crack in Longitudinal Girder-Beam (Bent) Angle Connection

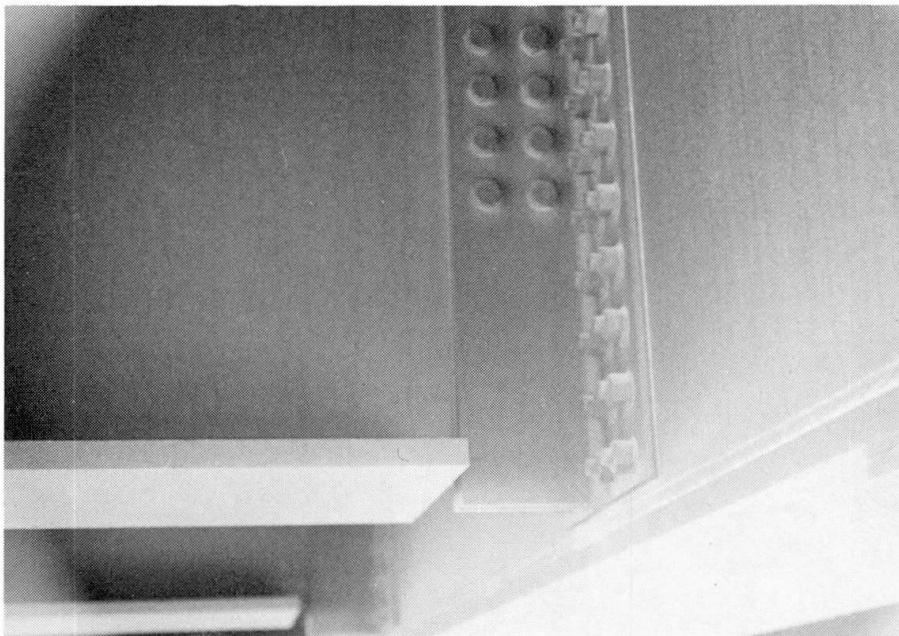
Fig. 8 Longitudinal Girder Not Bolted Full Depth to the Connection Angles

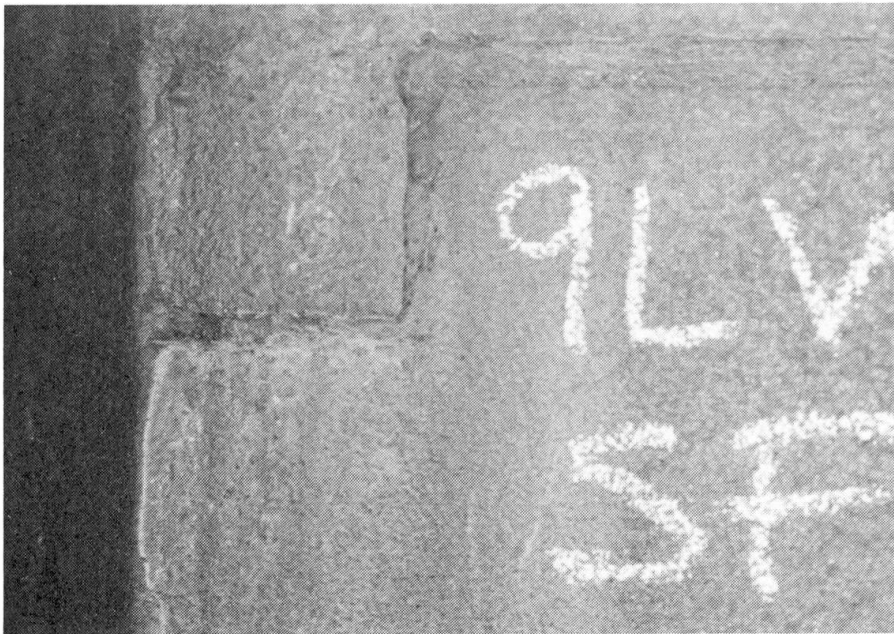
groove weld connecting the top flange of transverse beam to the column. Further grinding exposed the crack which extended from the back-up bar halfway through the groove weld thickness. Other bents revealed cracks at the web cope closure plates of the transverse box beam (Fig. 9). Grinding the fillet weld throat into the beam flange exposed cracks extending from the back-up bar into the groove weld thickness.

Fig. 9 Cracks at the Cope Closure Plates of a Box Beam

Connection geometry at the corner joints of the bent transverse beams produced a fabricated lack-of-fusion defect perpendicular to the primary stress field. Large initial defects and cracks are low fatigue resistant details, and with field measured stress range values exceeding the Category E fatigue limit of 31 MPa, crack growth would be expected. Measured differences in stress range between corners on the same transverse beam flange were observed and attributed to biaxial bending. Biaxial bending resulted from a combination of the vertical loading and longitudinal reaction and braking forces. Current design provisions do not take account of the longitudinal forces when evaluating fatigue resistance in these bent structures.

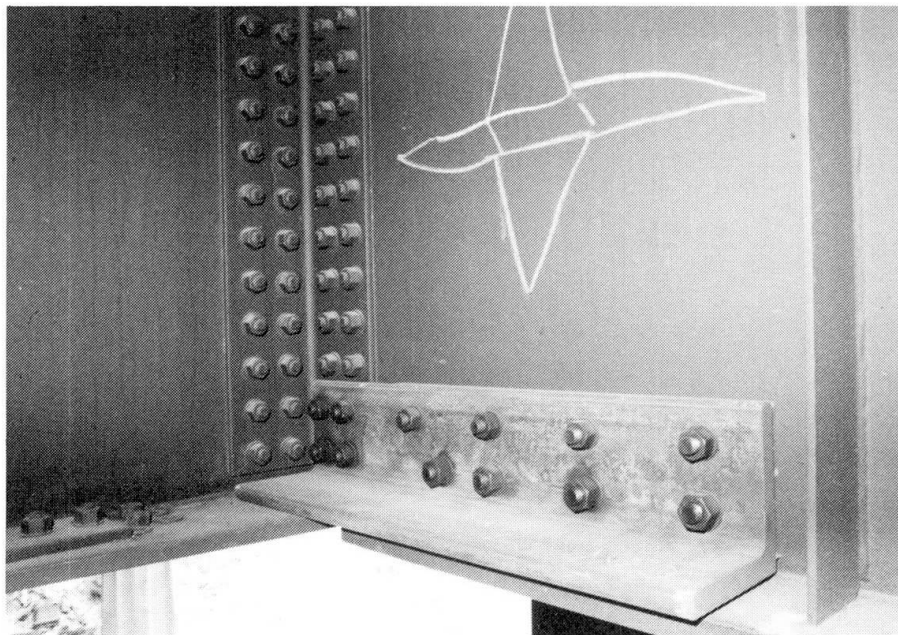
Fig. 10 Retrofit of a Longitudinal Girder Bottom Web Gap

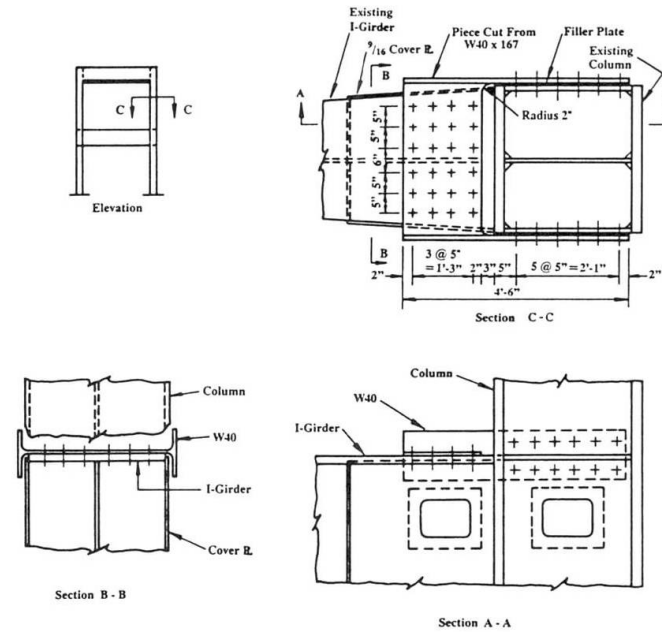
Fig. 11 Retrofit for an I Section Beam Column Connection

Transfer of the live load forces from the beam top flange to the bent column had to be assured for an effective retrofit of the beam column connection of the bent. Short sections of wide flange shapes were modified by partial removal of the web and were bolted to the top flange of the lower beam and webs of the column (Fig. 11). If the fatigue cracks in the groove welds continued to propagate and eventually led to fracture of the top beam flange to column connection, the live load forces would be transferred via the bolted splice. In addition, the reinforcement provided more resistance to the longitudinal forces.

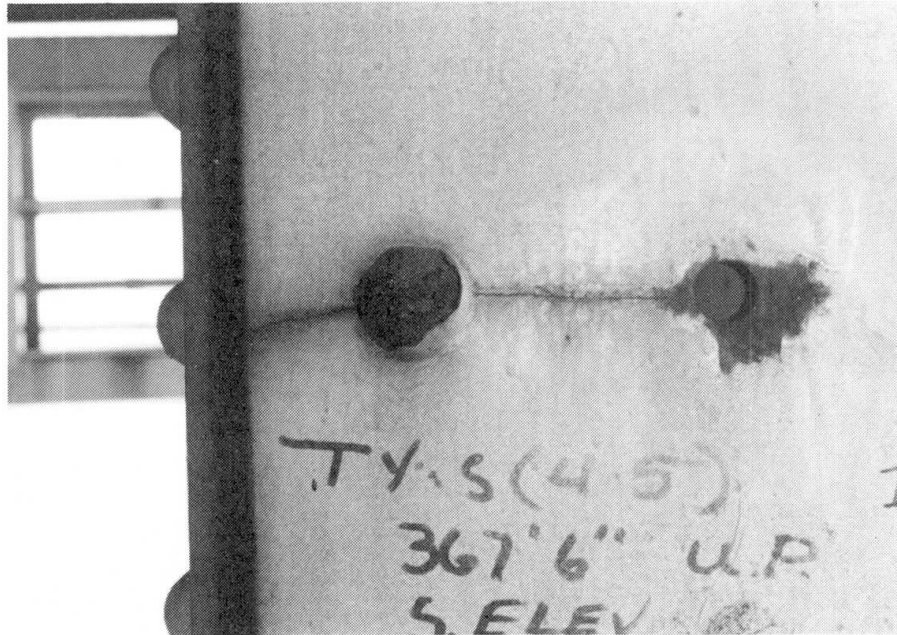
Inspections of the structure revealed fatigue cracks emanating from the rivet holes in several hanger box sections (Fig. 13). In addition to the fatigue cracks, significant amounts of corrosion product was found between the corner angles and both web and flange plates of the hanger sections (Fig. 13). Environmental corrosion was also found between the gusset and hanger plate as well as on the gusset at the elevation of the pin connection (Fig. 14).

Fig. 13 Corrosion Between a Hanger Flange Plate and Interior Connection Angle and Web Crack from Rivet Hole

The hanger connections are located directly below open roadway expansion joints which allows salt, water, and debris to fall and collect on the pin and hangers, thereby assisting and accelerating the corrosion process. Field inspections and strain measurements demonstrated that the development of corrosion caused pin restraint which, in turn, led to bending in the hangers. When the bending moment at the hanger joint was high enough to overcome the restraint, sudden release of the pin connection produced the dynamic action. Lubrication of the pins was effective in minimizing hanger bending and dynamic effects by reducing pin restraint and as such, was recommended as a routine maintenance practice. A longer term correction will require the redesign of the pin connection as well as effective control of water and debris by the elimination of open expansion joints.

Cracked hanger plates were temporarily retrofitted by the drilling of holes to blunt the crack tips. For the cracked hanger flange plates, the maximum measured stress range of 55 MPa exceeded the fatigue limit of 48 MPa for riveted members. Fatigue crack propagation is expected to continue in the flange plates. As a result, twice a year inspection of the hangers will be required, until the eventual replacement of the damaged hangers.

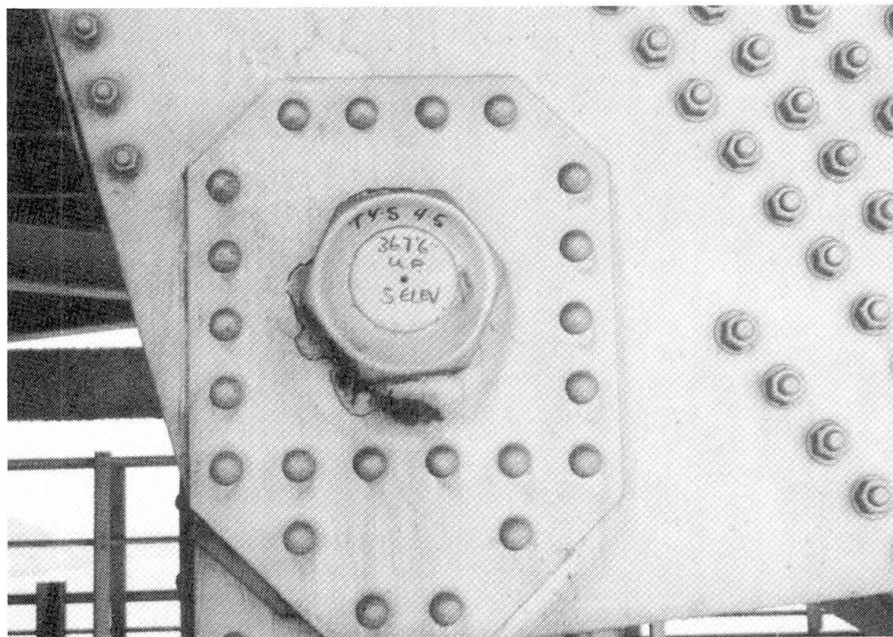
Fig. 14 Corrosion at Upper Pin
