Artikel: Fatigue crack detection and repair of steel bridge structures
Autor: Fisher, John W. / Menzemer, Craig C. / Yen, Ben T.
DOI: <https://doi.org/10.5169/seals-45726>

Fatigue Crack Detection and Repair of Steel Bridge Structures

3.0 I-93 CENTRAL ARTERY

4.0 I-95 OVER THE SUSQUEHANNA RIVER

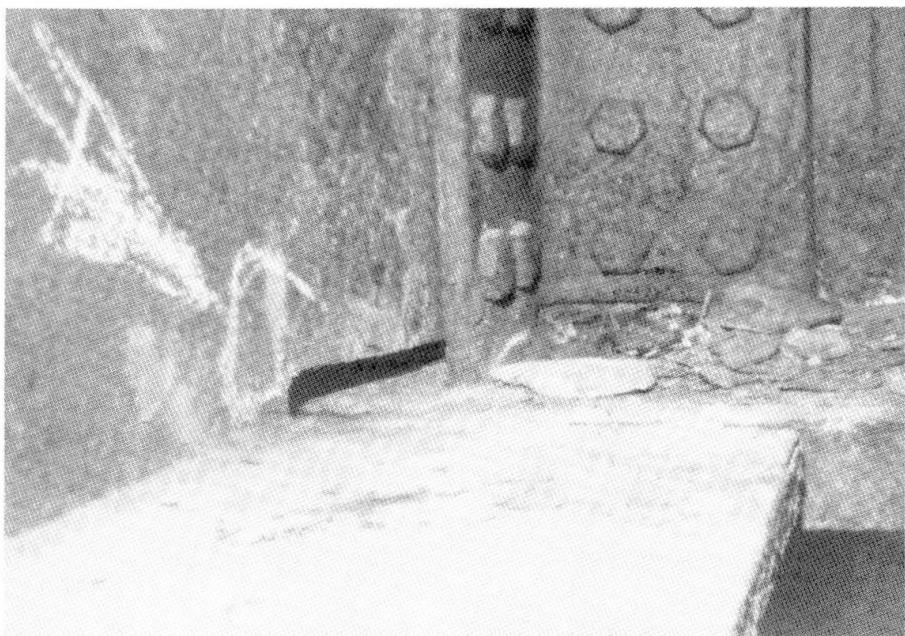
Inspection of the structure revealed several areas which contained fatigue cracks. In addition, lateral displacement of several longitudinal girder bottom flanges was also observed. Fatigue cracks were found along the longitudinal girder web to flange weld at the flange terminations and vertical cracks were observed in the longitudinal girder webs at the reentrant corner of the bottom copes (Fig. 5). Cracking was occasionally observed along the bolt fixity line of the connection angles (Fig. 6).

Fig. 5 Vertical and Horizontal Fatigue Cracks at Bottom Web Cope

Coping by flame cutting the longitudinal girder and floorbeam webs resulted in high tensile residual stresses along the cut edge as well as at reentrant corner. In addition, coping greatly reduced the section modulus for in-plane bending and left an unstiffened segment of girder web between the flange terminations and the bolt fixity line of the longitudinal girders. At locations where the longitudinal girders were not bolted full depth to the connection angles, the girder web could rotate in plane without developing significant compressive forces in the lower portion of the girder. This resulted in no bottom flange lateral displacement, no web gap distortion, and no fatigue cracking in the web cope or connection angles. In locations where the girder was bolted full depth to the connection angles of the transverse beam, connection restraint resulted in lateral displacement of the bottom flange and web gap distortion from the compressive stresses in the web. Hence, fatigue cracks along the bottom edges of the connection angles were all displacement induced.

Retrofits recommended for fatigue cracking in the longitudinal girders included the drilling of holes to blunt the crack tips. Further retrofit was required to prevent the lateral displacement of the bottom flange and minimize web gap distortion. Otherwise, fatigue crack reinitiation from the retrofit holes and continued crack propagation along the bolt fixity line would result. Several rows of bolts were removed from the girder to transverse beam connection to reduce the compression in the web and help move the flange toward normal alignment. Angles were then bolted to the inside longitudinal girder web and flange and to the connection angle to prevent lateral motion of the bottom flange (Fig. 10) and to provide greater resistance to the end restraint.

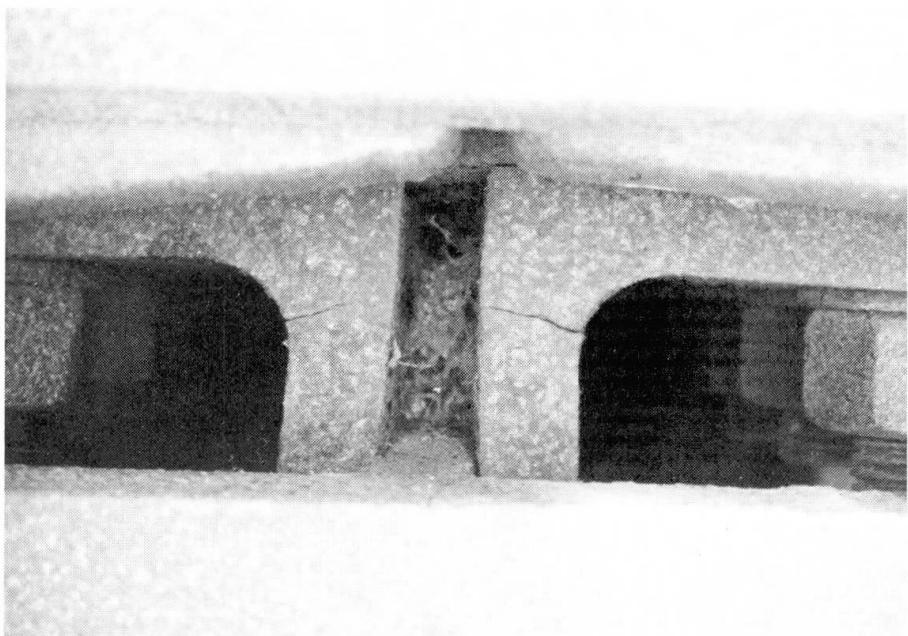
Fig. 6 Cross-Sectional View of Angle with Fatigue Cracks

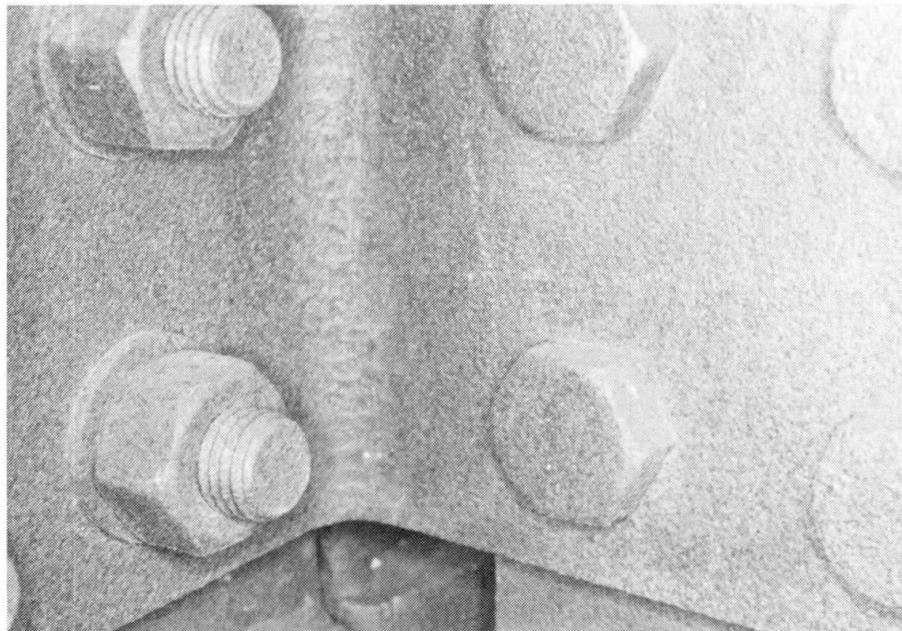
Figure 7 shows cracks which extended several inches along the bottom end of the angle fillet, between the girder web and the transverse beam of the bents. The cracks were found only at locations where the longitudinal girder web was bolted full depth to the connection angles. Other locations where the girder web was not bolted full depth exhibited no evidence of cracking (Fig. 8).

Fig. 7 Fatigue Crack in Longitudinal Girder-Beam (Bent) Angle Connection

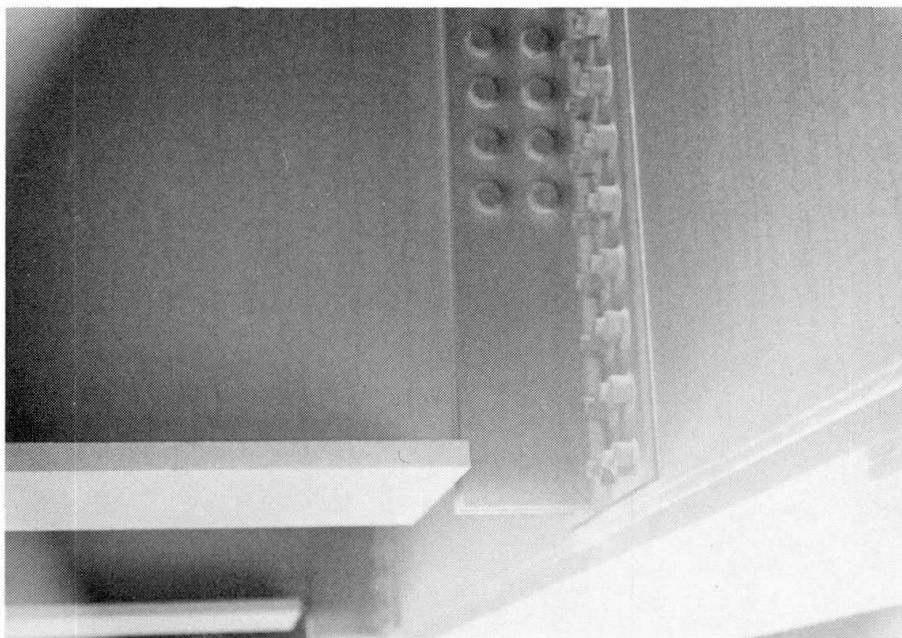
Fig. 8 Longitudinal Girder Not Bolted Full Depth to the Connection Angles

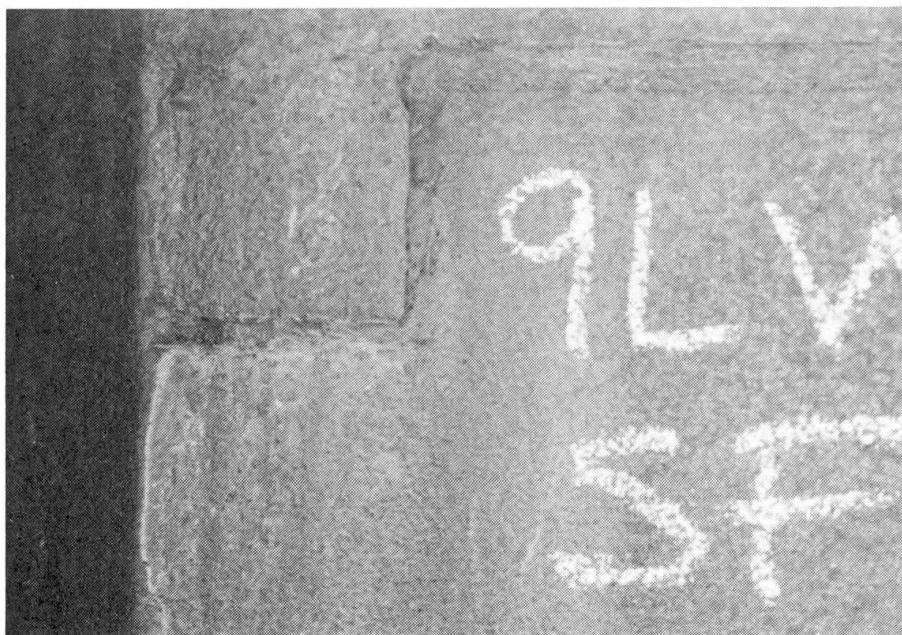
groove weld connecting the top flange of transverse beam to the column. Further grinding exposed the crack which extended from the back-up bar halfway through the groove weld thickness. Other bents revealed cracks at the web cope closure plates of the transverse box beam (Fig. 9). Grinding the fillet weld throat into the beam flange exposed cracks extending from the back-up bar into the groove weld thickness.

Fig. 9 Cracks at the Cope Closure Plates of a Box Beam

Connection geometry at the corner joints of the bent transverse beams produced a fabricated lack-of-fusion defect perpendicular to the primary stress field. Large initial defects and cracks are low fatigue resistant details, and with field measured stress range values exceeding the Category E fatigue limit of 31 MPa, crack growth would be expected. Measured differences in stress range between corners on the same transverse beam flange were observed and attributed to biaxial bending. Biaxial bending resulted from a combination of the vertical loading and longitudinal reaction and braking forces. Current design provisions do not take account of the longitudinal forces when evaluating fatigue resistance in these bent structures.

Transfer of the live load forces from the beam top flange to the bent column had to be assured for an effective retrofit of the beam column connection of the bent. Short sections of wide flange shapes were modified by partial removal of the web and were bolted to the top flange of the lower beam and webs of the column (Fig. 11). If the fatigue cracks in the groove welds continued to propagate and eventually led to fracture of the top beam flange to column connection, the live load forces would be transferred via the bolted splice. In addition, the reinforcement provided more resistance to the longitudinal forces.

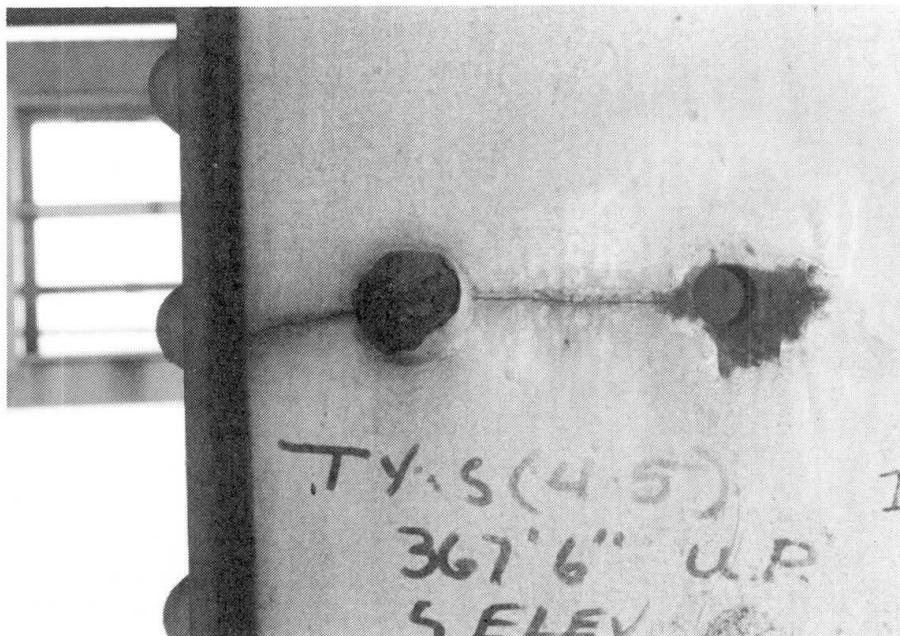
Inspections of the structure revealed fatigue cracks emanating from the rivet holes in several hanger box sections (Fig. 13). In addition to the fatigue cracks, significant amounts of corrosion product was found between the corner angles and both web and flange plates of the hanger sections (Fig. 13). Environmental corrosion was also found between the gusset and hanger plate as well as on the gusset at the elevation of the pin connection (Fig. 14).

Fig. 13 Corrosion Between a Hanger Flange Plate and Interior Connection Angle and Web Crack from Rivet Hole

The hanger connections are located directly below open roadway expansion joints which allows salt, water, and debris to fall and collect on the pin and hangers, thereby assisting and accelerating the corrosion process. Field inspections and strain measurements demonstrated that the development of corrosion caused pin restraint which, in turn, led to bending in the hangers. When the bending moment at the hanger joint was high enough to overcome the restraint, sudden release of the pin connection produced the dynamic action. Lubrication of the pins was effective in minimizing hanger bending and dynamic effects by reducing pin restraint and as such, was recommended as a routine maintenance practice. A longer term correction will require the redesign of the pin connection as well as effective control of water and debris by the elimination of open expansion joints.

Cracked hanger plates were temporarily retrofitted by the drilling of holes to blunt the crack tips. For the cracked hanger flange plates, the maximum measured stress range of 55 MPa exceeded the fatigue limit of 48 MPa for riveted members. Fatigue crack propagation is expected to continue in the flange plates. As a result, twice a year inspection of the hangers will be required, until the eventual replacement of the damaged hangers.

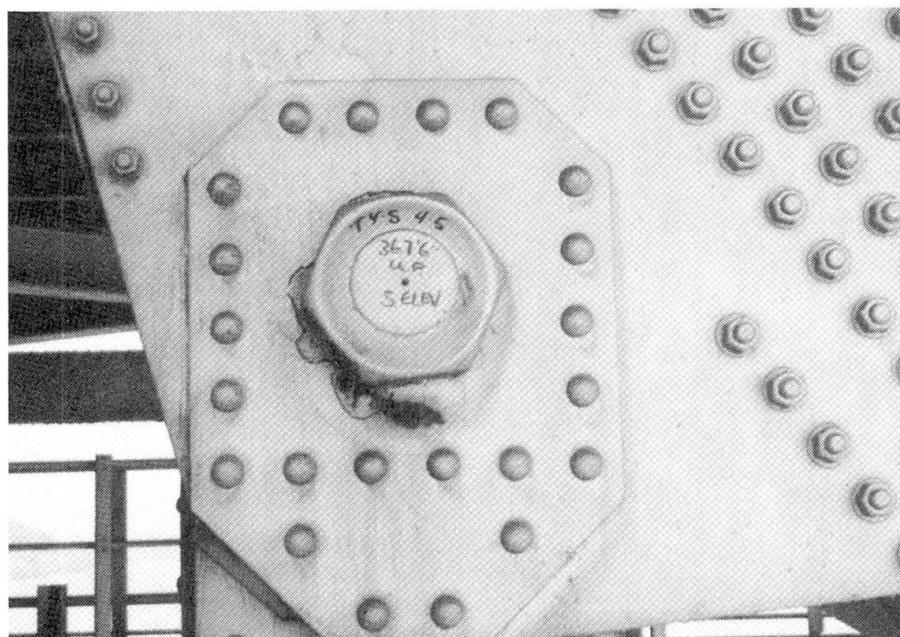
Fig. 14 Corrosion at Upper Pin
