Zeitschrift: IABSE reports = Rapports AIPC = IVBH Berichte
Band: 59 (1990)

Artikel: Fatigue crack detection and repair of steel bridge structures
Autor: Fisher, John W. / Menzemer, Craig C. / Yen, Ben T.
DOI: <https://doi.org/10.5169/seals-45726>

Fatigue Crack Detection and Repair of Steel Bridge Structures

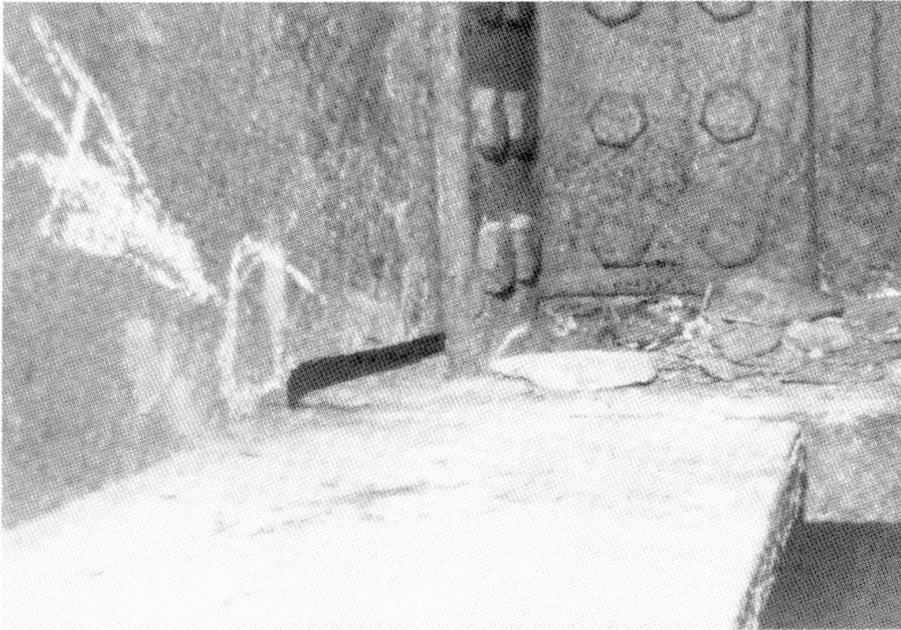
Inspection of the structure revealed several areas which contained fatigue cracks. In addition, lateral displacement of several longitudinal girder bottom flanges was also observed. Fatigue cracks were found along the longitudinal girder web to flange weld at the flange terminations and vertical cracks were observed in the longitudinal girder webs at the reentrant corner of the bottom copes (Fig. 5). Cracking was occasionally observed along the bolt fixity line of the connection angles (Fig. 6).

Fig. 5 Vertical and Horizontal Fatigue Cracks at Bottom Web Cope

Coping by flame cutting the longitudinal girder and floorbeam webs resulted in high tensile residual stresses along the cut edge as well as at reentrant corner. In addition, coping greatly reduced the section modulus for in-plane bending and left an unstiffened segment of girder web between the flange terminations and the bolt fixity line of the longitudinal girders. At locations where the longitudinal girders were not bolted full depth to the connection angles, the girder web could rotate in plane without developing significant compressive forces in the lower portion of the girder. This resulted in no bottom flange lateral displacement, no web gap distortion, and no fatigue cracking in the web cope or connection angles. In locations where the girder was bolted full depth to the connection angles of the transverse beam, connection restraint resulted in lateral displacement of the bottom flange and web gap distortion from the compressive stresses in the web. Hence, fatigue cracks along the bottom edges of the connection angles were all displacement induced.

Retrofits recommended for fatigue cracking in the longitudinal girders included the drilling of holes to blunt the crack tips. Further retrofit was required to prevent the lateral displacement of the bottom flange and minimize web gap distortion. Otherwise, fatigue crack reinitiation from the retrofit holes and continued crack propagation along the bolt fixity line would result. Several rows of bolts were removed from the girder to transverse beam connection to reduce the compression in the web and help move the flange toward normal alignment. Angles were then bolted to the inside longitudinal girder web and flange and to the connection angle to prevent lateral motion of the bottom flange (Fig. 10) and to provide greater resistance to the end restraint.

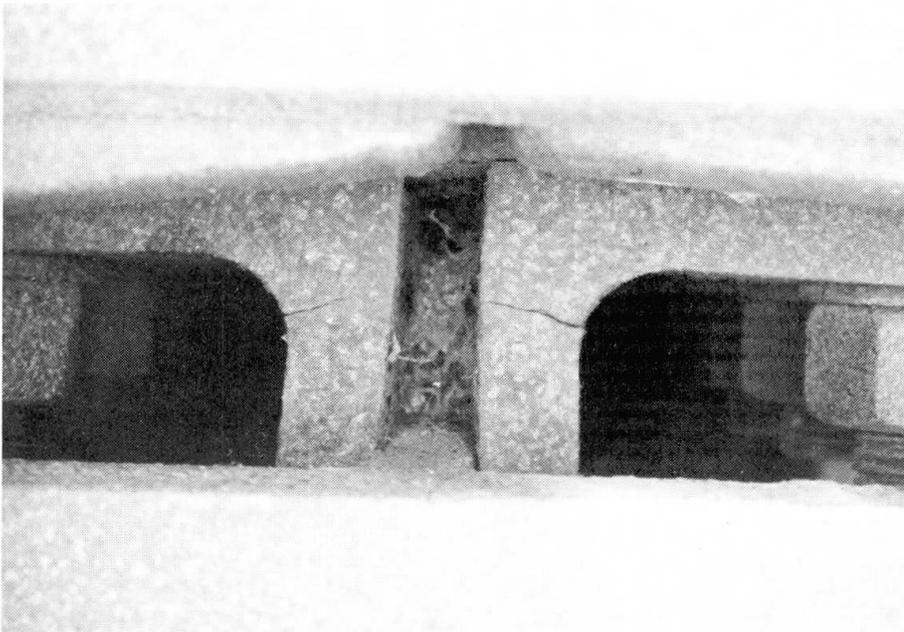
Fig. 6 Cross-Sectional View of Angle with Fatigue Cracks

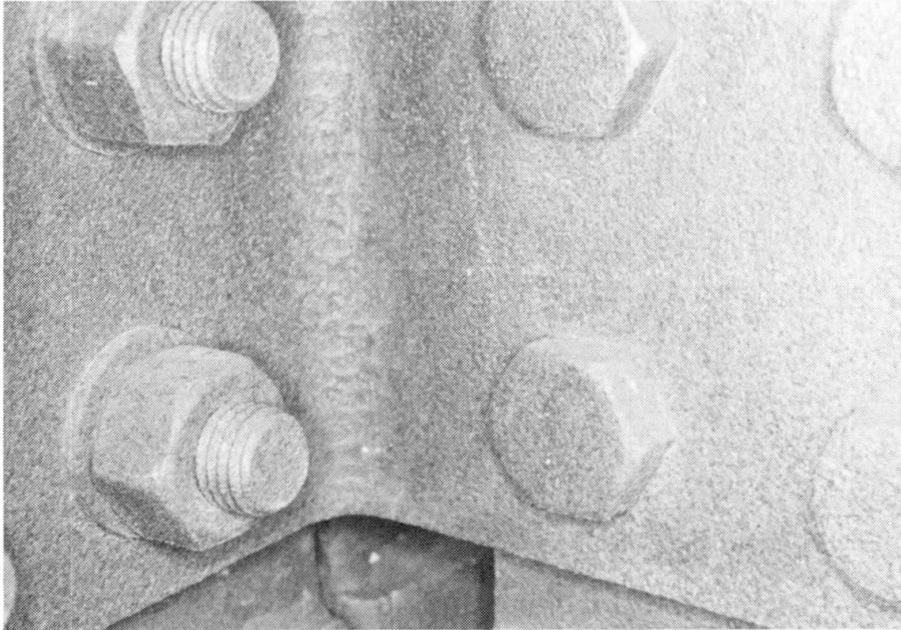
Figure 7 shows cracks which extended several inches along the bottom end of the angle fillet, between the girder web and the transverse beam of the bents. The cracks were found only at locations where the longitudinal girder web was bolted full depth to the connection angles. Other locations where the girder web was not bolted full depth exhibited no evidence of cracking (Fig. 8).

Fig. 7 Fatigue Crack in Longitudinal Girder-Beam (Bent) Angle Connection

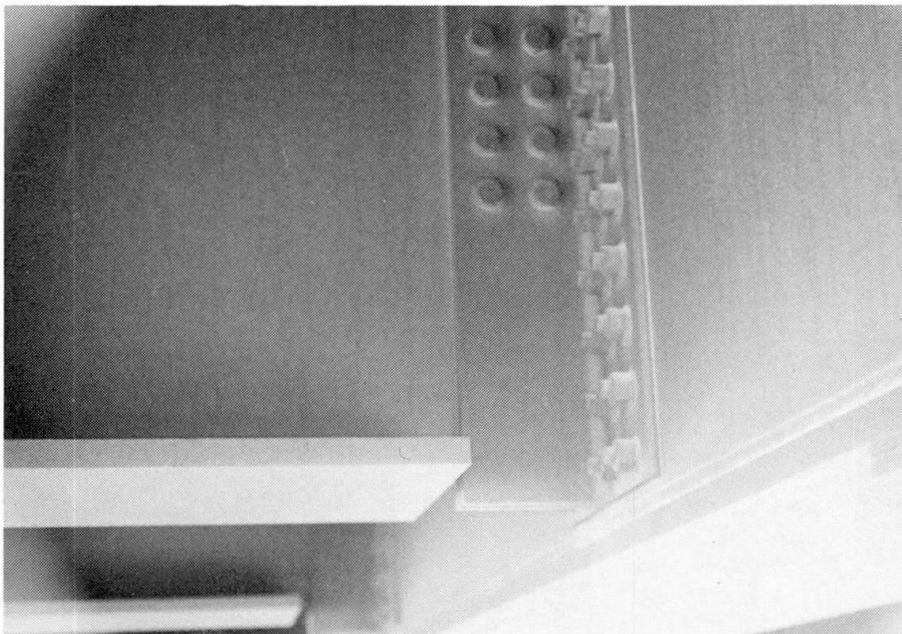
Fig. 8 Longitudinal Girder Not Bolted Full Depth to the Connection Angles

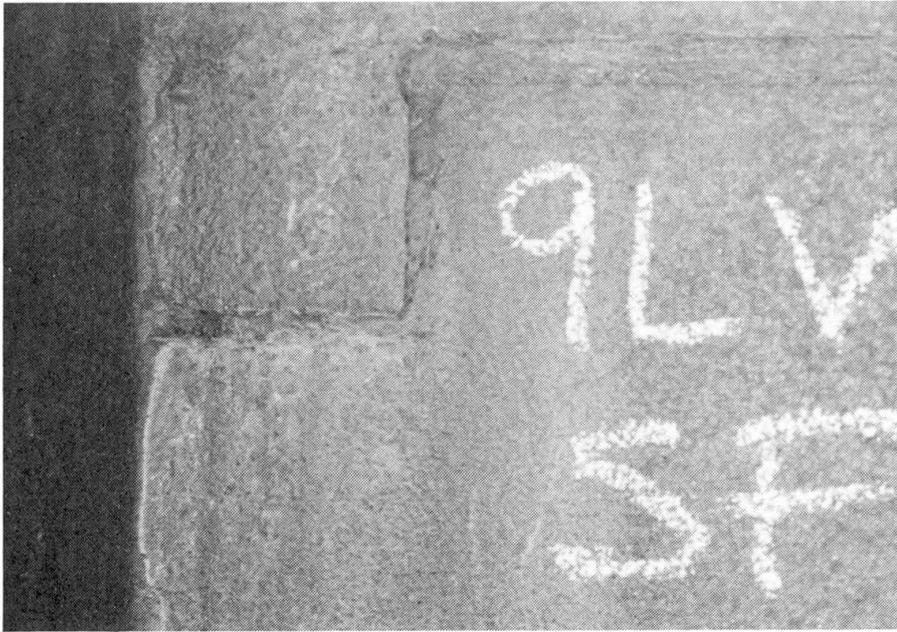
groove weld connecting the top flange of transverse beam to the column. Further grinding exposed the crack which extended from the back-up bar halfway through the groove weld thickness. Other bents revealed cracks at the web cope closure plates of the transverse box beam (Fig. 9). Grinding the fillet weld throat into the beam flange exposed cracks extending from the back-up bar into the groove weld thickness.

Fig. 9 Cracks at the Cope Closure Plates of a Box Beam

Connection geometry at the corner joints of the bent transverse beams produced a fabricated lack-of-fusion defect perpendicular to the primary stress field. Large initial defects and cracks are low fatigue resistant details, and with field measured stress range values exceeding the Category E fatigue limit of 31 MPa, crack growth would be expected. Measured differences in stress range between corners on the same transverse beam flange were observed and attributed to biaxial bending. Biaxial bending resulted from a combination of the vertical loading and longitudinal reaction and braking forces. Current design provisions do not take account of the longitudinal forces when evaluating fatigue resistance in these bent structures.

Transfer of the live load forces from the beam top flange to the bent column had to be assured for an effective retrofit of the beam column connection of the bent. Short sections of wide flange shapes were modified by partial removal of the web and were bolted to the top flange of the lower beam and webs of the column (Fig. 11). If the fatigue cracks in the groove welds continued to propagate and eventually led to fracture of the top beam flange to column connection, the live load forces would be transferred via the bolted splice. In addition, the reinforcement provided more resistance to the longitudinal forces.

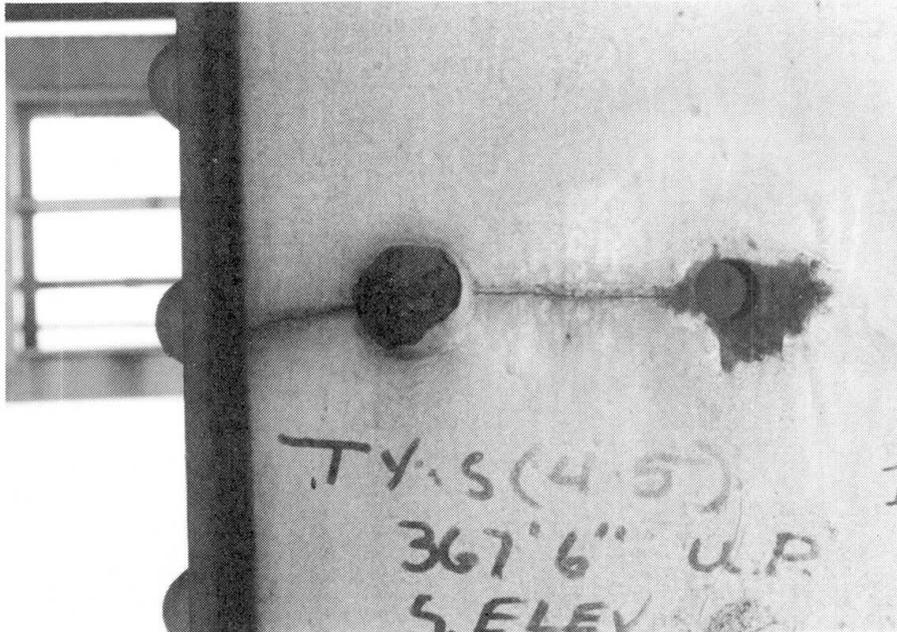
Inspections of the structure revealed fatigue cracks emanating from the rivet holes in several hanger box sections (Fig. 13). In addition to the fatigue cracks, significant amounts of corrosion product was found between the corner angles and both web and flange plates of the hanger sections (Fig. 13). Environmental corrosion was also found between the gusset and hanger plate as well as on the gusset at the elevation of the pin connection (Fig. 14).

Fig. 13 Corrosion Between a Hanger Flange Plate and Interior Connection Angle and Web Crack from Rivet Hole

The hanger connections are located directly below open roadway expansion joints which allows salt, water, and debris to fall and collect on the pin and hangers, thereby assisting and accelerating the corrosion process. Field inspections and strain measurements demonstrated that the development of corrosion caused pin restraint which, in turn, led to bending in the hangers. When the bending moment at the hanger joint was high enough to overcome the restraint, sudden release of the pin connection produced the dynamic action. Lubrication of the pins was effective in minimizing hanger bending and dynamic effects by reducing pin restraint and as such, was recommended as a routine maintenance practice. A longer term correction will require the redesign of the pin connection as well as effective control of water and debris by the elimination of open expansion joints.

Cracked hanger plates were temporarily retrofitted by the drilling of holes to blunt the crack tips. For the cracked hanger flange plates, the maximum measured stress range of 55 MPa exceeded the fatigue limit of 48 MPa for riveted members. Fatigue crack propagation is expected to continue in the flange plates. As a result, twice a year inspection of the hangers will be required, until the eventual replacement of the damaged hangers.

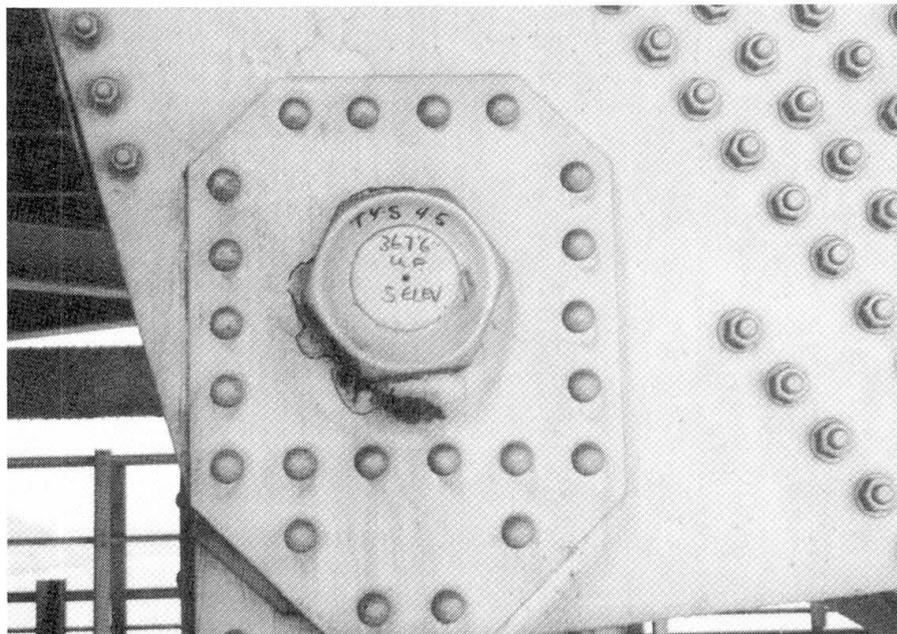
Fig. 14 Corrosion at Upper Pin
