Zeitschrift: IABSE reports = Rapports AIPC = IVBH Berichte
Band: 67 (1993)

Artikel: Safe capacity of suspension bridge cables
Autor: Sluszk, Peter / Kendall, Martin
DOI: <https://doi.org/10.5169/seals-51399>

Safe Capacity of Suspension Bridge Cables **Sécurité de la capacité portante des câbles de ponts suspendus** **Sichere Traglast von Hängebrückenseilen**

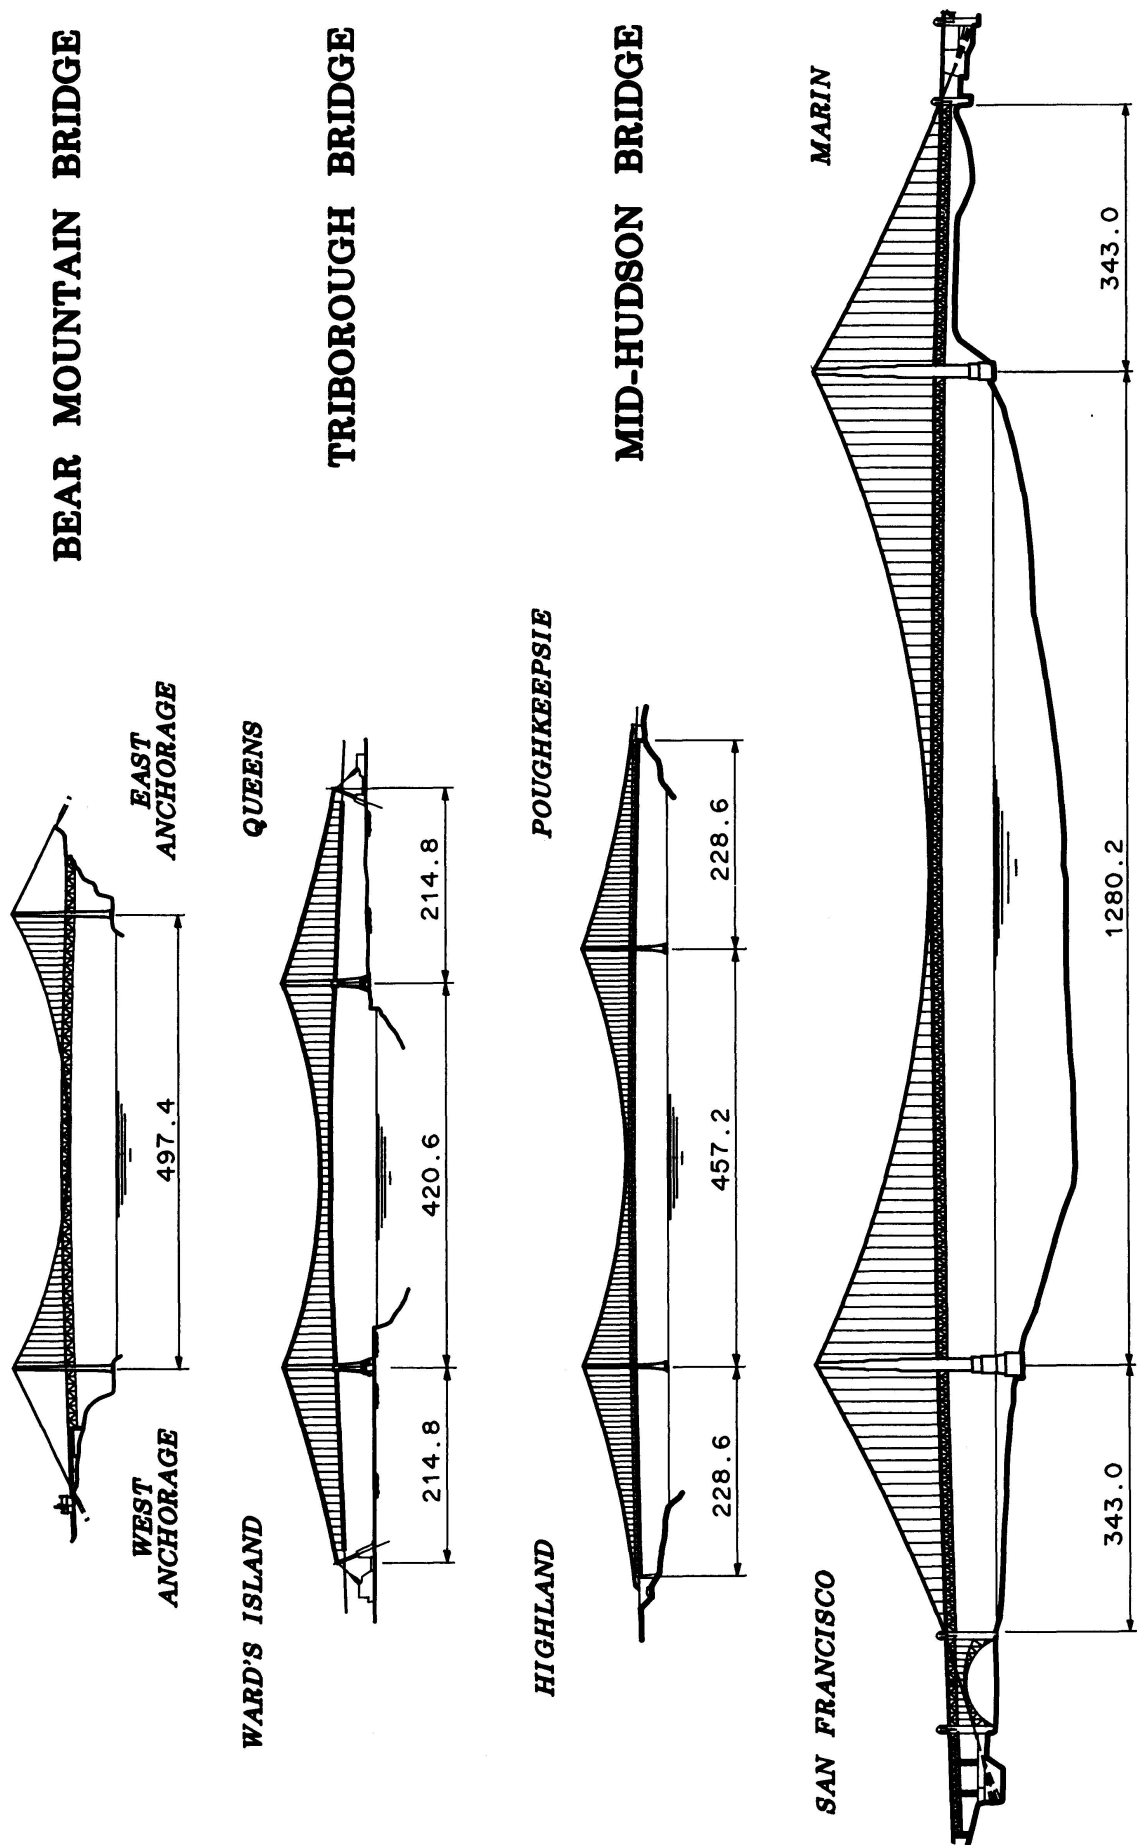
Figure 1

1.6 The size of the spans and cables, with the exception of the Golden Gate Bridge are all roughly comparable. The make-up, size of cable, and spans are listed in Table 1 and the bridges are illustrated in Figure 1.
