Artikel: Structural assessment of St. Mark's Basilica, Venice

Autor: Rossi, Pier Paolo / Ventrucci, Franco / Vio, Ettore

Structural Assessment of St. Mark's Basilica, Venice

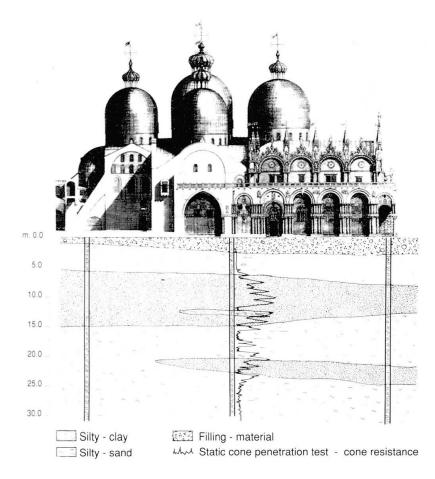
Fig. 2 - Stratigraphic profile along the North side of the Basilica.

A detailed survey of the subsoil of the Cathedral was carried out in order to define the stratigraphy of the soil as well as the mechanical characteristics of the different soil lavers. Seven boreholes (30 m deep) were drilled around the perimeter of the Basilica and many undisturbed samples were taken for carrying out physical and mechanical laboratory tests. Static cone penetration tests were also carried out in three testing points, using a digital cone, in order to identify the mechanical characteristics of the different layers of soil. On the basis of in situ and laboratory tests, the stratigraphy of the soil was identified. As an example, fig. 2 shows the stratigraphic profile obtained by correlating the results of three boreholes drilled on the North side of the Cathedral. Under a surface layer of filling material, a silty-clay layer (about 5 m thick) has been observed. A

silty-sand layer with higher mechanical characteristics is also present with a thickness varying between 5 and 10 m. Under the sand layer, silty-clay material was found. The presence of local lenses of sand inside the silty-clay material was observed as usual in lagoon-side environments. Three boreholes were equipped with electric piezometers and three with long base settlement-gauges connected to an automatic reading unit. This monitoring system will allow the settlement of the perimeter of the Cathedral to be controlled as a function of time and water-table variations.

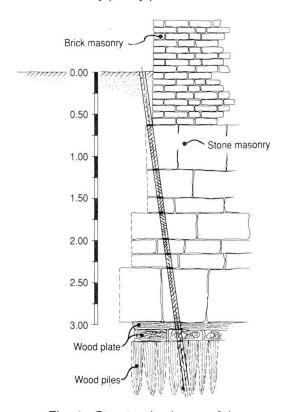
Fig. 4 - Structural scheme of the foundation masonry

An in-depth investigation was also carried out to analyze the geometric and structural characteristics of the foundation masonry of the perimeter walls and of the pillars. Several small boreholes (diameter 62 mm) were cored by using a light diamond saw and the lateral surface of the boreholes was surveyed by means of a colour video camera. Fig. 3 shows the drilling equipment installed at the base of a pillar for coring the foundation masonry. More than 50 subvertical boreholes were drilled to investigate the structural characteristics of the foundation masonries. In order to obtain qualitative information concerning the mechanical characteristics of the masonry structures, a sonic-log survey was carried out as well as crosshole measurements by using two parallel boreholes. As a result of the coring and video camera survey, the typical structural scheme of the foundation masonry was determined (Fig. 4). At a depth of about 70-90 cm from floor level, a stone basement made with large blocks of sandstone is present with a thickness of about 2 m. Underneath this stone basement there is a wood plate (10 cm thick) which is about 3.0 m below the floor. This wood plate rests on short wooden piles which are very poorly preserved.

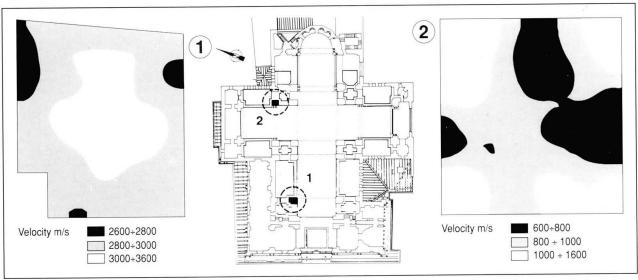
Fig. 5 - Results of tomographic survey in two pillars with different mechanical characteristics

shows the results for pillars 1 and 2. It can be clearly observed that pillar 1, which was consolidated by grouting about 30 years ago, clearly shows high velocity values, especially in the internal zone which was involved in the grouting operation. On the contrary, the velocity values obtained for pillar 2 show that the mechanical characteristics of this pillar are very poor (in fact no consolidation work was performed on this pillar in the past).

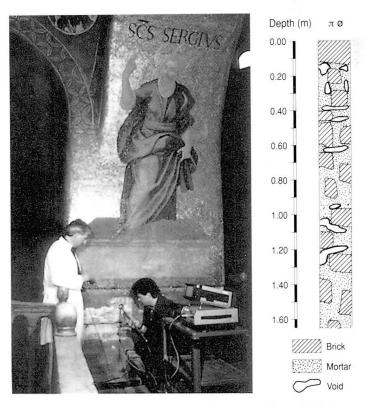
Fig. 6 - Video-camera survey equipment and result of the inspection into the horizontal borehole drilled in the pillar n. 2

In every pillar, horizontal and vertical boreholes (more than 60) were drilled by using light drilling equipment. Then a video camera survey was performed with a detailed description of the surface of the boreholes. Fig. 6 shows the equipment used for the video camera survey and the results of the inspection into the horizontal borehole of the pillar 2 indicated in fig. 5. A large number of voids can be observed inside the masonry, which confirms the results obtained by sonic tomography. By drilling subvertical boreholes (about 4 m long) starting from the level of the women's gallery, it was possible to investigate the lower part of the pillars lined with marble plates. Several boreholes were also carried out along the perimeter walls of the Basilica.

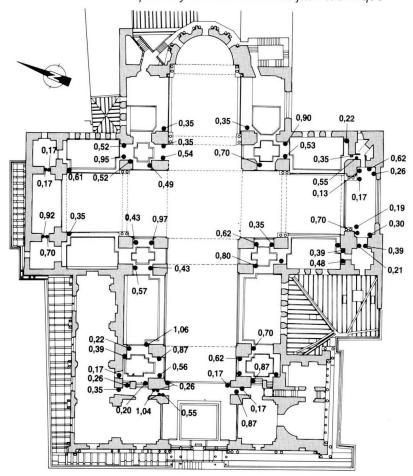
Fig. 8 - General lay-out of the flat-jack testing point with the indication of the measured states of stress

The stress values measured on the pillars are shown in fig. 8. A certain heterogeneity of the state of stress in the pillars can be observed, which is related not only to the position and size of the pillars but also to the type and extent of the consolidation works which some pillars have undergone in the past. High stress values (up to 1.1 MPa) were measured in some pillars. Furthermore, in the above-mentioned pillar 2 (the south-east pillar of the St. John's Dome), a state of stress of 0.95 MPa was measured. This value was considered very high in relation to the results obtained by sonic tomography, coring and video camera survey.

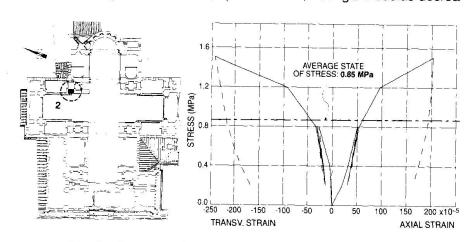
Fig. 9 - Stress-strain diagrams obtained by flat-jack tests on the pillar n. 2 with the indication of the measured state of stress

The combined analysis of the results obtained by flat-jack test, sonic tomography, coring and video camera survey clearly shows that the pillar n. 2 (sout-east pillar of St. John's Dome) has to withstand very severe loading conditions in comparison with the poor mechanical characteristics of the masonry. For this reason, it was decided to carry out a more detailed investigation in the lower part of the pillar after removing the marble lining. At first a detailed

crack pattern survey was carried out which showed the presence of several vertical small cracks, especially near the corners. Sonic tomography was performed at three sections of the pillar at different heights from the floor and the results obtained confirmed the low velocity values presented in fig. 5. In several points of the pillar, the state of stress was measured by flat-jack test and an average value of 0.85 MPa was found. Then, in two points, the deformability characteristics were determined by two parallel flat-jacks. The typical stress-strain curve of the masonry is shown in fig. 9, where axial and transversal strain values are presented as functions of axial stress. The average value of the measured state of stress is also indicated. It can be observed that the masonry presents a linear behaviour up to a stress level of about 0.8 MPa with a value of Young's modulus of about 2.000 MPa. For higher stress levels, up to 1.2 MPa, Young's modulus decrea-

ses to a value of about 900 MPa and for the stress range between 1.2 and 1.5 MPa the modulus is lower than 300 MPa. It can be observed that the average state of stress measured in the pillar exceeds the limit between elastic and plastic behaviour. This supplementary investigation clearly confirmed that the static conditions of the pillar are not satisfactory and for this reason it was decided to carry out urgent consolidation works which are now in the design phase.

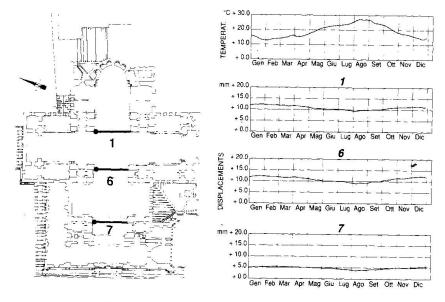
Fig. 10 - Diagrams of the relative horizontal displacements of some pillars during the first year of observation

All the instruments are connected to an automatic data acquisition and recording unit which can quickly indicate possible anomalies in the structural behaviour. The analysis of the deformations as a function of time and temperature makes it possible to separate thermal effect from the deformations arising from other structural causes. As an example, fig. 10 shows the diagrams of the relative horizontal movements between some pillars measured by three long base extensometers during the first period of observation. It can be clearly

seen that the deformation diagrams follow temperature changes and no permanent deformation is noticed at the end of the first yearly cycle.
