Artikel: Structural assessment of St. Mark's Basilica, Venice

Autor: Rossi, Pier Paolo / Ventrucci, Franco / Vio, Ettore

Structural Assessment of St. Mark's Basilica, Venice

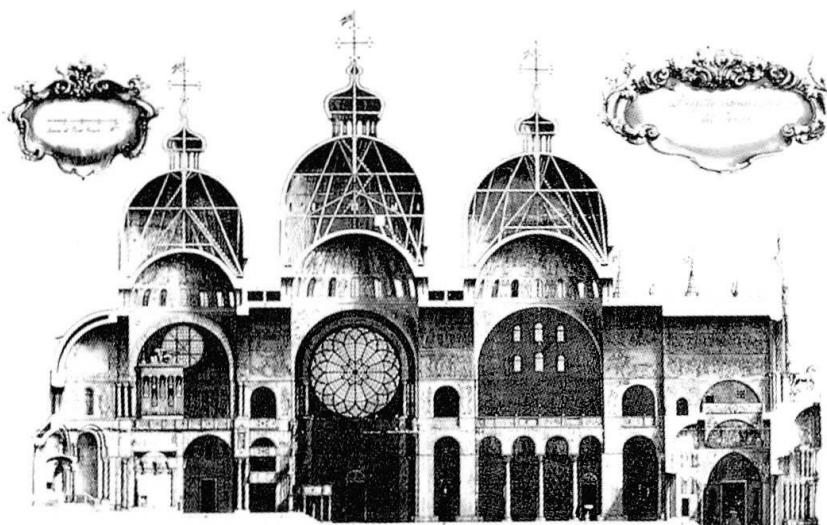
middle of the XIII century. It was only in the early XIX century, following the fall of the Venetian Republic, that the Austrian government enacted systematic restoration works based on the project developed by engineer Fustinelli, which was examined by a specially-appointed government commission. Above all, attempts were made to restore the walls, vaults and arches, and to consolidate the centuries-old structure which, under the thrust of the weight of the lead domes, was literally splitting the Basilica in two lengthways.

Fig. 1 - Longitudinal section (A. Visentini, XVIII century)

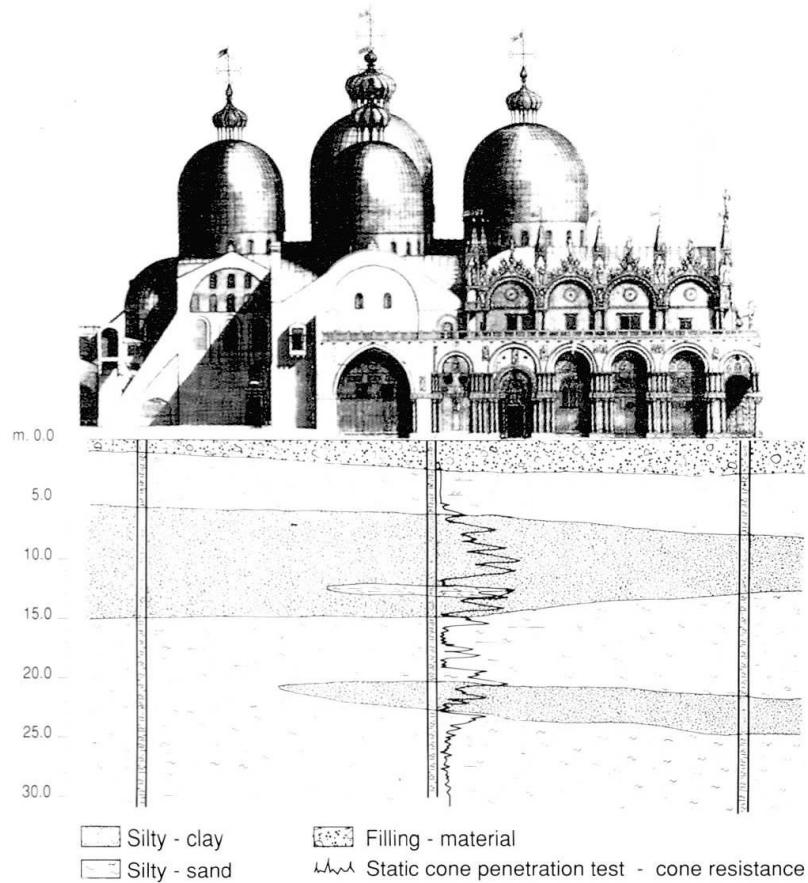
Fig. 2 - Stratigraphic profile along the North side of the Basilica.
The results of static cone penetration tests are presented

silty-sand layer with higher mechanical characteristics is also present with a thickness varying between 5 and 10 m. Under the sand layer, silty-clay material was found. The presence of local lenses of sand inside the silty-clay material was observed as usual in lagoon-side environments. Three boreholes were equipped with electric piezometers and three with long base settlement-gauges connected to an automatic reading unit. This monitoring system will allow the settlement of the perimeter of the Cathedral to be controlled as a function of time and water-table variations.

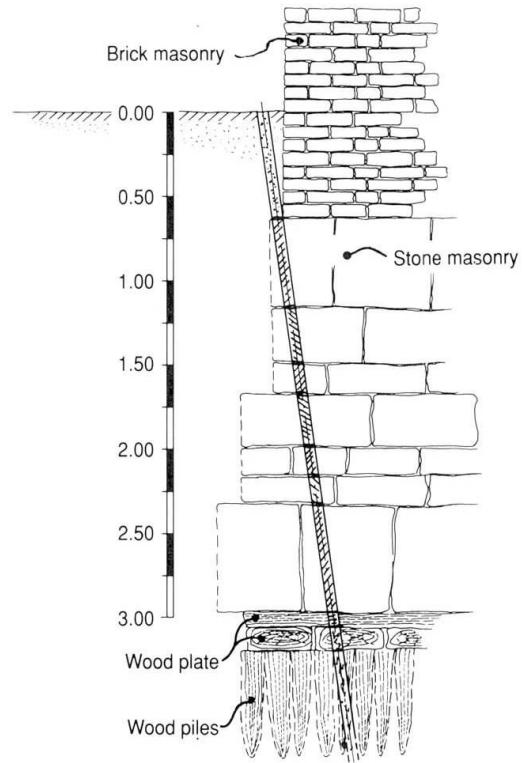
An in-depth investigation was also carried out to analyze the geometric and structural characteristics of the foundation masonry of the perimeter walls and of the pillars. Several small boreholes (diameter 62 mm) were cored by using a light diamond saw and the lateral surface of the boreholes was surveyed by means of a colour video camera. Fig. 3 shows the drilling equipment installed at the base of a pillar for coring the foundation masonry. More than 50 subvertical boreholes were drilled to investigate the structural characteristics of the foundation masonries. In order to obtain qualitative information concerning the mechanical characteristics of the masonry structures, a sonic-log survey was carried out as well as cross-hole measurements by using two parallel boreholes. As a result of the coring and video camera survey, the typical structural scheme of the foundation masonry was determined (Fig. 4). At a depth of about 70-90 cm from floor level, a stone basement made with large blocks of sandstone is present with a thickness of about 2 m. Underneath this stone basement there is a wood plate (10 cm thick) which is about 3.0 m below the floor. This wood plate rests on short wooden piles which are very poorly preserved.

Fig. 4 - Structural scheme of the foundation masonry

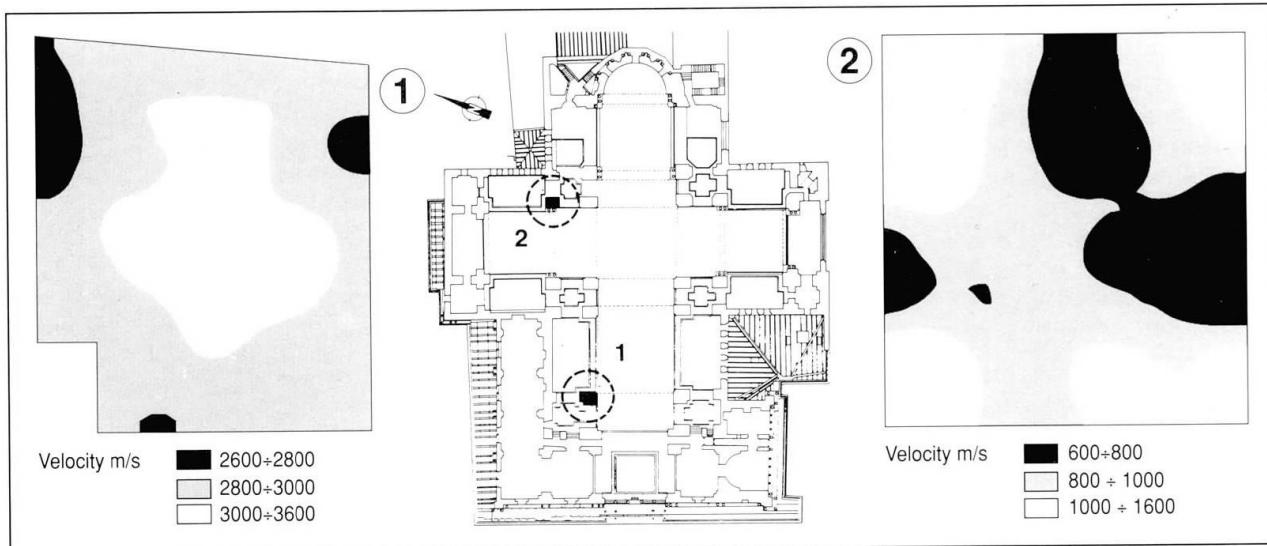
Fig. 5 - Results of tomographic survey in two pillars with different mechanical characteristics

shows the results for pillars 1 and 2. It can be clearly observed that pillar 1, which was consolidated by grouting about 30 years ago, clearly shows high velocity values, especially in the internal zone which was involved in the grouting operation. On the contrary, the velocity values obtained for pillar 2 show that the mechanical characteristics of this pillar are very poor (in fact no consolidation work was performed on this pillar in the past).

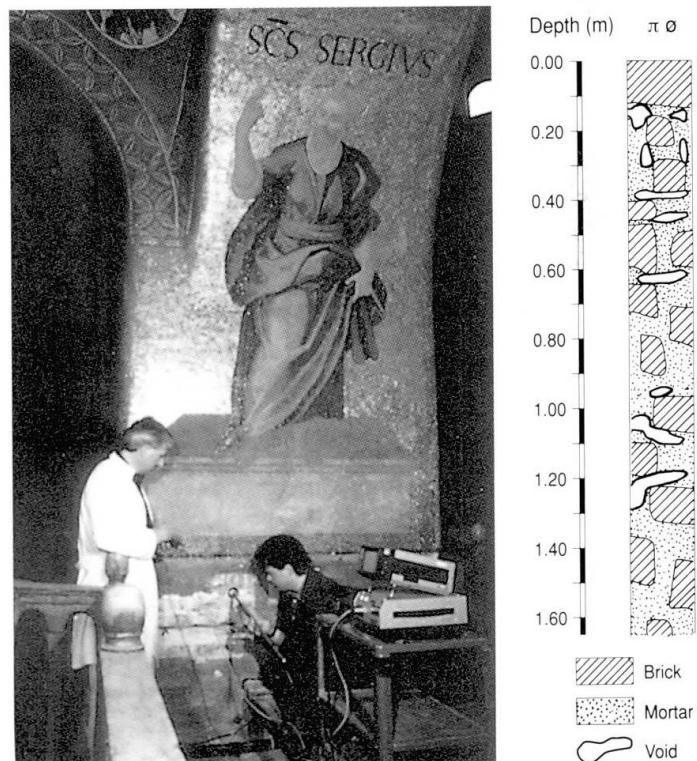
In every pillar, horizontal and vertical boreholes (more than 60) were drilled by using light drilling equipment. Then a video camera survey was performed with a detailed description of the surface of the boreholes. Fig. 6 shows the equipment used for the video camera survey and the results of the inspection into the horizontal borehole of the pillar 2 indicated in fig. 5. A large number of voids can be observed inside the masonry, which confirms the results obtained by sonic tomography. By drilling subvertical boreholes (about 4 m long) starting from the level of the women's gallery, it was possible to investigate the lower part of the pillars lined with marble plates. Several boreholes were also carried out along the perimeter walls of the Basilica.

Fig. 6 - Video-camera survey equipment and result of the inspection into the horizontal borehole drilled in the pillar n. 2

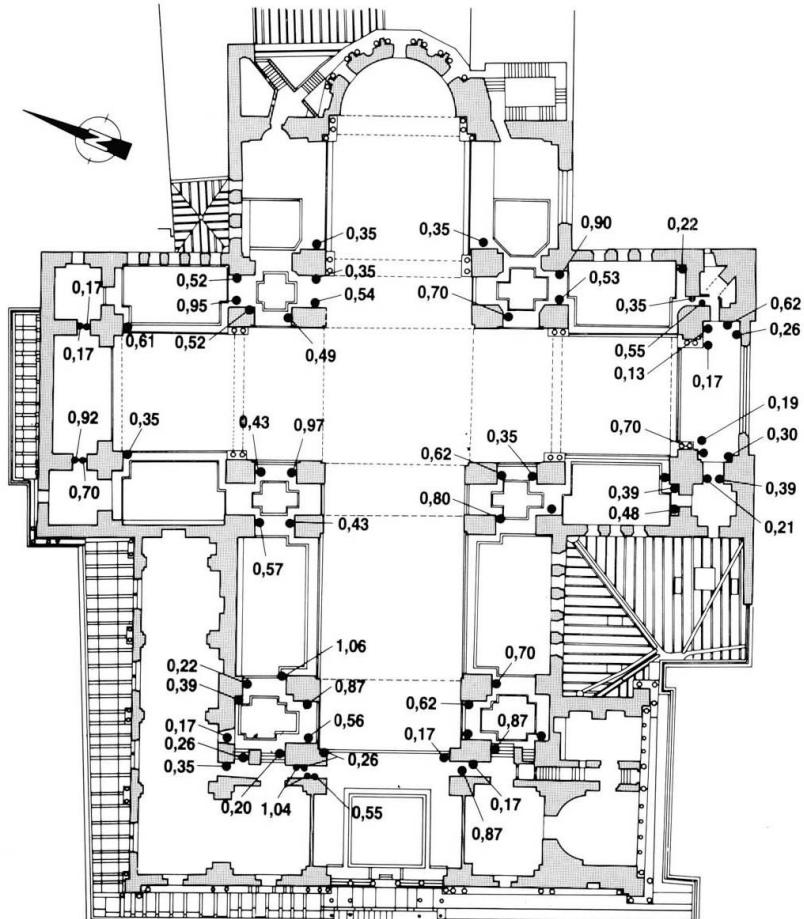
The stress values measured on the pillars are shown in fig. 8. A certain heterogeneity of the state of stress in the pillars can be observed, which is related not only to the position and size of the pillars but also to the type and extent of the consolidation works which some pillars have undergone in the past. High stress values (up to 1.1 MPa) were measured in some pillars. Furthermore, in the above-mentioned pillar 2 (the south-east pillar of the St. John's Dome), a state of stress of 0.95 MPa was measured. This value was considered very high in relation to the results obtained by sonic tomography, coring and video camera survey.

Fig. 8 - General lay-out of the flat-jack testing point with the indication of the measured states of stress

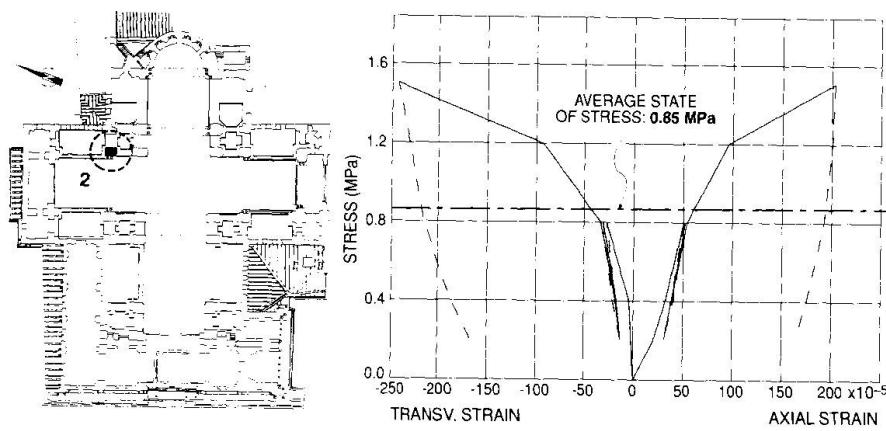
crack pattern survey was carried out which showed the presence of several vertical small cracks, especially near the corners. Sonic tomography was performed at three sections of the pillar at different heights from the floor and the results obtained confirmed the low velocity values presented in fig. 5. In several points of the pillar, the state of stress was measured by flat-jack test and an average value of 0.85 MPa was found. Then, in two points, the deformability characteristics were determined by two parallel flat-jacks. The typical stress-strain curve of the masonry is shown in fig. 9, where axial and transversal strain values are presented as functions of axial stress. The average value of the measured state of stress is also indicated. It can be observed that the masonry presents a linear behaviour up to a stress level of about 0.8 MPa with a value of Young's modulus of about 2.000 MPa. For higher stress levels, up to 1.2 MPa, Young's modulus decreases to a value of about 900 MPa and for the stress range between 1.2 and 1.5 MPa the modulus is lower than 300 MPa. It can be observed that the average state of stress measured in the pillar exceeds the limit between elastic and plastic behaviour. This supplementary investigation clearly confirmed that the static conditions of the pillar are not satisfactory and for this reason it was decided to carry out urgent consolidation works which are now in the design phase.

Fig. 9 - Stress-strain diagrams obtained by flat-jack tests on the pillar n. 2 with the indication of the measured state of stress

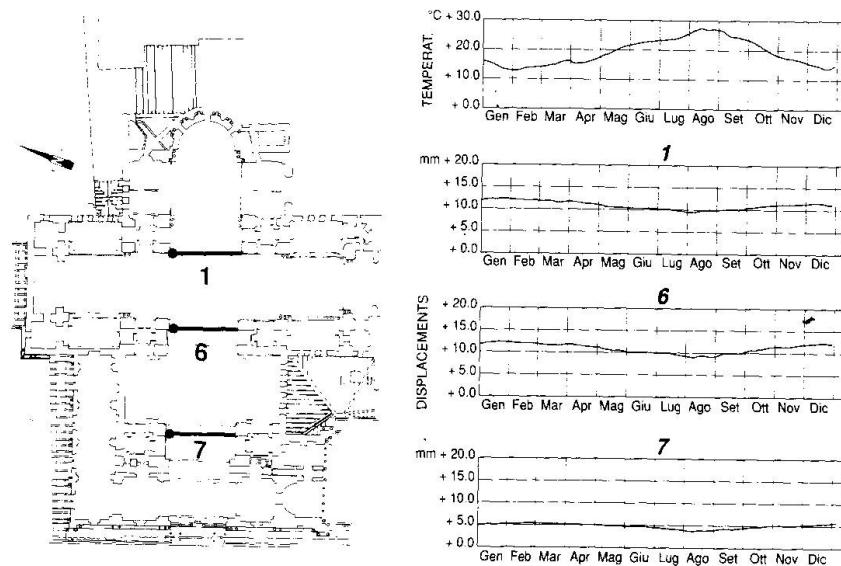
Fig. 10 - Diagrams of the relative horizontal displacements of some pillars during the first year of observation

seen that the deformation diagrams follow temperature changes and no permanent deformation is noticed at the end of the first yearly cycle.
