Artikel: Structural assessment of St. Mark's Basilica, Venice

Autor: Rossi, Pier Paolo / Ventrucci, Franco / Vio, Ettore

Structural Assessment of St. Mark's Basilica, Venice
Evaluation structurale de la Basilique de St. Marc, Venise
Tragfähigkeitsbeurteilung der Basilika von San Marco, Venedig

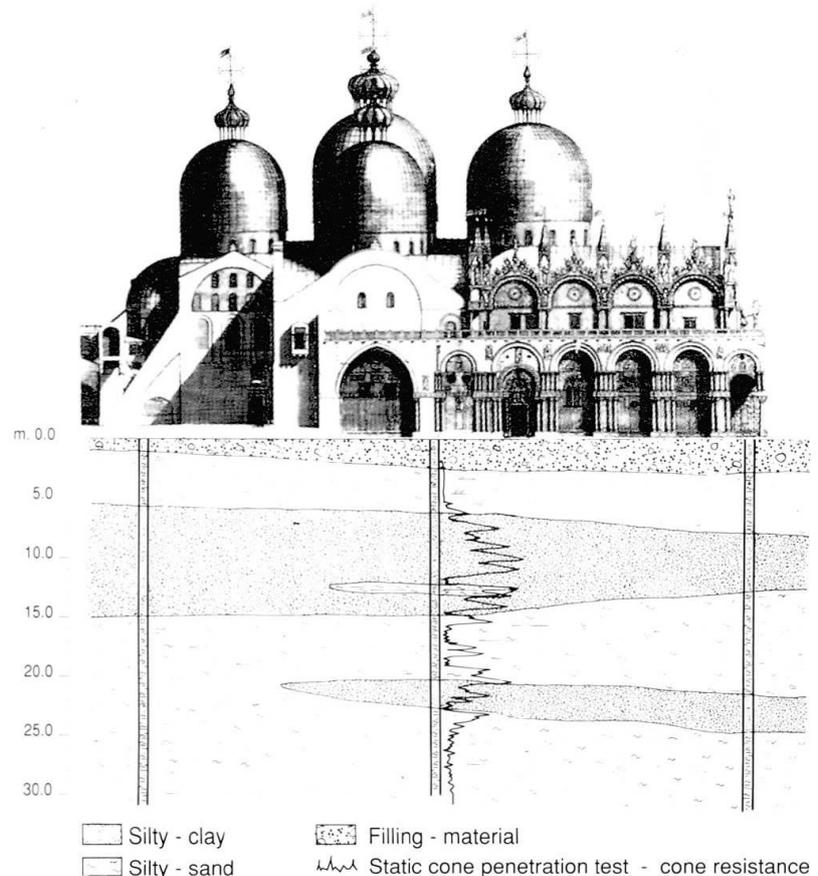
Fig. 2 - Stratigraphic profile along the North side of the Basilica. The results of static cone penetration tests are presented

silty-sand layer with higher mechanical characteristics is also present with a thickness varying between 5 and 10 m. Under the sand layer, silty-clay material was found. The presence of local lenses of sand inside the silty-clay material was observed as usual in lagoon-side environments. Three boreholes were equipped with electric piezometers and three with long base settlement-gauges connected to an automatic reading unit. This monitoring system will allow the settlement of the perimeter of the Cathedral to be controlled as a function of time and water-table variations.

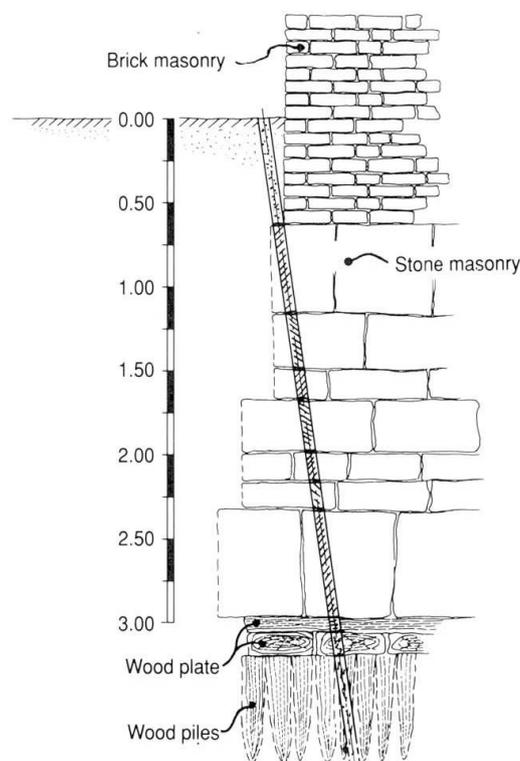
Fig. 4 - Structural scheme of the foundation masonry

An in-depth investigation was also carried out to analyze the geometric and structural characteristics of the foundation masonry of the perimeter walls and of the pillars. Several small boreholes (diameter 62 mm) were cored by using a light diamond saw and the lateral surface of the boreholes was surveyed by means of a colour video camera. Fig. 3 shows the drilling equipment installed at the base of a pillar for coring the foundation masonry. More than 50 subvertical boreholes were drilled to investigate the structural characteristics of the foundation masonries. In order to obtain qualitative information concerning the mechanical characteristics of the masonry structures, a sonic-log survey was carried out as well as cross-hole measurements by using two parallel boreholes. As a result of the coring and video camera survey, the typical structural scheme of the foundation masonry was determined (Fig. 4). At a depth of about 70-90 cm from floor level, a stone basement made with large blocks of sandstone is present with a thickness of about 2 m. Underneath this stone basement there is a wood plate (10 cm thick) which is about 3.0 m below the floor. This wood plate rests on short wooden piles which are very poorly preserved.

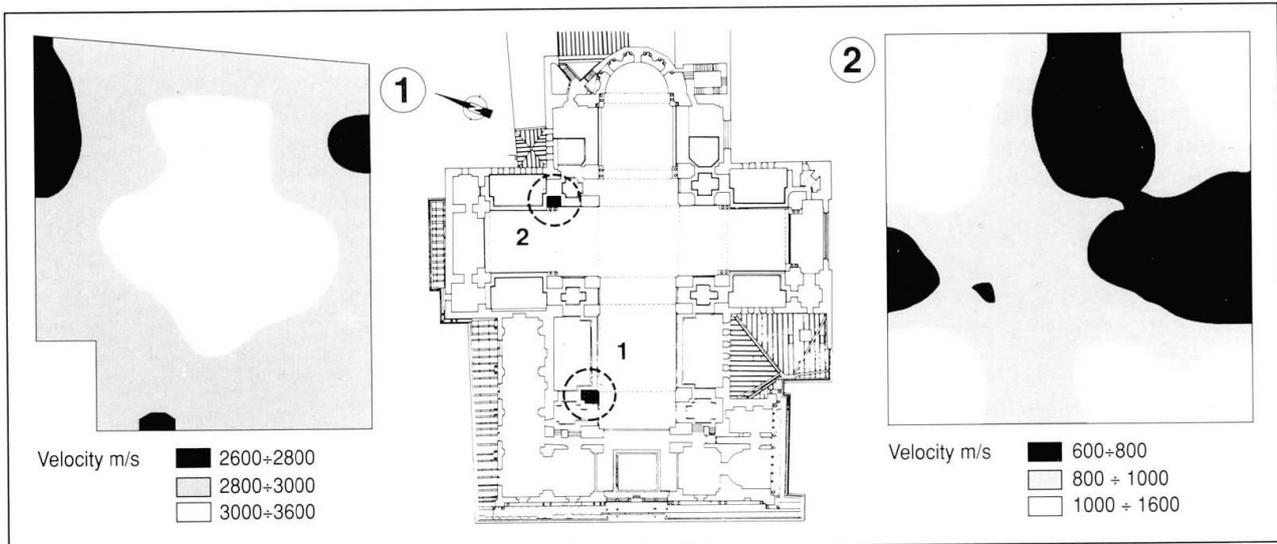
Fig. 5 - Results of tomographic survey in two pillars with different mechanical characteristics

shows the results for pillars 1 and 2. It can be clearly observed that pillar 1, which was consolidated by grouting about 30 years ago, clearly shows high velocity values, especially in the internal zone which was involved in the grouting operation. On the contrary, the velocity values obtained for pillar 2 show that the mechanical characteristics of this pillar are very poor (in fact no consolidation work was performed on this pillar in the past).

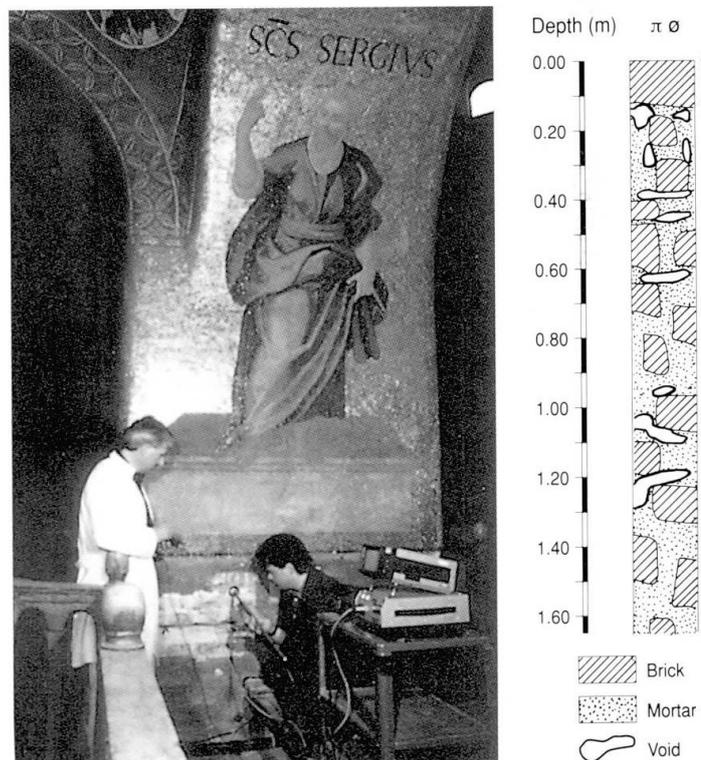
Fig. 6 - Video-camera survey equipment and result of the inspection into the horizontal borehole drilled in the pillar n. 2

In every pillar, horizontal and vertical boreholes (more than 60) were drilled by using light drilling equipment. Then a video camera survey was performed with a detailed description of the surface of the boreholes. Fig. 6 shows the equipment used for the video camera survey and the results of the inspection into the horizontal borehole of the pillar 2 indicated in fig. 5. A large number of voids can be observed inside the masonry, which confirms the results obtained by sonic tomography. By drilling subvertical boreholes (about 4 m long) starting from the level of the women's gallery, it was possible to investigate the lower part of the pillars lined with marble plates. Several boreholes were also carried out along the perimeter walls of the Basilica.

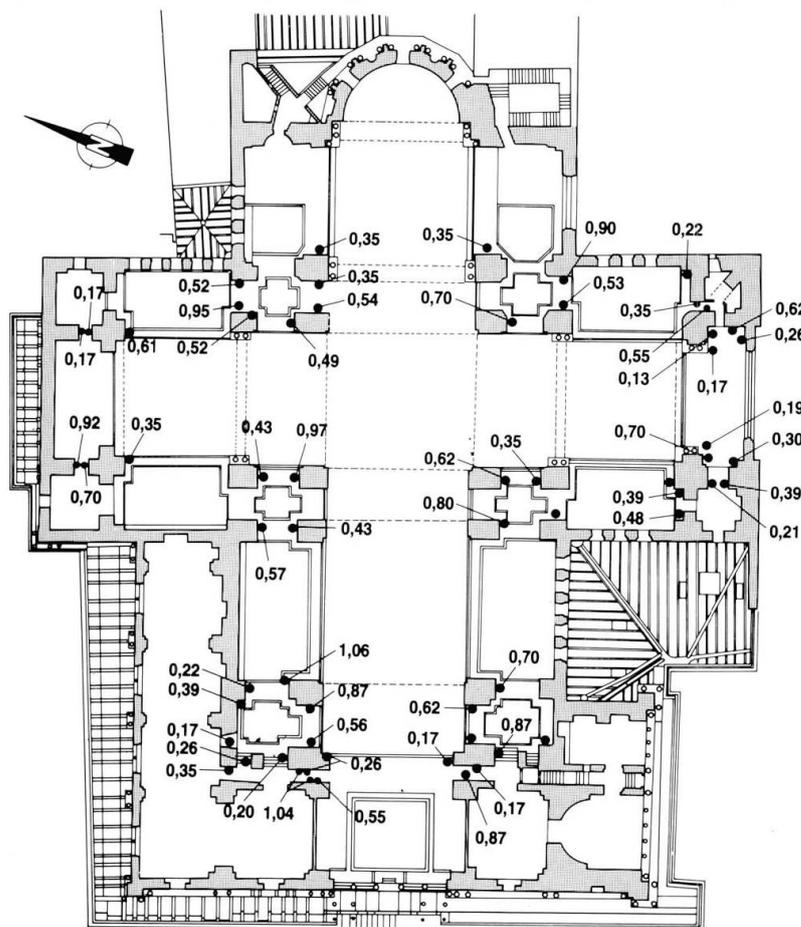
Fig. 8 - General lay-out of the flat-jack testing point with the indication of the measured states of stress

The stress values measured on the pillars are shown in fig. 8. A certain heterogeneity of the state of stress in the pillars can be observed, which is related not only to the position and size of the pillars but also to the type and extent of the consolidation works which some pillars have undergone in the past. High stress values (up to 1.1 MPa) were measured in some pillars. Furthermore, in the above-mentioned pillar 2 (the south-east pillar of the St. John's Dome), a state of stress of 0.95 MPa was measured. This value was considered very high in relation to the results obtained by sonic tomography, coring and video camera survey.

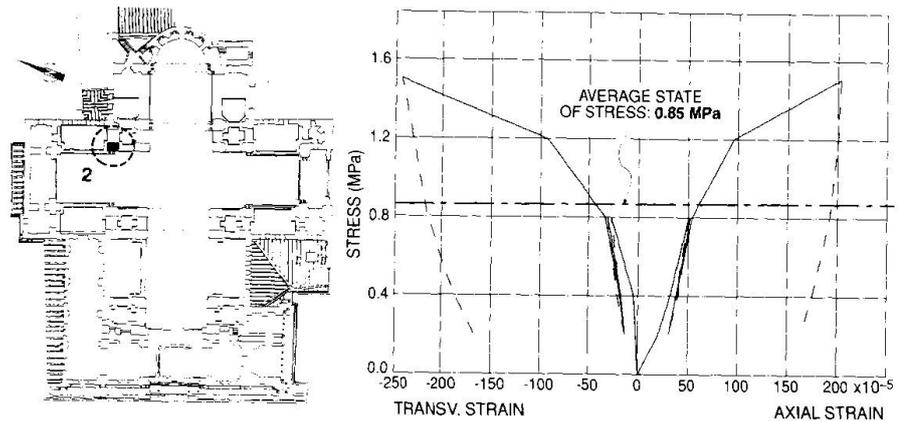
Fig. 9 - Stress-strain diagrams obtained by flat-jack tests on the pillar n. 2 with the indication of the measured state of stress

The combined analysis of the results obtained by flat-jack test, sonic tomography, coring and video camera survey clearly shows that the pillar n. 2 (south-east pillar of St. John's Dome) has to withstand very severe loading conditions in comparison with the poor mechanical characteristics of the masonry. For this reason, it was decided to carry out a more detailed investigation in the lower part of the pillar after removing the marble lining. At first a detailed

crack pattern survey was carried out which showed the presence of several vertical small cracks, especially near the corners. Sonic tomography was performed at three sections of the pillar at different heights from the floor and the results obtained confirmed the low velocity values presented in fig. 5. In several points of the pillar, the state of stress was measured by flat-jack test and an average value of 0.85 MPa was found. Then, in two points, the deformability characteristics were determined by two parallel flat-jacks. The typical stress-strain curve of the masonry is shown in fig. 9, where axial and transversal strain values are presented as functions of axial stress. The average value of the measured state of stress is also indicated. It can be observed that the masonry presents a linear behaviour up to a stress level of about 0.8 MPa with a value of Young's modulus of about 2.000 MPa. For higher stress levels, up to 1.2 MPa, Young's modulus decreases to a value of about 900 MPa and for the stress range between 1.2 and 1.5 MPa the modulus is lower than 300 MPa. It can be observed that the average state of stress measured in the pillar exceeds the limit between elastic and plastic behaviour. This supplementary investigation clearly confirmed that the static conditions of the pillar are not satisfactory and for this reason it was decided to carry out urgent consolidation works which are now in the design phase.

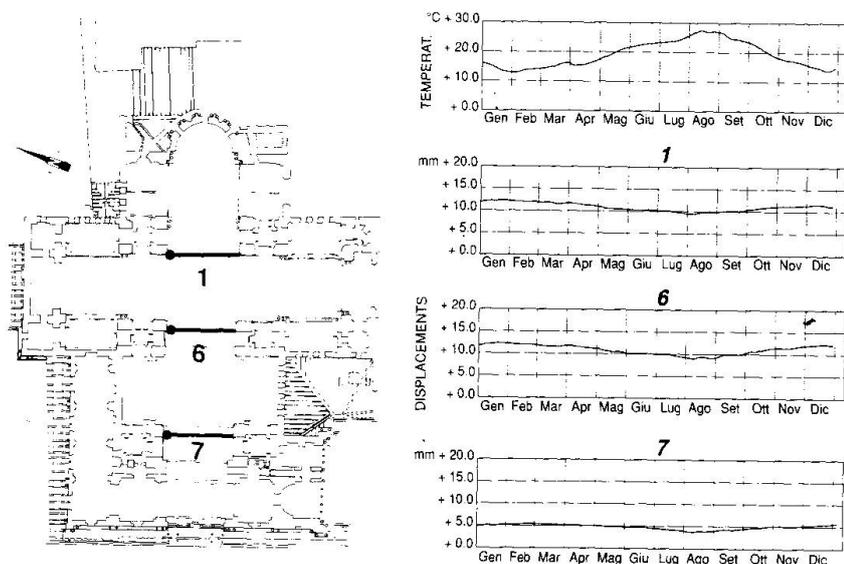
Fig. 10 - Diagrams of the relative horizontal displacements of some pillars during the first year of observation

All the instruments are connected to an automatic data acquisition and recording unit which can quickly indicate possible anomalies in the structural behaviour. The analysis of the deformations as a function of time and temperature makes it possible to separate thermal effect from the deformations arising from other structural causes. As an example, fig. 10 shows the diagrams of the relative horizontal movements between some pillars measured by three long base extensometers during the first period of observation. It can be clearly

seen that the deformation diagrams follow temperature changes and no permanent deformation is noticed at the end of the first yearly cycle.
