Artikel: Investigation of the Roman aqueduct structure of Acqui Terme

Autor: Nascè, Vittorio / Pistone, Giuseppe / Roccati, Roberto

Investigation of the Roman Aqueduct Structure of Acqui Terme

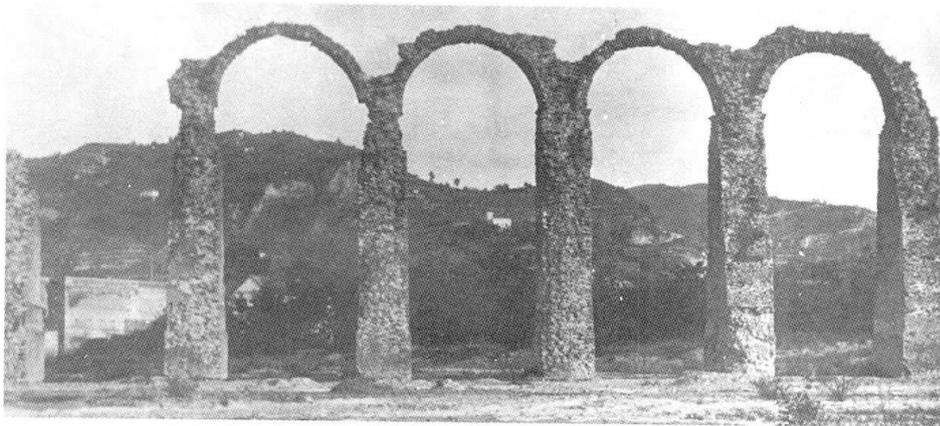
At the end of the 19th century (1896), when erosion had already damaged severely both the facing and the inner masonry (photo 1), restoration work was started and carried out in several stages, mostly on the arches.

Photo 1 - General view of the aqueduct in 1896.

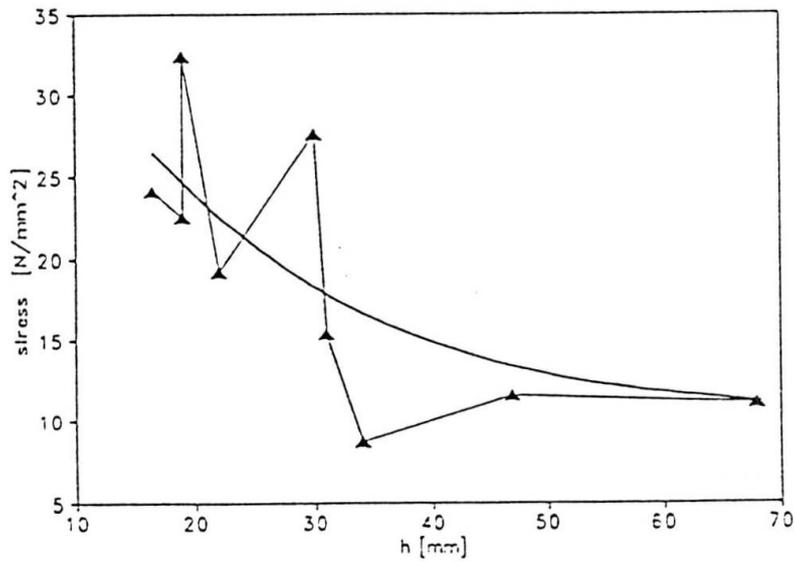
Fig. 1 - Strength as a function of the specimen height.

In the mortar, compressive strength and the elastic modulus were determined on cylinders of different heights: strength was seen to decrease with increasing specimen height (fig. 1), this being an aspect of special interest in the case being considered, on account of the sizeable discontinuities present in the mortar beds of the inner masonry, in terms of both thickness and area.

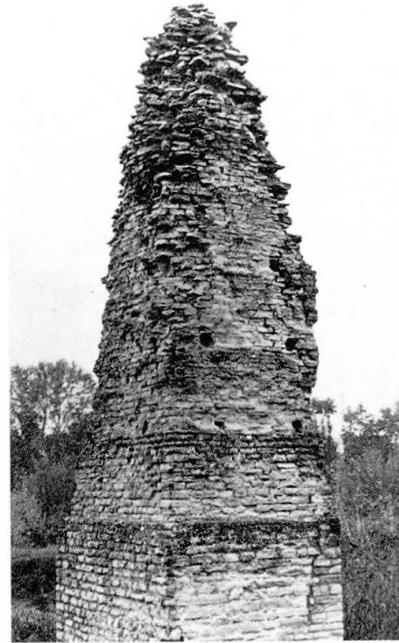
The composition of the original masonry may therefore be discerned best in isolated piers which underwent but limited repair work (photo 2). The facing layer consists of sandstone blocks, of variable width (25 cm on average) 8 cm thick, squared on the outer surface. Mortar joints, whether horizontal or vertical, have a thickness of between 2 and 3 cm, which is generally seen to increase towards the innermost part of the masonry. The average value of the ratio between the area of the mortar and the total area of the facing layer is about 0.3 (photos 3 and 4). The inner part of the masonry instead is made of sandstone blocks exhibiting irregular edges between the two parallel faces. Narrower and thinner than the facing blocks, all these elements were carefully laid horizontally one at a time. The mortar beds of the inner blocks reveal marked discontinuities and their thickness, on average, is greater than that of the facing blocks: the average value of the ratio between the mortar area and the total area of an inner vertical section, in fact, is about 0.5 (photos 5, 6). In the inner part of the masonry there are many cavities, mostly located in the median portion of the thinner vertical joints. These cavities were produced both by insufficient flow of the mortar from the bottom up as the blocks were laid and by insufficient filling of the upper mortar bed.

Photo 2 - Non restored isolated pier.

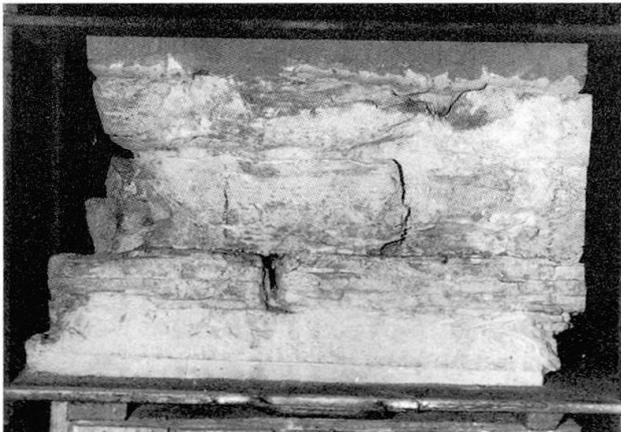
Photo 3 - Sample obtained from facing masonry.

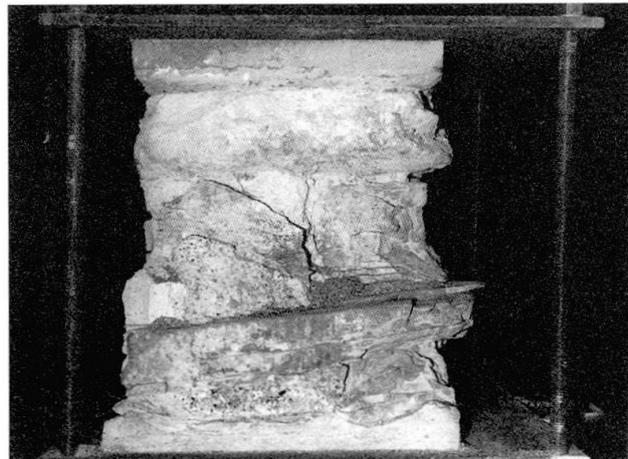
Photo 4 - Sample obtained from facing masonry.

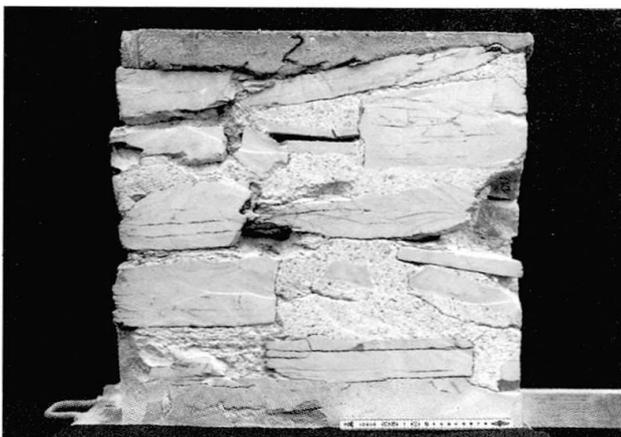
Photo 5 - Sample obtained from inner masonry.

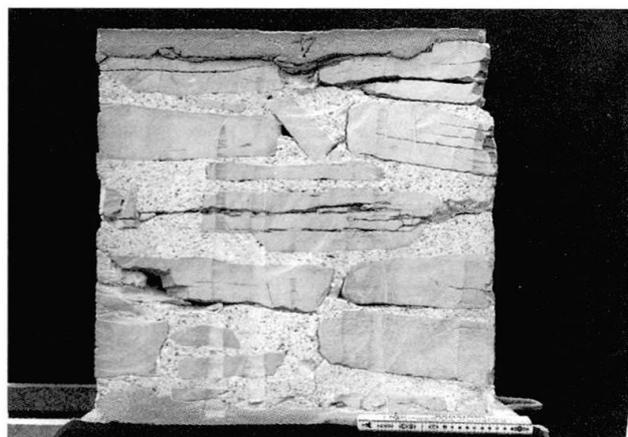
Photo 6 - Sample obtained from inner masonry.

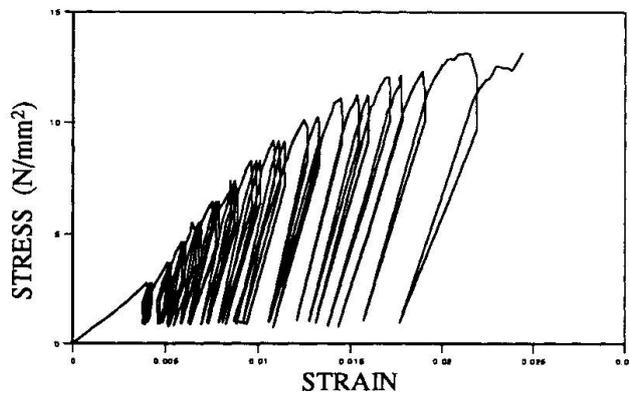
In specimen No. 2 the compression and bending effects were much smaller, on account of a more regular composition (fig. 2), and failure occurred under a load of 1420 KN (13.1 N/mm^2).

Fig. 2 - Stress-strain curve of strain gauge 7 - specimen 2.

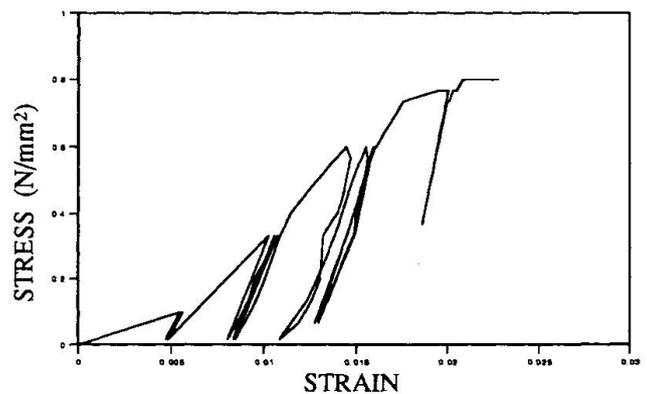
Fig. 3 - Average stress-strain curve - specimen 3.

The progressive opening of cracks did not prevent the material from exhibiting overall elastic behaviour in the individual loading cycles up to very high stress values, as confirmed by the diagram in fig. 3. This diagram illustrates a typical behaviour which was observed throughout the tests: the initial load increase, for each testing level, was accompanied by high strain values and marked residual strain, while in subsequent cycles (the load being the same) strain was lower and residual strain was virtually negligible.

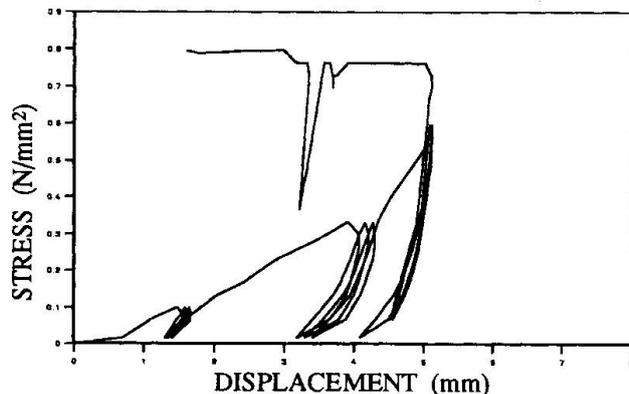
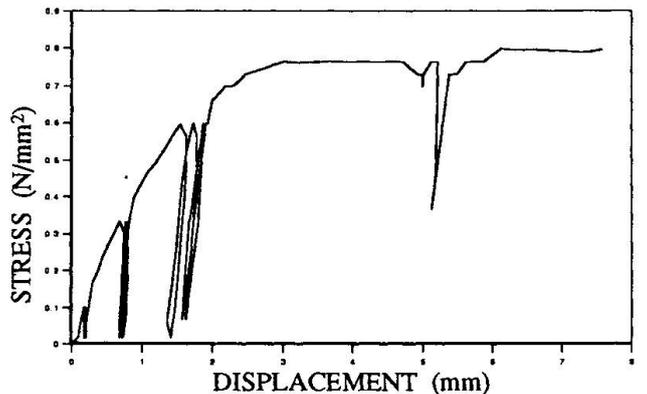
Figs. 4 - 5 - Stress-strain curve of strain gauge 4 (vertical) and 9 (horizontal) - specimen 3.

A comparison between the diagrams plotted from the readings taken by two strain gauges of about the same length on the same face of specimen No. 3 (figs. 4, 5), - a vertical and a horizontal gauge, Nos. 4 and 9, respectively - shows that the strain values are of the same order of magnitude and the horizontal one entails a transverse strain modulus about three times as high as that of the masonry at the elastic stage. Moreover, the downward portion of the curve in fig. 5 reveals a major overall settlement of the specimen under the load, this behaviour closely resembling that of specimen No. 1 already described above (fig. 6). Thus we find that the transverse strains that have been observed are greater than would be expected on the basis of the Poisson modulus of the components, and are independent - even in terms of their direction - of vertical ones in the proximity of failure. Failure involved the masonry specimen as a whole, as shown in photo 13. Strain stabilisation was especially slow at a load level corresponding to 90% of the failure load and required a waiting period of about 20 minutes, this being a confirmation of the major influence exercised by the permanence of the load on the collapse of very irregular masonry.

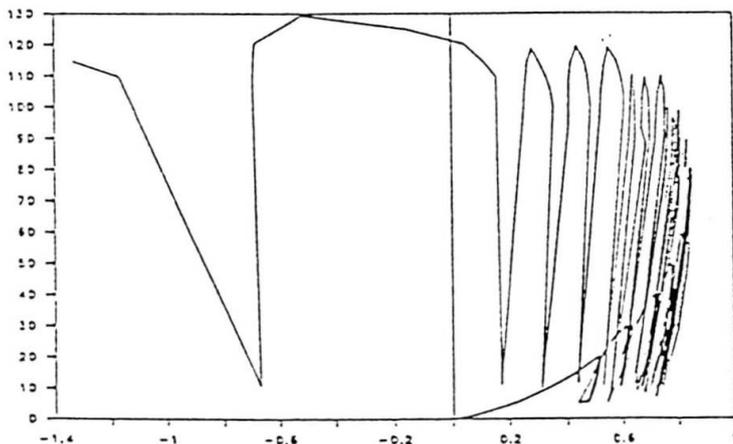
In the case of sample No. 1, though care had been taken to apply the load to its centre of gravity, a marked compression and bending effect occurred due to the presence of a stiffer and stronger core in one of the corner area. Failure took place at 1180 KN (8.6 N/mm^2), during the second loading cycle of the last triplet, at a strain value markedly higher than that observed during the previous cycle where the specimen, however, had reached a load of 1300 KN (9.4 N/mm^2).

Fig. 6 - Load-displacement curve of strain gauge 5 - specimen 1.

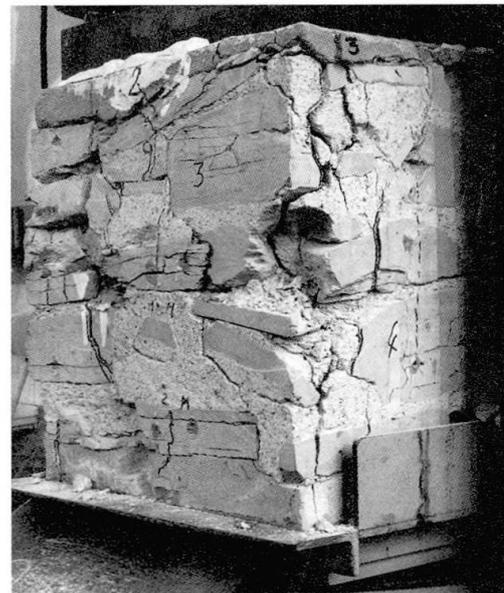
The behaviour of specimen No. 3 was relatively uniform, with no sizeable compression and bending effects: a series of diffused micro-cracks appeared rather early over all the faces. At 1000 KN (3.3 N/mm^2 , 40% of the failure load), widespread crack formation was already evident and it kept increasing over the successive cycles, the load level remaining the same (photo 7). This phenomenon continued steadily until failure which occurred at 2400 KN (8.0 N/mm^2).

Photo 7 - Collapse of specimen No. 3.
