Artikel: Investigation of the Roman aqueduct structure of Acqui Terme

Investigation of the Roman Aqueduct Structure of Acqui Terme

The research concerns the remnants of a Roman aqueduct of stone block masonry at Acqui Terme in Piemont, Italy. Its aim was to acquire exhaustive data on the mechanical behaviour of the aqueduct, to serve as a basis for assessments concerning the safety and preservation of this monument.

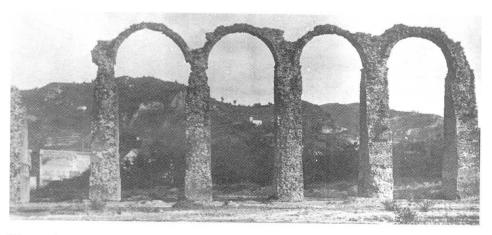
At the end of the 19th century (1896), when erosion had already damaged severely both the facing and the inner masonry (photo 1), restoration work was started and carried out in several stages, mostly on the arches.

Photo 1 - General view of the aqueduct in 1896.

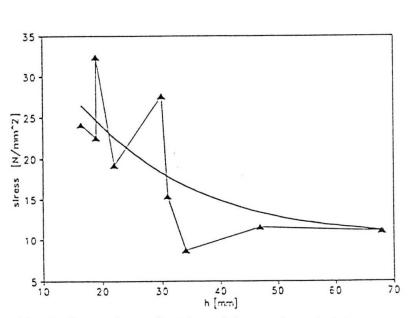
$\underline{Fig.\ 1}$ - Strength as a function of the specimen height.

In the mortar, compressive strength and the elastic modulus were determined on cylinders of different heights: strength was seen to decrease with increasing specimen height (fig. 1), this being an aspect of special interest in the case being considered, on account of the sizeable discontinuities present in the mortar beds of the inner masonry, in terms of both thickness and area.

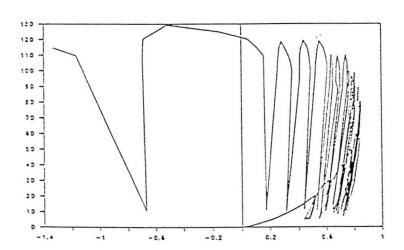
Fig. 6 - Load-displacement curve of strain gauge 5 - specimen 1.
