Artikel: Investigation of the Roman aqueduct structure of Acqui Terme
Autor: Nascè, Vittorio / Pistone, Giuseppe / Roccati, Roberto
DOI: <https://doi.org/10.5169/seals-53299>

Investigation of the Roman Aqueduct Structure of Acqui Terme

The research concerns the remnants of a Roman aqueduct of stone block masonry at Acqui Terme in Piemonte, Italy. Its aim was to acquire exhaustive data on the mechanical behaviour of the aqueduct, to serve as a basis for assessments concerning the safety and preservation of this monument.

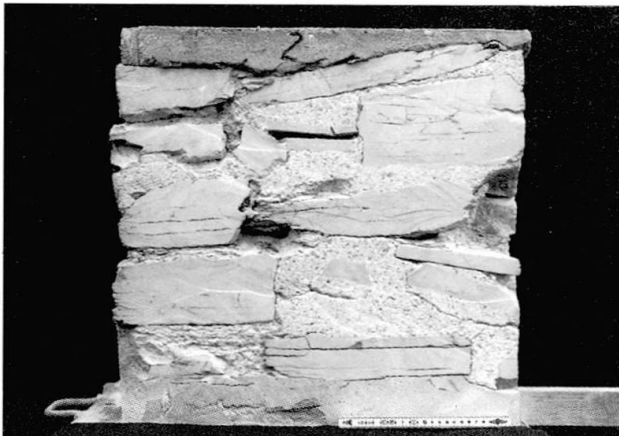
Photo 5 - Sample obtained from inner masonry.

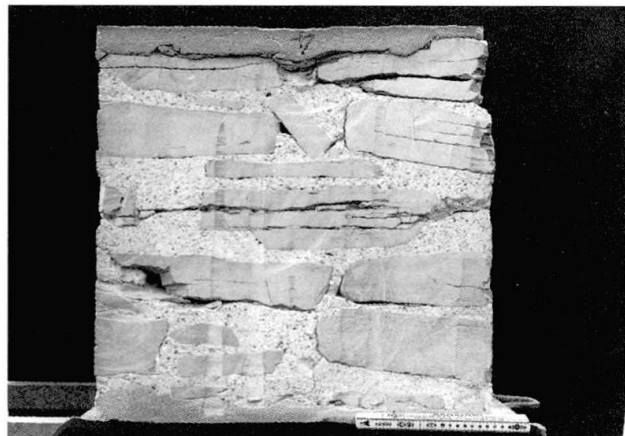
Photo 6 - Sample obtained from inner masonry.
