Artikel: Investigation of the Roman aqueduct structure of Acqui Terme
Autor: Nascè, Vittorio / Pistone, Giuseppe / Roccati, Roberto
DOI: <https://doi.org/10.5169/seals-53299>

Investigation of the Roman Aqueduct Structure of Acqui Terme

The research concerns the remnants of a Roman aqueduct of stone block masonry at Acqui Terme in Piemont, Italy. Its aim was to acquire exhaustive data on the mechanical behaviour of the aqueduct, to serve as a basis for assessments concerning the safety and preservation of this monument.

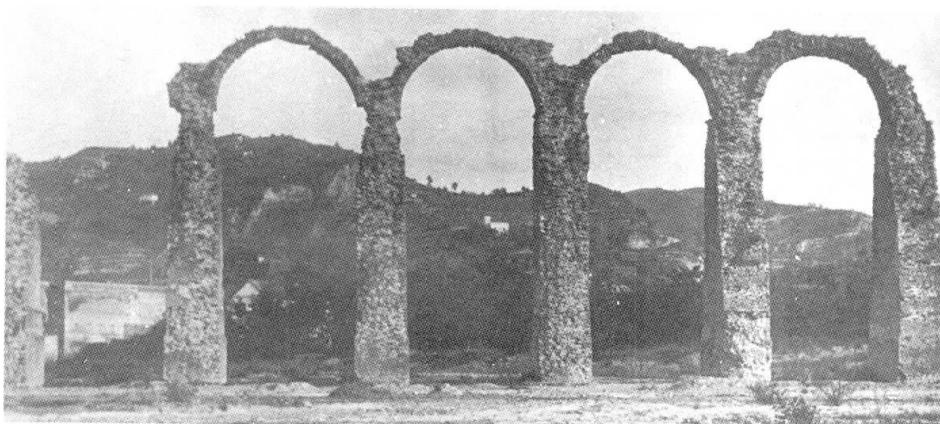
At the end of the 19th century (1896), when erosion had already damaged severely both the facing and the inner masonry (photo 1), restoration work was started and carried out in several stages, mostly on the arches.

Photo 1 - General view of the aqueduct in 1896.

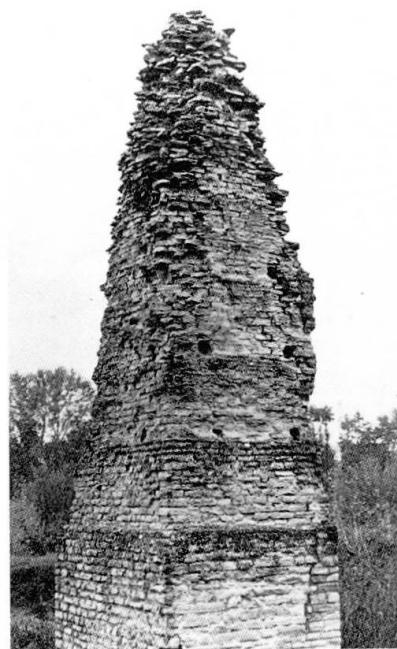
The composition of the original masonry may therefore be discerned best in isolated piers which underwent but limited repair work (photo 2). The facing layer consists of sandstone blocks, of variable width (25 cm on average) 8 cm thick, squared on the outer surface. Mortar joints, whether horizontal or vertical, have a thickness of between 2 and 3 cm, which is generally seen to increase towards the innermost part of the masonry. The average value of the ratio between the area of the mortar and the total area of the facing layer is about 0.3 (photos 3 and 4). The inner part of the masonry instead is made of sandstone blocks exhibiting irregular edges between the two parallel faces. Narrower and thinner than the facing blocks, all these elements were carefully laid horizontally one at a time. The mortar beds of the inner blocks reveal marked discontinuities and their thickness, on average, is greater than that of the facing blocks: the average value of the ratio between the mortar area and the total area of an inner vertical section, in fact, is about 0.5 (photos 5, 6). In the inner part of the masonry there are many cavities, mostly located in the median portion of the thinner vertical joints. These cavities were produced both by insufficient flow of the mortar from the bottom up as the blocks were laid and by insufficient filling of the upper mortar bed.

Photo 2 - Non restored isolated pier.

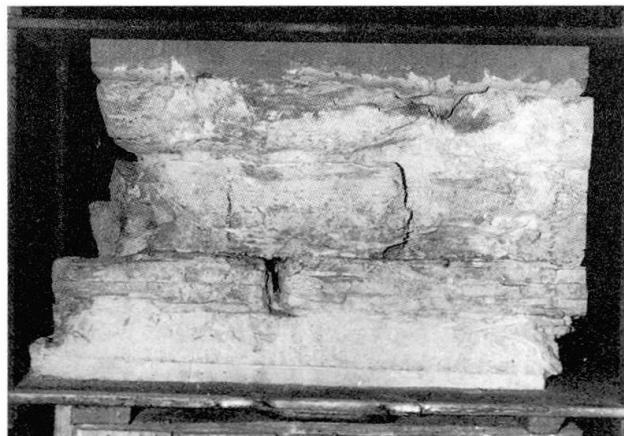
Photo 3 - Sample obtained from facing masonry.

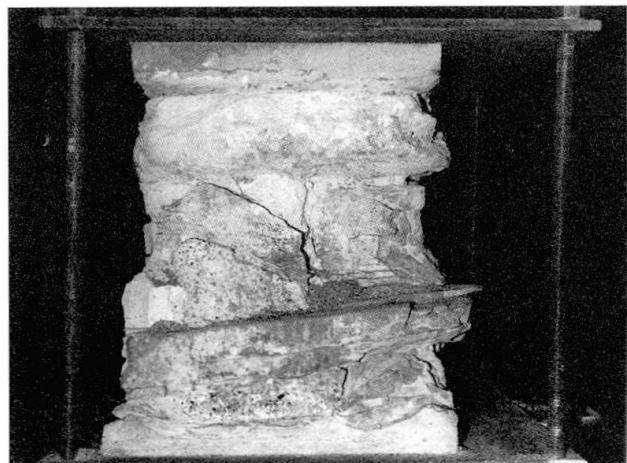
Photo 4 - Sample obtained from facing masonry.

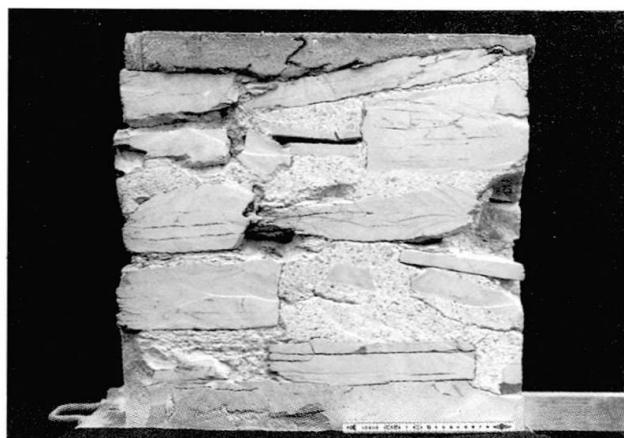
Photo 5 - Sample obtained from inner masonry.

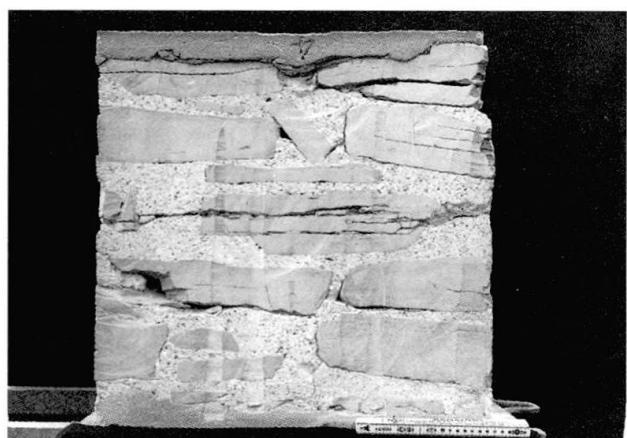
Photo 6 - Sample obtained from inner masonry.

This macro-porosity, already observed by Choisy in Roman masonry walls of this kind [1], was surely associated with the need to make limited use of water in the mortar mix and to improve its strength, which was very high in this particular case; another consideration was not to undermine the stability of the piers at the building stage. In all likelihood, the primary cause of erosion resulting in the monument's deterioration was this macro-porosity associated with freezing and thawing cycles; this was also one of the most significant factors, together with the thickness and discontinuity of the mortar joints, affecting the mechanical behaviour of the masonry as observed throughout the testing programme.

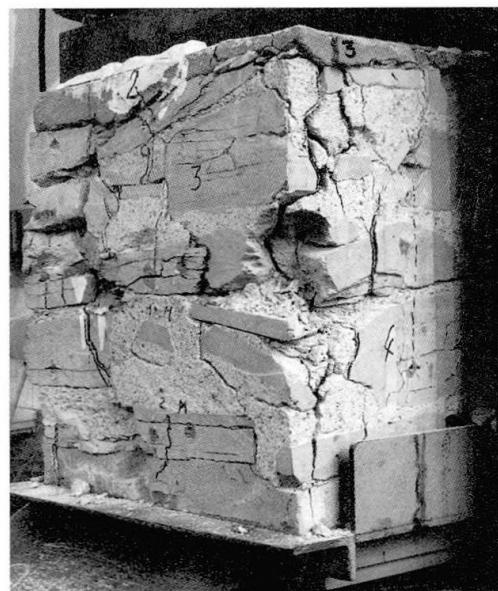
The behaviour of specimen No. 3 was relatively uniform, with no sizeable compression and bending effects: a series of diffused micro-cracks appeared rather early over all the faces. At 1000 KN (3.3 N/mm², 40% of the failure load), widespread crack formation was already evident and it kept increasing over the successive cycles, the load level remaining the same (photo 7). This phenomenon continued steadily until failure which occurred at 2400 KN (8.0 N/mm²).

Photo 7 - Collapse of specimen No. 3.
