**Artikel:** Strengthening of the Parish Church in Farigliano  
**Autor:** Lancelotta, Renato / Pistone, Giuseppe / Rovere, Renzo  
**DOI:** <https://doi.org/10.5169/seals-53300>

## Strengthening of the Parish Church in Farigliano

The foundations of the Parish Church of Farigliano are dug in soft, recently deposited materials with a high degree of compressibility. This explains the precarious behaviour exhibited in recent years by the static conditions of the structure. This report describes the urgent measures taken to protect the building, including the installation of a hydraulic levelling system.

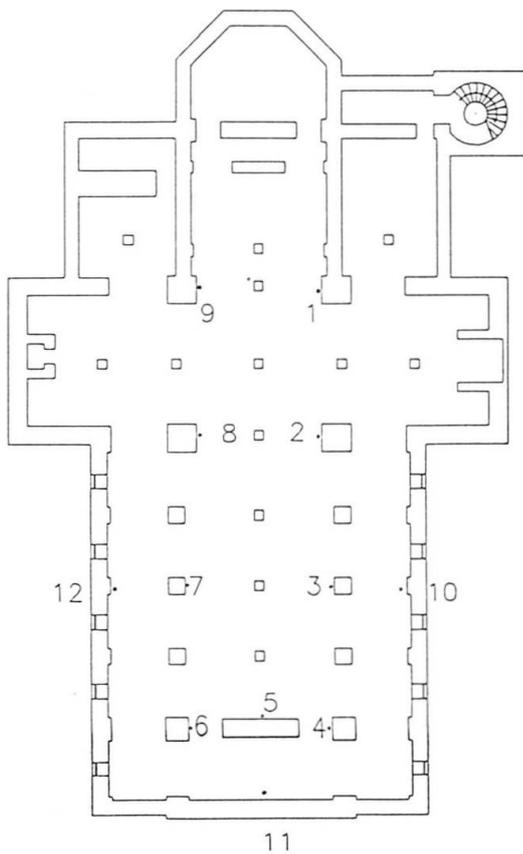
Fig. 2 - Plan of the basement showing the arrangement of the hydraulic levelling system measuring points.

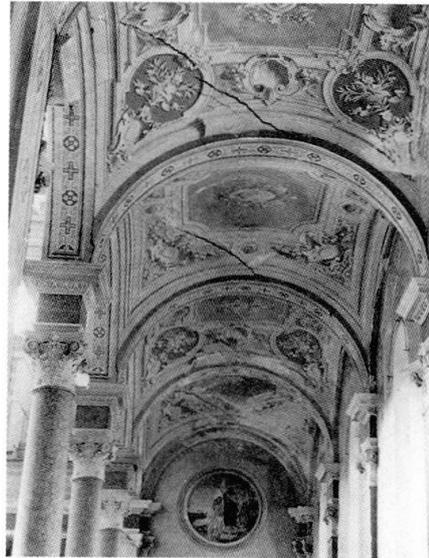
Fig. 3 - Fissures in the thin vaults of the side aisles.

- systematic fissures in the thin vaults covering the side aisles, of ancient origin, but probably made worse by recent damages; their width came to over 4 cm and their position in the building's plan revealed a markedly symmetrical arrangement; in particular, their 45° degree slant isolated, in each vault, a central part which was obviously in compression, as borne out by the relative slip of the crack edges and its enhanced curvature (fig. 3).

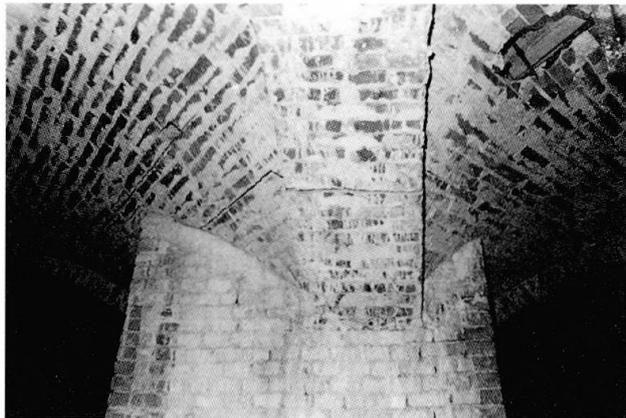
Fig. 4 - Fissures in the the 12 cm thick vaults on the underground level.

- a series of lesions, of recent appearance, involving the vaults and arches in the basement. The most important cracks were located all around the four main piers at the confluence of the transept and the central nave, and were as wide as 19 mm at the arches (fig. 4);

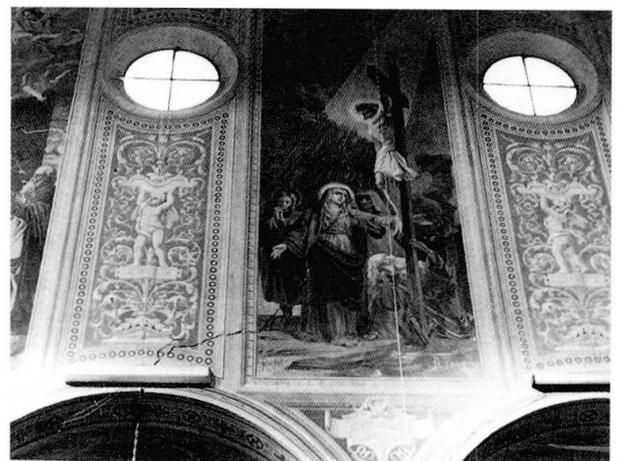
Fig. 5 - Fissures in the the wall defining the central nave.

- a few major cracks affecting the church proper, in the wall at the top of the columns defining the central nave (fig. 5);
- full height lesions of more recent formation (August 1989) in the right-hand side lateral wall of the presbytery, where the transept meets the nave, and in the facade wall.

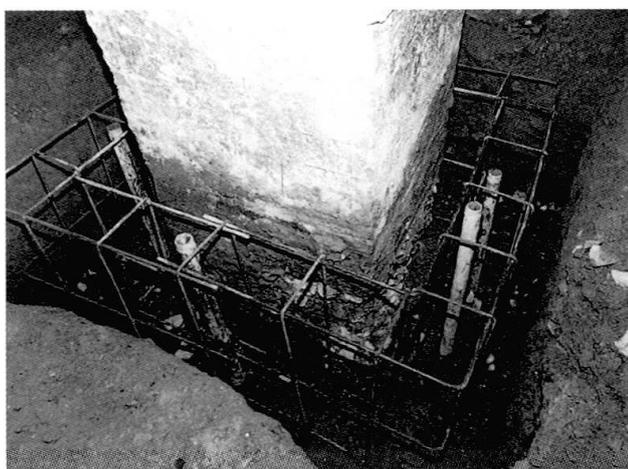
Fig. 6 - Collegamento tra basamento del pilastro e testa dei micropali.

In this situation, the first major protective measure taken was the underpinning of the foundations by means of micro-piles. To prevent the formation of undesirable lateral loads as would be produced by down-drag if the upper layer settled more than the micro-piles, raking piles were not used and the vertical piles were connected to the masonry foundations through reinforced concrete slabs (figs. 6 and 7).

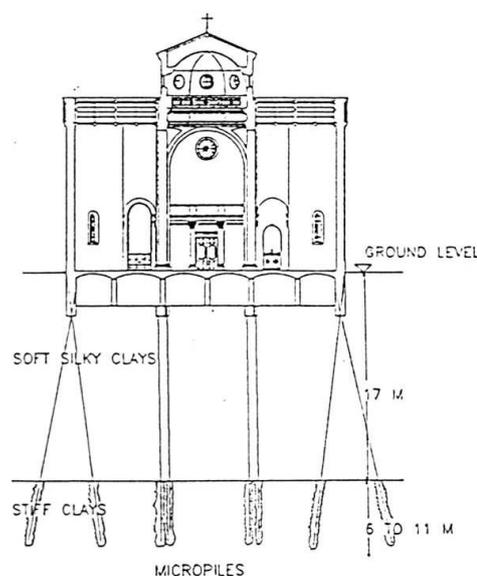
The data collected from 4 bore-holes have shown that the upper stratum of this recent silty clay of low to medium plasticity has a thickness of 17 m. Because of the chaotic structure of this foundation soil and on account of the scarce significance of laboratory tests performed on small samples, in situ compressibility has been evaluated through a back-analysis of the settlements observed in a lower level wall. This has yielded an operational value of soil stiffness as low as 1.5 MPa, which explains the large values of the cracks, fissures and settlements observed in the masonry structures.

Fig. 7 - Cross-section at the transept showing the stratigraphic composition of the soil and micro-piles.

The load applied to each of these micro-piles ranges from 130 to 400 KN and the negative skin friction varies between 120 and 200 KN.

According to these loads, the bearing length in the lower stiff-clay ranges from 6 to 11 m. In addition, in view of the large difference in settlements necessary to attain the desired resistance, only skin friction has been taken into account, neglecting base resistance, so as to prevent the occurrence of further movements of the structure.

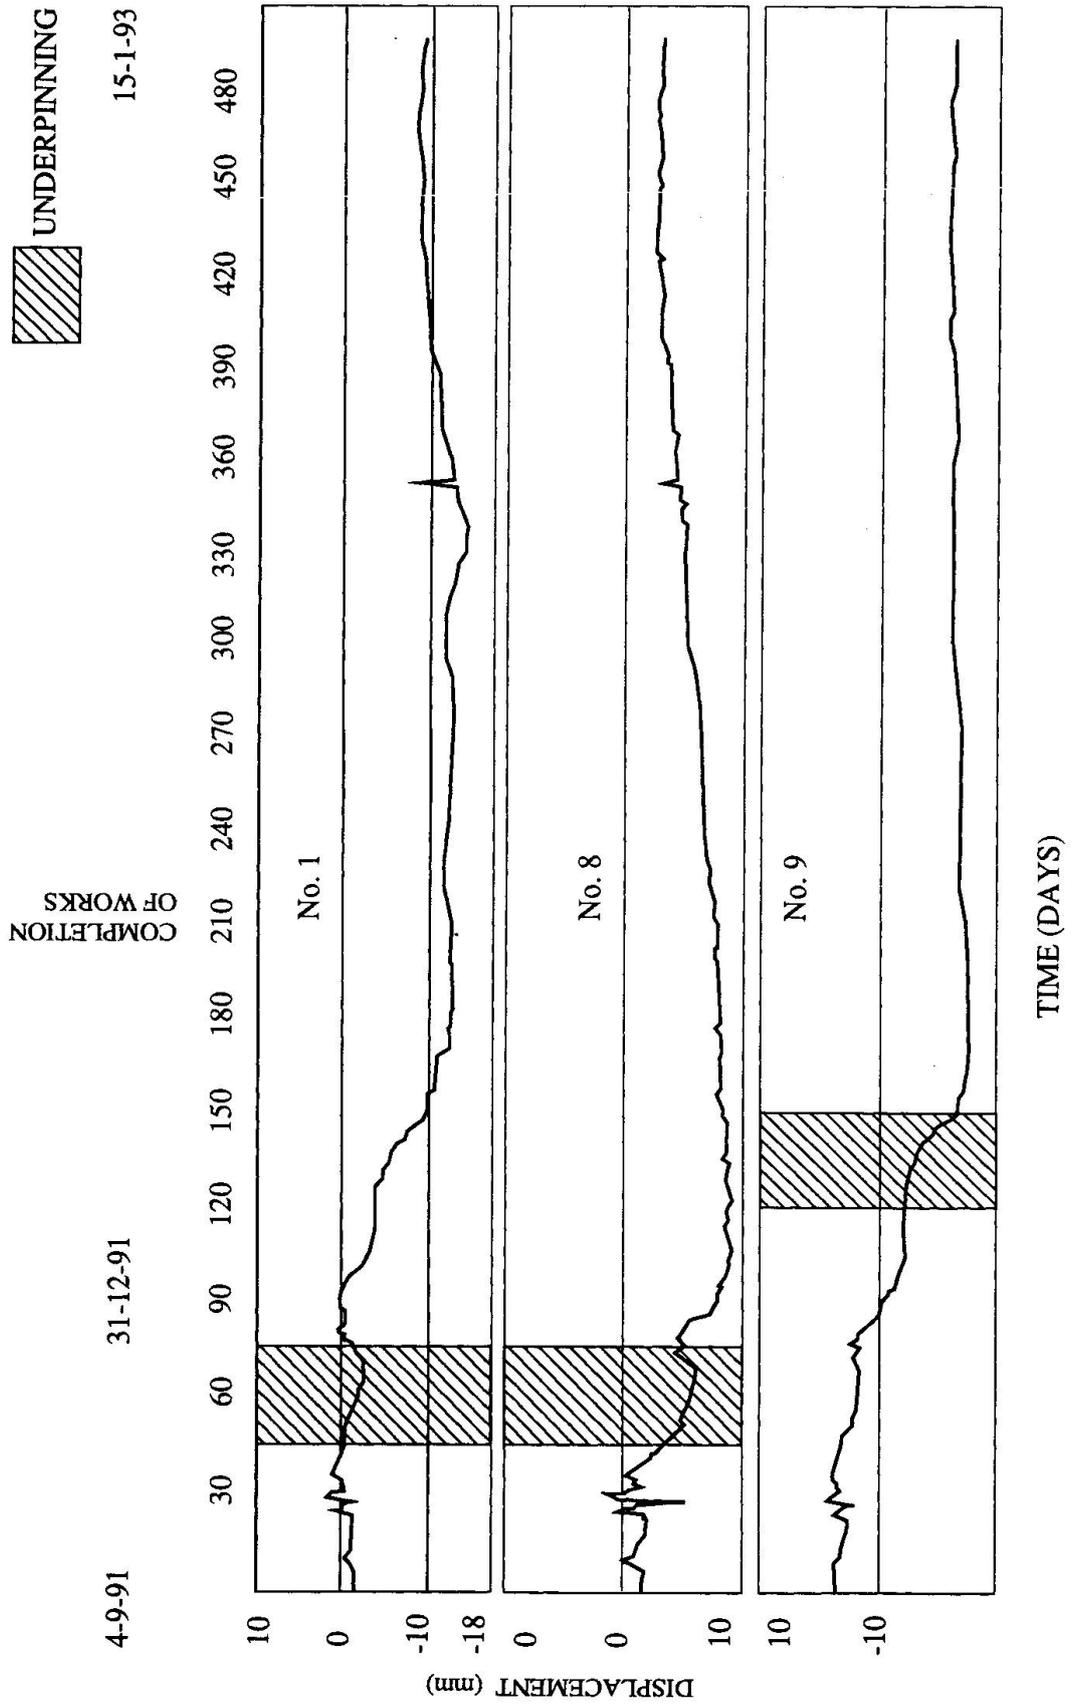
Fig. 8

Figure 2 shows the arrangement of the hydraulic levelling system and the most significant diagrams are shown in figs. 8 and 9.

Due to the re-activation of the movements in 1988, the first part of these diagrams clearly shows that the settlements were still evolving in 1991.

The time periods during which underpinning work was underway are also indicated by shaded portions of the diagrams and it can be seen that after the work was completed the structure did not suffer from any further movement.

Secondly, the settlement pattern shown here has to be understood in terms of relative settlements, because the values given are referred to point 11- a fixed point in the facade wall which certainly underwent minimal movements. This explains, in some cases (see points 1 and 8, for example), the unusual apparent reduction in the extent of the settlements with time.
