Zeitschrift: IABSE reports = Rapports AIPC = IVBH Berichte
Band: 70 (1993)

Artikel: Strengthening of the Parish Church in Farigliano
Autor: Lancelotta, Renato / Pistone, Giuseppe / Rovere, Renzo
DOI: <https://doi.org/10.5169/seals-53300>

Strengthening of the Parish Church in Farigliano

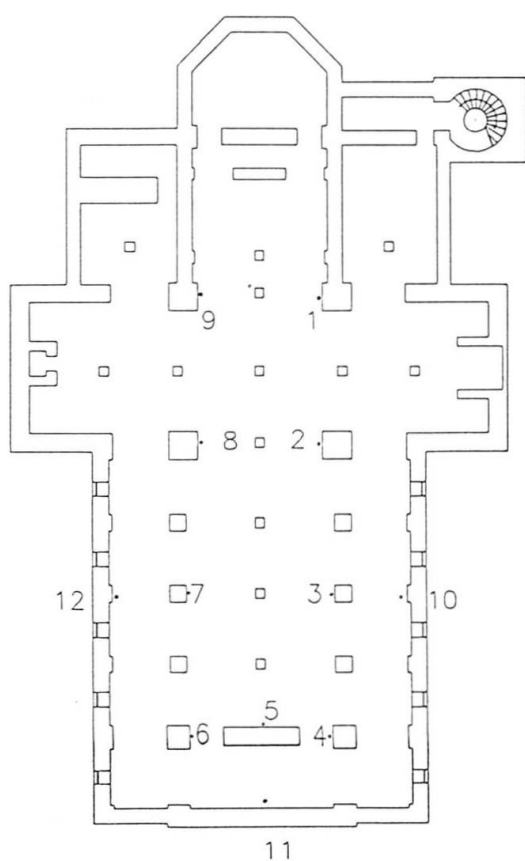
Fig. 2 - Plan of the basement showing the arrangement of the hydraulic levelling system measuring points.

Figure 2 shows the arrangement of the hydraulic levelling system and the most significant diagrams are shown in figs. 8 and 9.

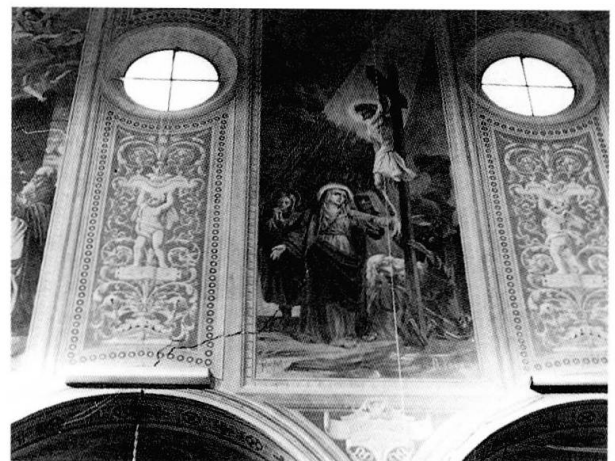
Fig. 5 - Fissures in the the wall defining the central nave.

- a few major cracks affecting the church proper, in the wall at the top of the columns defining the central nave (fig. 5);
- full height lesions of more recent formation (August 1989) in the right-hand side lateral wall of the presbytery, where the transept meets the nave, and in the facade wall.
