Artikel: Strengthening of the Parish Church in Farigliano

Autor: Lancelotta, Renato / Pistone, Giuseppe / Rovere, Renzo

Consolidation de l'église paroissiale de Farigliano Verstärkung der Pfarrkirche in Farigliano

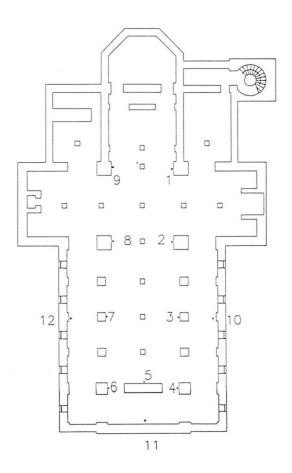
<u>Fig. 2</u> - Plan of the basement showing the arrangement of the hydraulic levelling system measuring points.

Figure 2 shows the arrangement of the hydraulic levelling system and the most significant diagrams are shown in figs. 8 and 9.

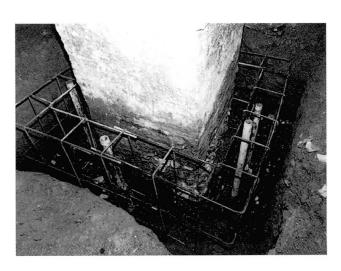
<u>Fig. 6</u> - Collegamento tra basamento del pilastro e testa dei micropali.

In this situation, the first major protective measure taken was the underpinning of the foundations by means of micro-piles. To prevent the formation of undesirable lateral loads as would be produced by down-drag if the upper layer settled more than the micro-piles, raking piles were not used and the vertical piles were connected to the masonry foundations through reinforced concrete slabs (figs. 6 and 7).

The load applied to each of these micro-piles ranges from 130 to 400 KN and the negative skin friction varies between 120 and 200 KN.

According to these loads, the bearing length in the lower stiff-clay ranges from 6 to 11 m. In addition, in view of the large difference in settlements necessary to attain the desired resistance, only skin friction has been taken into account, neglecting base resistance, so as to prevent the occurrence of further movements of the structure.

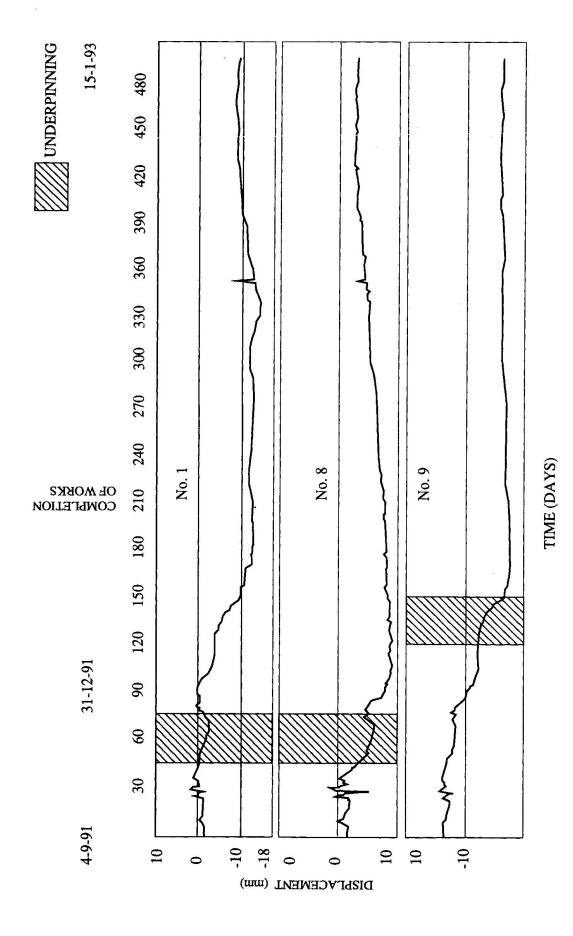
Fig. 8

Due to the re-activation of the movements in 1988, the first part of these diagrams clearly shows that the settlements were still evolving in 1991.

The time periods during which underpinning work was underway are also indicated by shaded portions of the diagrams and it can be seen that after the work was completed the structure did not suffer from any further movement.

Secondly, the settlement pattern shown here has to be understood in terms of relative settlements, because the values given are referred to point 11- a fixed point in the facade wall which certainly underwent minimal movements. This explains, in some cases (see points 1 and 8, for example), the unusual apparent reduction in the extent of the settlements with time.
