**Artikel:** Strengthening of the Parish Church in Farigliano

**Autor:** Lancelotta, Renato / Pistone, Giuseppe / Rovere, Renzo

## Strengthening of the Parish Church in Farigliano

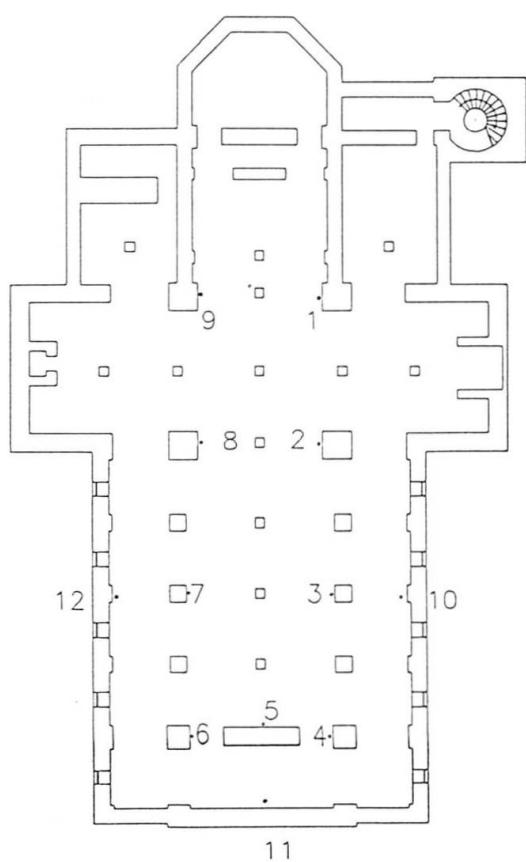
Fig. 2 - Plan of the basement showing the arrangement of the hydraulic levelling system measuring points.

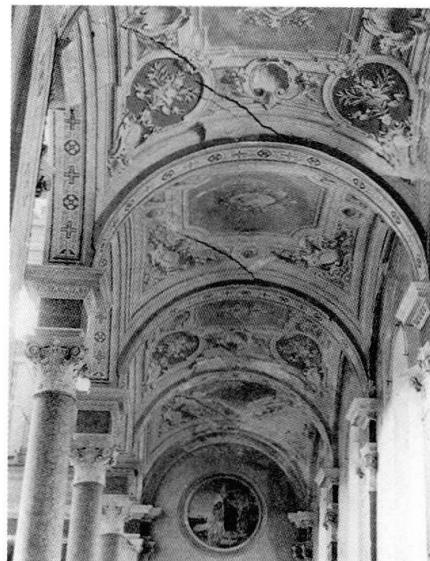
Fig. 3 - Fissures in the thin vaults of the side aisles.

- systematic fissures in the thin vaults covering the side aisles, of ancient origin, but probably made worse by recent damages; their width came to over 4 cm and their position in the building's plan revealed a markedly symmetrical arrangement; in particular, their 45° degree slant isolated, in each vault, a central part which was obviously in compression, as borne out by the relative slip of the crack edges and its enhanced curvature (fig. 3).

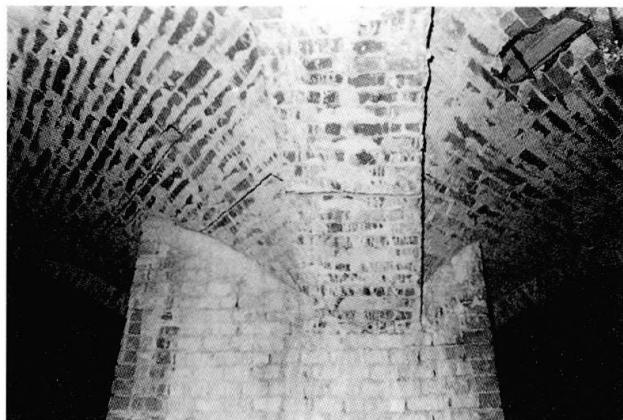
Fig. 4 - Fissures in the the 12 cm thick vaults on the underground level.

- a series of lesions, of recent appearance, involving the vaults and arches in the basement. The most important cracks were located all around the four main piers at the confluence of the transept and the central nave, and were as wide as 19 mm at the arches (fig. 4);

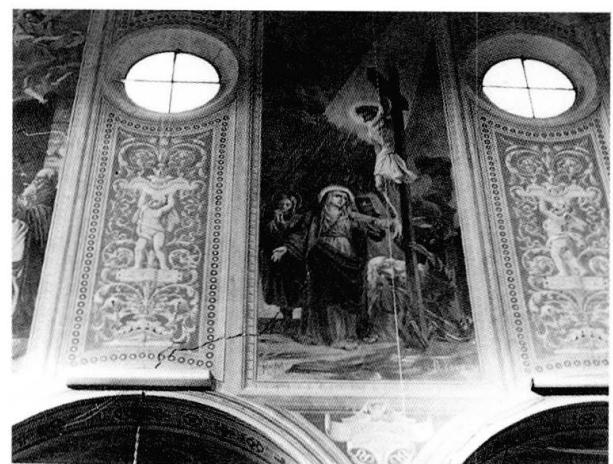
Fig. 5 - Fissures in the the wall defining the central nave.

- a few major cracks affecting the church proper, in the wall at the top of the columns defining the central nave (fig. 5);
- full height lesions of more recent formation (August 1989) in the right-hand side lateral wall of the presbytery, where the transept meets the nave, and in the facade wall.

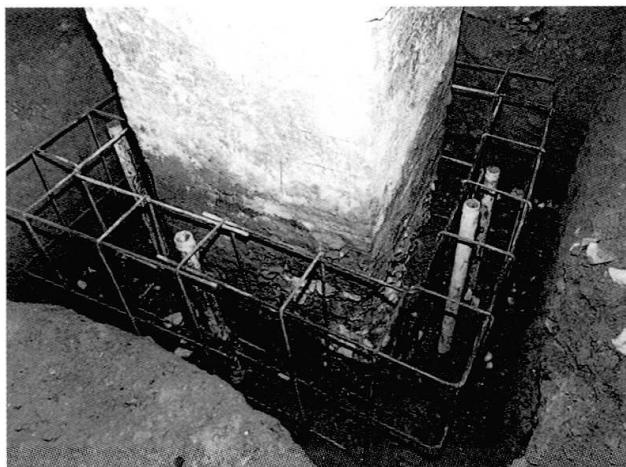
Fig. 6 - Collegamento tra basamento del pilastro e testa dei micropali.

In this situation, the first major protective measure taken was the underpinning of the foundations by means of micro-piles. To prevent the formation of undesirable lateral loads as would be produced by down-drag if the upper layer settled more than the micro-piles, raking piles were not used and the vertical piles were connected to the masonry foundations through reinforced concrete slabs (figs. 6 and 7).

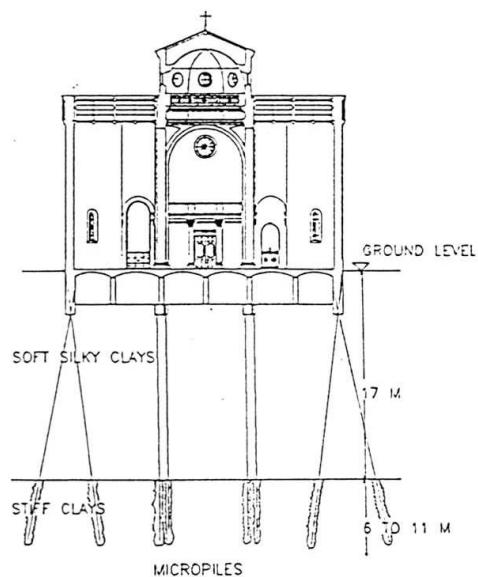
The data collected from 4 bore-holes have shown that the upper stratum of this recent silty clay of low to medium plasticity has a thickness of 17 m. Because of the chaotic structure of this foundation soil and on account of the scarce significance of laboratory tests performed on small samples, in situ compressibility has been evaluated through a back-analysis of the settlements observed in a lower level wall. This has yielded an operational value of soil stiffness as low as 1.5 MPa, which explains the large values of the cracks, fissures and settlements observed in the masonry structures.

Fig. 7 - Cross-section at the transept showing the stratigraphic composition of the soil and micro-piles.

The load applied to each of these micro-piles ranges from 130 to 400 KN and the negative skin friction varies between 120 and 200 KN.

According to these loads, the bearing length in the lower stiff-clay ranges from 6 to 11 m. In addition, in view of the large difference in settlements necessary to attain the desired resistance, only skin friction has been taken into account, neglecting base resistance, so as to prevent the occurrence of further movements of the structure.

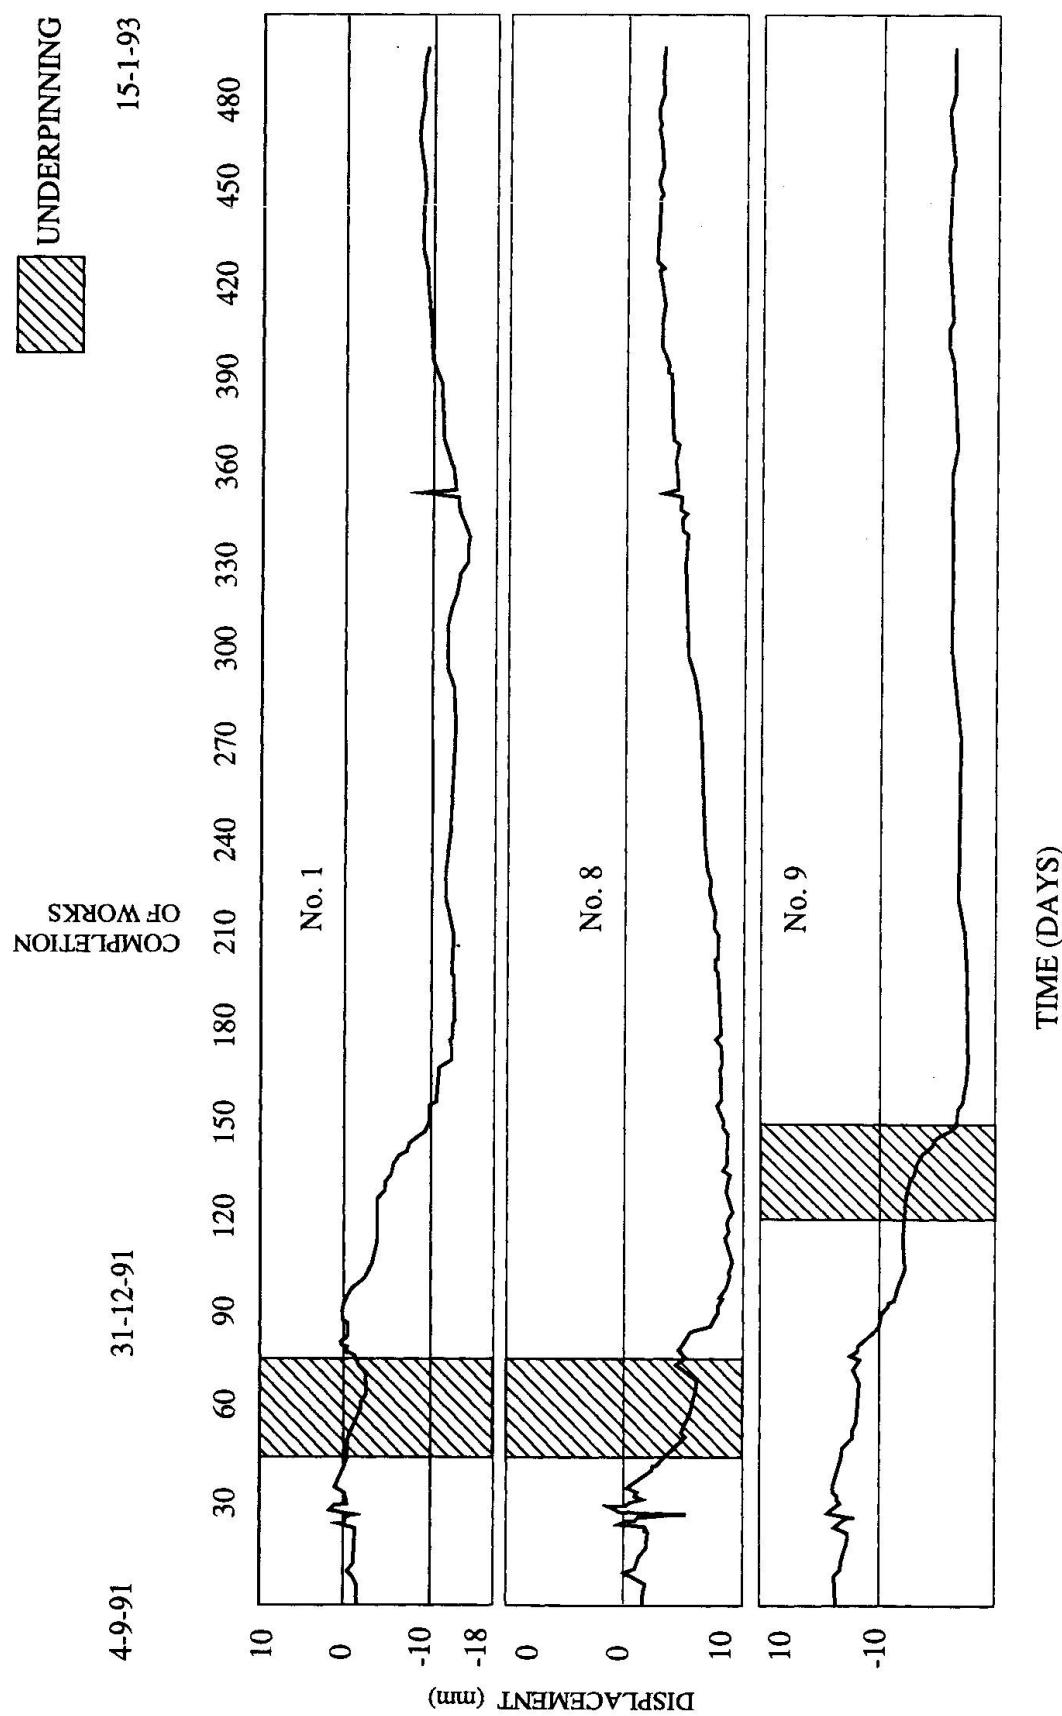
Fig. 8

Figure 2 shows the arrangement of the hydraulic levelling system and the most significant diagrams are shown in figs. 8 and 9.

Due to the re-activation of the movements in 1988, the first part of these diagrams clearly shows that the settlements were still evolving in 1991.

The time periods during which underpinning work was underway are also indicated by shaded portions of the diagrams and it can be seen that after the work was completed the structure did not suffer from any further movement.

Secondly, the settlement pattern shown here has to be understood in terms of relative settlements, because the values given are referred to point 11- a fixed point in the facade wall which certainly underwent minimal movements. This explains, in some cases (see points 1 and 8, for example), the unusual apparent reduction in the extent of the settlements with time.
