**Zeitschrift:** IABSE reports = Rapports AIPC = IVBH Berichte  
**Band:** 70 (1993)

**Artikel:** Studies for the rehabilitation of Mexico City Cathedral  
**Autor:** Meli, Roberto / Sanchez-Ramirez, A. Roberto  
**DOI:** <https://doi.org/10.5169/seals-53324>

## Studies for the Rehabilitation of the Mexico City Cathedral

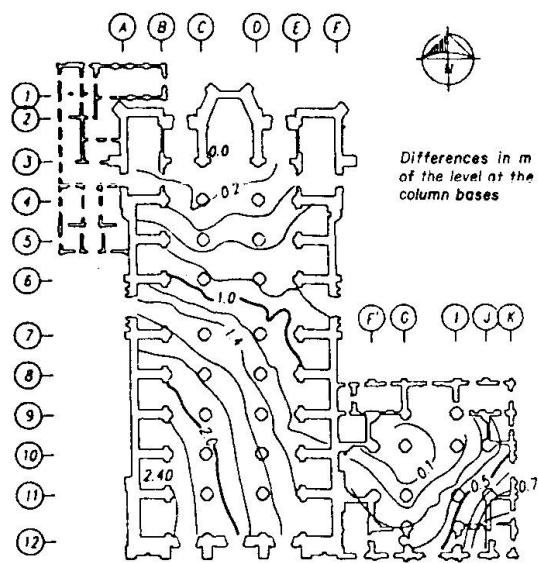
**Fig. 3** Differential settlements (Dec. 1989)

Fig. 3 shows the pattern of differential settlements measured in the floor of the Cathedral some time before at the beginning of the rehabilitation work (late 1989). Another useful representation of the phenomenon is given by the curves of equal rate of differential settlements in the year before the commencement of the works (Fig. 4). Two major mechanisms of deformation can be appreciated. One is the sinking toward the Southwest corner, another is the "emergence" of the central nave in the Northern part.

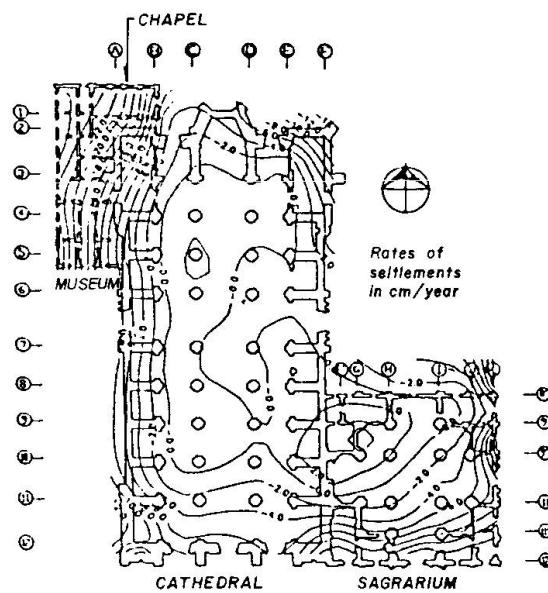
**Fig. 4** Annual rate of increase in differential settlements (1991)

The first mechanism has produced a pattern of transverse cracks in the roof and walls, especially near the central dome, and some separation of the Southern facade, with its very heavy towers, from the rest of the church.

The second mechanism produced the outward rotation of the columns and lateral walls, and the opening of the vaults and arches in the roof, originating a pattern of longitudinal cracks in the roof, floor and foundation. This second mechanism is the most critical from the structural point of view, because of the inclination of the columns receiving the greatest vertical loads, especially those supporting the central dome. As can be seen in Fig. 5, the present shape of the column shaft shows changes of direction due to corrections made during the construction. The total eccentricity between the upper and lower part of the column is, for this case, 0.6m representing 25% of the size of the column. Some vertical cracks at the upper part of the column are attributed to the compressive stresses generated by the eccentric compression.

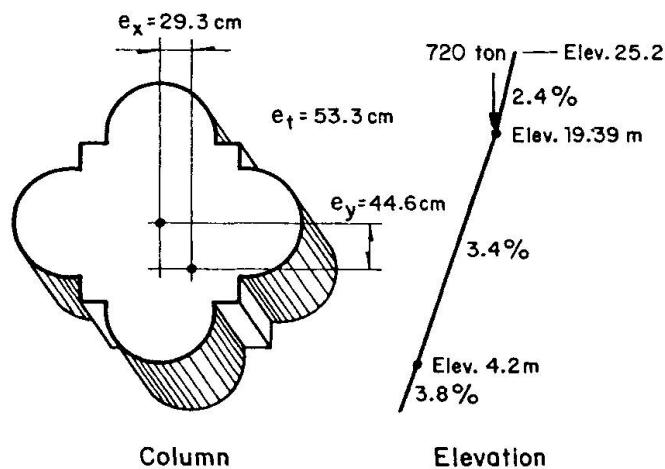
**Fig. 5** Deformed shape of a central column and applied forces due to self-weight

stability of the central columns shows that bending moments induced by the eccentricity of the force produced by the weight of the roof, increase the maximum compressive stress 2.3 times above that computed for the undeflected shape of the column. In this fashion stresses are now very near to the maximum capacity of the stone.

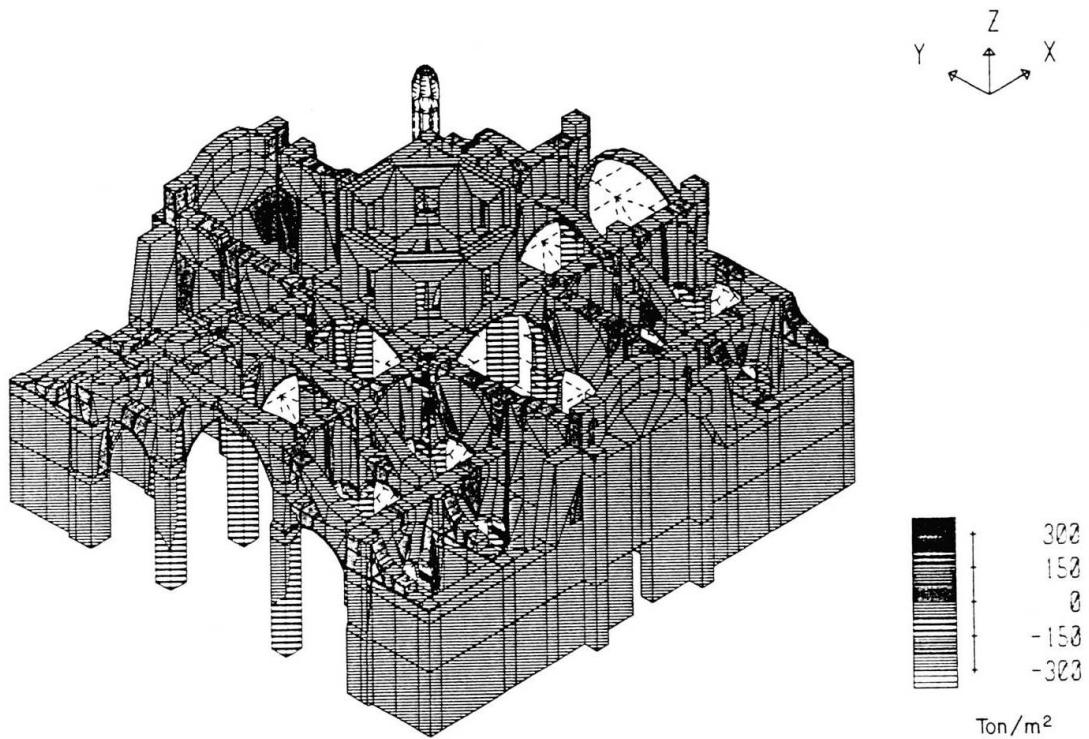
**Fig. 6** State of stress due to gravity loading from a finite element analysis of the central portion of the Cathedral

A thorough view of the state of stresses induced by the vertical loads in the central part of the monument is shown in Fig. 6. A more schematic representation of the flow of forces in members supporting the central dome is shown in Fig. 7. It can be appreciated that the weight is transmitted toward the foundation essentially by axial forces in the vaults, arches, columns and walls. The level of stresses in the members of the original structure disregarding the changes in their geometry due to settlements and adjustments, is well within the range of capacity of the materials.

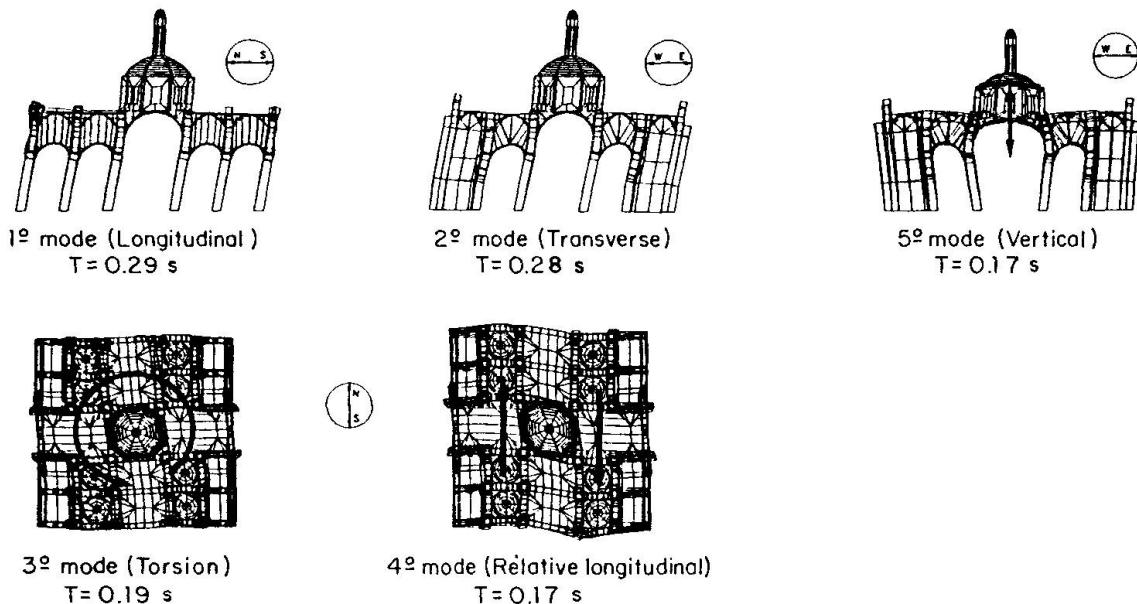
Fig. 9 Modal shapes of vibration from a finite element model of the central portion of the Cathedral

The previously described linear elastic tri-dimensional model was used for a dynamic analysis to compute the modal shapes and periods of vibration (Fig. 9). It was found that in plan deformations of the roof favoured torsional modes of vibration and that the large concentrated mass of the central dome produced significant vertical vibration. Computed periods were compared with those derived by measuring the vibration of the building in ambient conditions. Consistently, computed periods are smaller than those measured. This is attributed to the lack of fixity of the base of the structure where the foundation allows significant rotations of the walls and columns. Additionally, the extensive cracking of the structure significantly reduces the stiffness, thus increasing the vibration period.

For the assessment of the seismic safety, a constant spectral ordinate of 0.2m was assumed. It was considered that, because of the existing cracking and of the small tensile strength of the materials, parts of the structure could vibrate independently from the rest. Therefore, the seismic safety of the most critical portions was assessed primarily by simplified methods. In general terms, it was concluded that the strong peripheral belt constituted by the facade walls and by the walls surrounding the chapels provided a satisfactory overall safety. Nevertheless, the additional lateral displacements of the columns during their
