Artikel: Studies for the rehabilitation of Mexico City Cathedral

Autor: Meli, Roberto / Sanchez-Ramirez, A. Roberto

Studies for the Rehabilitation of the Mexico City Cathedral

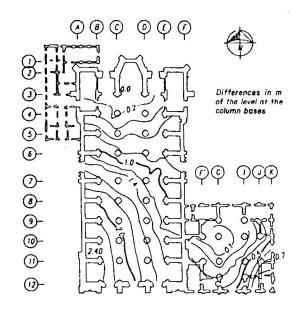
Fig. 3 Differential settlements
(Dec. 1989)

Fig. 3 shows the pattern of differential settlements measured in the floor of the Cathedral some time before at the beginning of the rehabilitation work (late 1989). Another useful representation of the phenomenon is given by the curves of equal rate of differential settlements in the year before the commencement of the works (Fig. 4). Two major mechanisms of deformation can be appreciated. One is the sinking toward the Southwest corner, another is the "emergence" of the central nave in the Northern part.

The first mechanism has produced a pattern of transverse cracks in the roof and walls, especially near the central dome, and some separation of the Southern facade, with its very heavy towers, from the rest of the church.

The second mechanism produced the outward rotation of the columns and lateral walls, and the opening of the vaults and arches in the roof, originating a pattern of longitudinal cracks in the roof, floor and foundation. This second mechanism is the most critical from the structural point of view, because of the inclination of the columns receiving the greatest vertical loads, especially those supporting the central dome. As can be seen in Fig. 5, the present shape of the column shaft shows changes of direction due to corrections made during the construction. The total eccentricity between the upper and lower part of the column is, for this case, 0.6m representing 25% of the size of the column. Some vertical cracks at the upper part of the column are attributed to the compressive stresses generated by the eccentric compression.

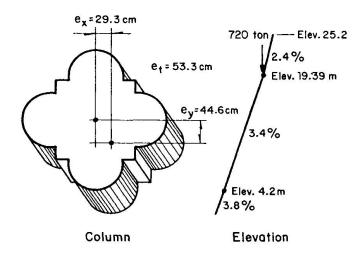
Fig. 5 Deformed shape of a central column and applied forces due to self-weight

stability of the central columns shows that bending moments induced by the eccentricity of the force produced by the weight of the roof, increase the maximum compressive stress 2.3 times above that computed for the undeflected shape of the column. In this fashion stresses are now very near to the maximum capacity of the stone.

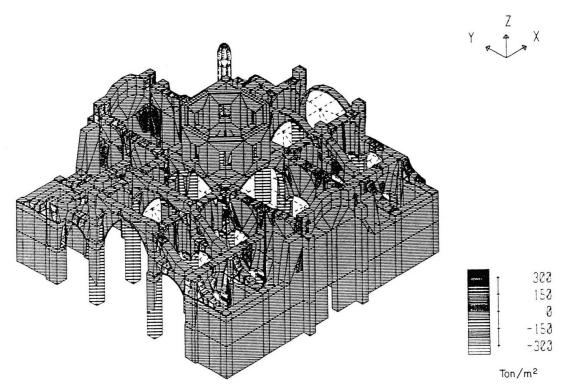
$\underline{\text{Fig. 6}}$ State of stress due to gravity loading from a finite element analysis of the central portion of the Cathedral

A thorough view of the state of stresses induced by the vertical loads in the central part of the monument is shown in Fig. 6. A move schematic representation of the flow of forces in members supporting the central dome is shown in Fig. 7. It can be appreciated that the weight transmitted toward the foundation essentially by axial forces in the vaults, arches, columns and walls. The level of stresses in the members of the original structure disregarding the changes in their geometry due to settlements and adjustements, is well within the range of capacity of the materials.

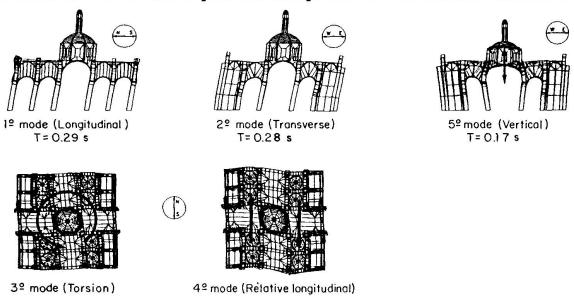
$\underline{\text{Fig. 9}}$ Modal shapes of vibration from a finite element model of the central portion of the Cathedral

The previously described linear elastic tri-dimensional model was used for a dynamic analysis to compute the modal shapes and periods of vibration (Fig. 9). It was found that in plan deformations of the roof favoured torsional modes of vibration and that the large concentrated mass of the central dome produced significant vertical vibration. Computed periods were compared with those derived by measuring the vibration of the building in ambient conditions. Consistently, computed periods are smaller than those measured. This is attributed to the lack of fixity of the base of the structure where the foundation allows significant rotations of the walls and columns. Additionally, the extense cracking of the structure significantly reduces the stiffness, thus increasing the vibration period.

For the assessment of the seismic safety, a constant spectral ordinate of 0.2m was assumed. It was considered that, because of the existing cracking and of the small tensile strength of the materials, parts of the structure could vibrate independently from the rest. Therefore, the seismic safety of the most critical portions was assessed primarily by simplified methods. In general terms, it was concluded that the strong peripheral belt constituted by the facade walls and by the walls sorrounding the chapels provided a satisfactory overall safety. Nevertheless, the additional lateral displacements of the columns during their
