Studies for the Rehabilitation of the Mexico City Cathedral

Roberto MELI

A. Roberto SANCHEZ-RAMIREZ

SUMMARY

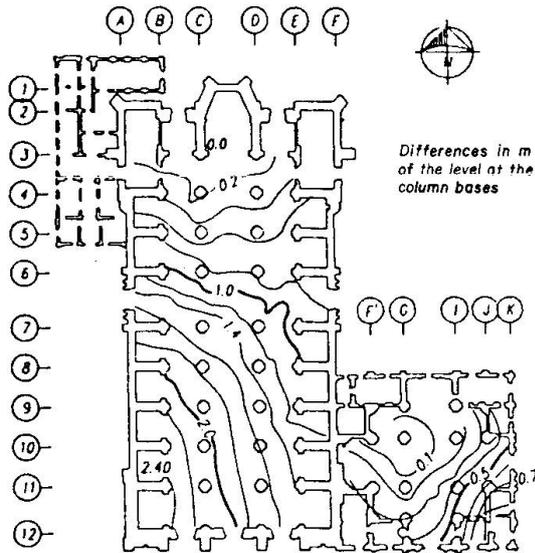
Fig. 3 Differential settlements (Dec. 1989)

Fig. 3 shows the pattern of differential settlements measured in the floor of the Cathedral some time before at the beginning of the rehabilitation work (late 1989). Another useful representation of the phenomenon is given by the curves of equal rate of differential settlements in the year before the commencement of the works (Fig. 4). Two major mechanisms of deformation can be appreciated. One is the sinking toward the Southwest corner, another is the "emergence" of the central nave in the Northern part.

The first mechanism has produced a pattern of transverse cracks in the roof and walls, especially near the central dome, and some separation of the Southern facade, with its very heavy towers, from the rest of the church.

The second mechanism produced the outward rotation of the columns and lateral walls, and the opening of the vaults and arches in the roof, originating a pattern of longitudinal cracks in the roof, floor and foundation. This second mechanism is the most critical from the structural point of view, because of the inclination of the columns receiving the greatest vertical loads, especially those supporting the central dome. As can be seen in Fig. 5, the present shape of the column shaft shows changes of direction due to corrections made during the construction. The total eccentricity between the upper and lower part of the column is, for this case, 0.6m representing 25% of the size of the column. Some vertical cracks at the upper part of the column are attributed to the compressive stresses generated by the eccentric compression.

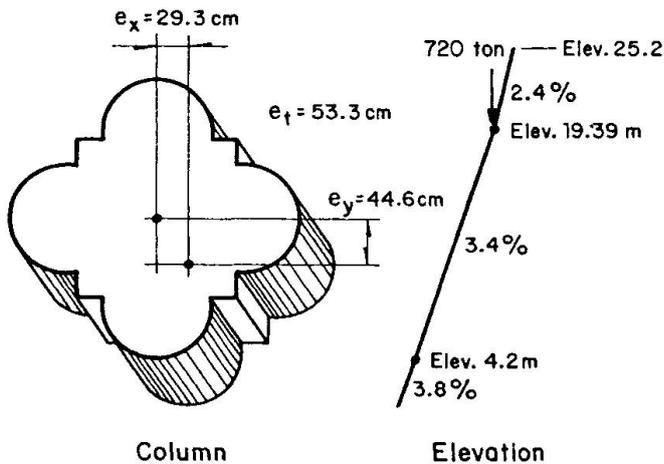
Fig. 5 Deformed shape of a central column and applied forces due to self-weight

stability of the central columns shows that bending moments induced by the eccentricity of the force produced by the weight of the roof, increase the maximum compressive stress 2.3 times above that computed for the undeflected shape of the column. In this fashion stresses are now very near to the maximum capacity of the stone.

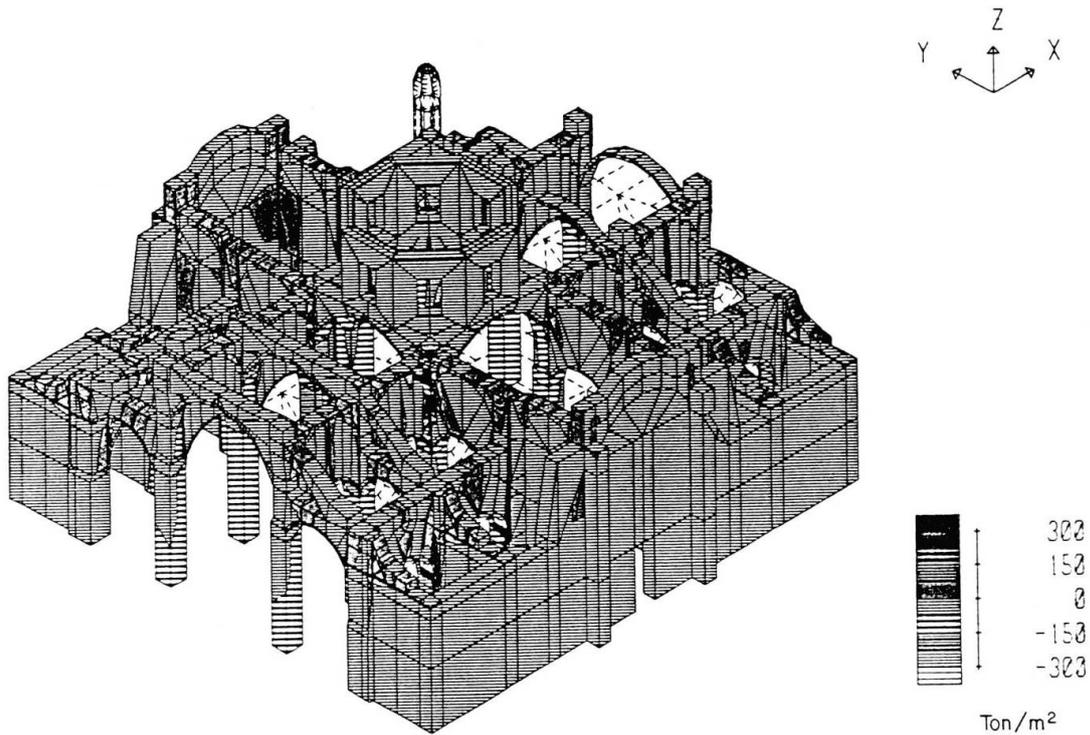
Fig. 6 State of stress due to gravity loading from a finite element analysis of the central portion of the Cathedral

A thorough view of the state of stresses induced by the vertical loads in the central part of the monument is shown in Fig. 6. A move schematic representation of the flow of forces in members supporting the central dome is shown in Fig. 7. It can be appreciated that the weight is transmitted toward the foundation essentially by axial forces in the vaults, arches, columns and walls. The level of stresses in the members of the original structure disregarding the changes in their geometry due to settlements and adjustments, is well within the range of capacity of the materials.

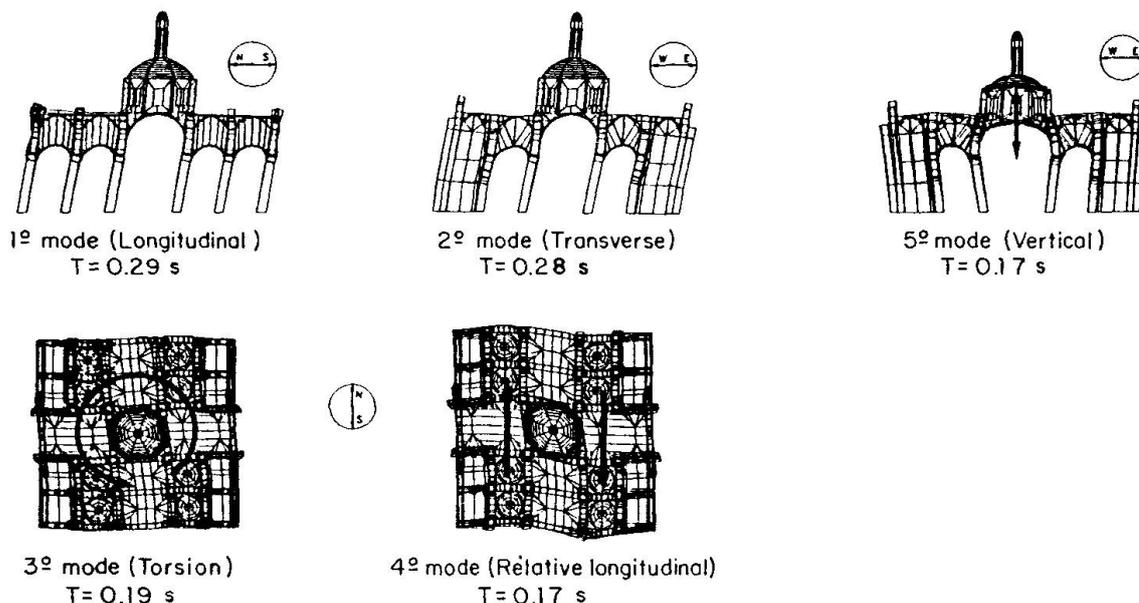
Fig. 9 Modal shapes of vibration from a finite element model of the central portion of the Cathedral

The previously described linear elastic tri-dimensional model was used for a dynamic analysis to compute the modal shapes and periods of vibration (Fig. 9). It was found that in plan deformations of the roof favoured torsional modes of vibration and that the large concentrated mass of the central dome produced significant vertical vibration. Computed periods were compared with those derived by measuring the vibration of the building in ambient conditions. Consistently, computed periods are smaller than those measured. This is attributed to the lack of fixity of the base of the structure where the foundation allows significant rotations of the walls and columns. Additionally, the extense cracking of the structure significantly reduces the stiffness, thus increasing the vibration period.

For the assessment of the seismic safety, a constant spectral ordinate of 0.2m was assumed. It was considered that, because of the existing cracking and of the small tensile strength of the materials, parts of the structure could vibrate independently from the rest. Therefore, the seismic safety of the most critical portions was assessed primarily by simplified methods. In general terms, it was concluded that the strong peripheral belt constituted by the facade walls and by the walls surrounding the chapels provided a satisfactory overall safety. Nevertheless, the additional lateral displacements of the columns during their
