Studies for the Rehabilitation of the Mexico City Cathedral

Roberto MELI

A. Roberto SANCHEZ-RAMIREZ

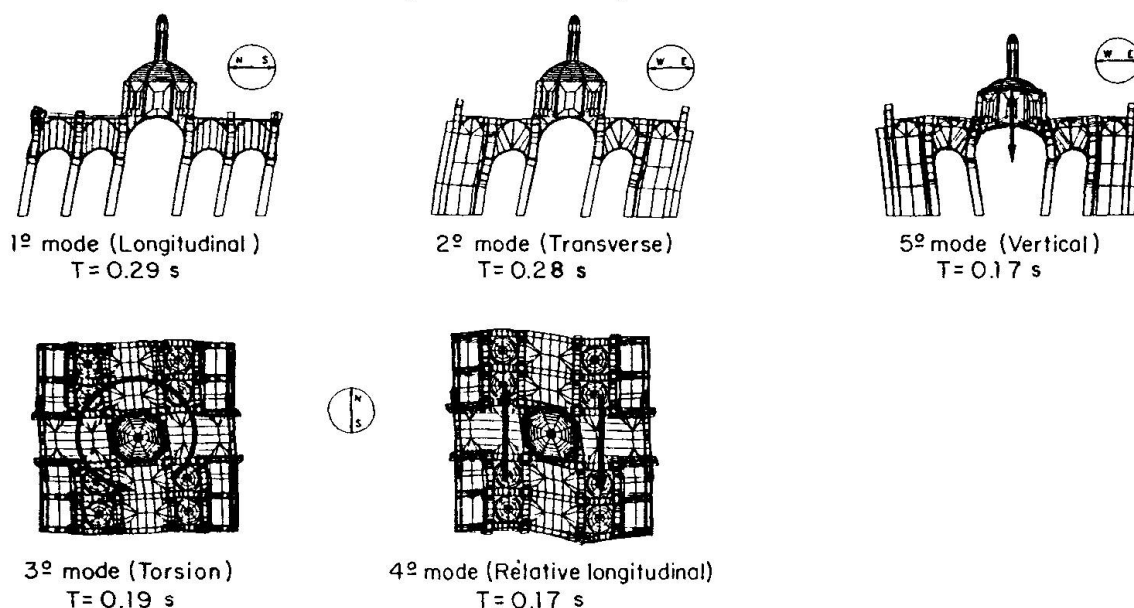
Fig. 9 Modal shapes of vibration from a finite element model of the central portion of the Cathedral

The previously described linear elastic tri-dimensional model was used for a dynamic analysis to compute the modal shapes and periods of vibration (Fig. 9). It was found that in plan deformations of the roof favoured torsional modes of vibration and that the large concentrated mass of the central dome produced significant vertical vibration. Computed periods were compared with those derived by measuring the vibration of the building in ambient conditions. Consistently, computed periods are smaller than those measured. This is attributed to the lack of fixity of the base of the structure where the foundation allows significant rotations of the walls and columns. Additionally, the extense cracking of the structure significantly reduces the stiffness, thus increasing the vibration period.

For the assessment of the seismic safety, a constant spectral ordinate of 0.2m was assumed. It was considered that, because of the existing cracking and of the small tensile strength of the materials, parts of the structure could vibrate independently from the rest. Therefore, the seismic safety of the most critical portions was assessed primarily by simplified methods. In general terms, it was concluded that the strong peripheral belt constituted by the facade walls and by the walls surrounding the chapels provided a satisfactory overall safety. Nevertheless, the additional lateral displacements of the columns during their
