**Artikel:** Strengthening landmarks for improved seismic performance

Autor: Wyllie, Loring A.

# Strengthening Landmarks for Improved Seismic Performance

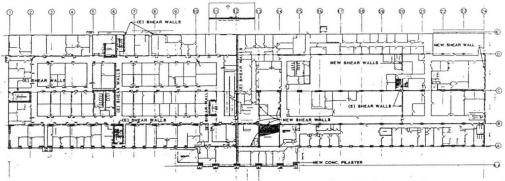
The 1989 Loma Prieta earthquake caused more damage. Several columns in the tower buckled where the X-bracing had eccentric working points. The steel flagpole atop the tower bent as it did in 1906. The front facade of the low-rise aligning with the tower was permanently displaced about 20 mm. There was various damage and cracking of the masonry walls and parapet in the south half and the end wall cracked, failed its few connecting bolts to the roof and separated about 5 mm from the roof. There was no damage in the north half which was stiffer and stronger for lateral forces.

Figure 1. Second Floor of Ferry Building showing existing and recommended locations of shear walls. The tower is between columns 12-13-A-B.

Based on a detailed analysis at the beginning of the project, we also recommended adding some additional interior reinforced concrete shear walls beneath the tower and in the south half of the building. This work is also being funded by FEMA as a reasonable measure to reduce damage in future earthquakes. Care is being taken on locating these walls to minimize their impact on the historic fabric remaining on the interior of the building.

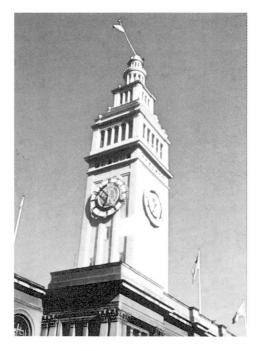
The building was heavily damaged in the 1906 San Francisco earthquake when eyebars in the tower both failed and permanently elongated about 50 mm. The sandstone on the tower was heavily damaged and replaced with reinforced concrete after the earthquake. Sandstone and brick infill in the low-rise was also damaged and repaired.

Figure 2. Photograph of Ferry Building tower after Loma Prieta earthquake with bent flagpole.

The United States federal government pays for repairs to local government buildings such as the Ferry Building through the Federal Emergency Management Agency (FEMA). Thus, the basic damage to the tower, flagpole and cracked masonry is being repaired. We were able to convince FEMA that the most suitable repair of parapet damage was to brace the parapet with reinforced concrete and steel braces. The sandstone facade in front of the tower that was permanently displaced will be left displaced but the stones will be anchored to new reinforced concrete backing. This includes the decorative facade columns which are a series of round or square stones atop each other with no steel reinforcement. The cracked and slightly leaning south wall will be reconstructed by removing two wythes of brick from the exterior (250 mm thick) and replacing it with reinforced concrete anchored to all floors and the roof. This new concrete both repairs the south wall damage, significantly strengthens the end of the building, preserves the historic interior brick and stone arched window at the Third Floor and allows us to restore previous modifications in the south wall by replicating the original arched windows and trancery. FEMA also agreed to fund these improvements as repairs.

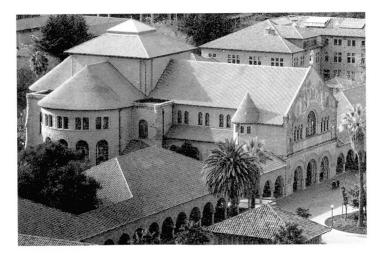
In the 1989 Loma Prieta earthquake, the "new" concrete walls performed well but the original arches of the crossing were damaged. The arches are about 22 m high and each consists of two 1.6 m deep by 550 mm wide stone arches with carved faces. The pairs of arches support a brick wall and are separated by a void about 0.5 m wide where the structural steel for the original tower is located. In the 1989 earthquake, several of the arches moved perpendicular to their plane and caused stones near the center of the arch to crack and drop about 25 mm. At the junction of the arches, the plaster mosaics were damaged with a portion falling to the floor below.

Figure 3. Stanford Memorial Church, Stanford University.

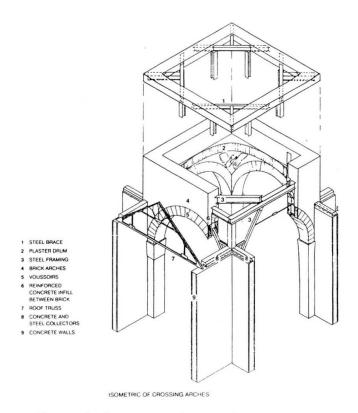
<u>Figure 4</u>. Isometric of strengthening of the Crossing Arches of Stanford Memorial Church.

The damage was analyzed, the conditions determined and an analysis was completed. It was decided to strengthen the arches by filling the void in their center with some heavily reinforced concrete, to provide a diaphragm at the top of the walls above the arches consisting of a substantial reinforced concrete cap beam and steel diagonal braces. The added steel included a stiff downward cantilever to stiffen the arches against perpendicular movement. The reinforced core between the arches was also tied horizontally to the reinforced concrete walls of the four projections from the crossing to improve structural ties and the transfer of lateral forces. The wood roof diaphragms over the entire Church were strengthened with new plywood and stronger ties and connections at the concrete walls. All of this work was completed in concealed locations with no visible evidence of the repairs and strengthening. Figure 4 illustrates the strengthening scheme.

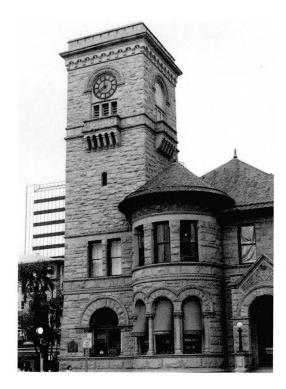
The building was extensively damaged in the 1906 San Francisco earthquake when the tower collapsed. The building was rebuilt with minor revisions to the top of the tower. In the 1989 Loma Prieta earthquake, there was minor damage consisting of cracking in the tower near the bottom of the 1906 collapse. There was no damage in the lower floors, but in a partial Third Floor attic slab, there was significant cracking at locations where the steel framing and brick arches changed directions. At those locations, there were no continuous tension ties in the floor diaphragm to prevent spreading and resist tension forces. In the lower floors, both the steel beams and the girder-to-column connections were bolted for continuity, providing tension capacity for the floors.

Figure 5. San Jose Museum of Art, formerly the United States Post Office.

The tower and Third Floor attic have been repaired by strengthening, again funded by FEMA. The tower was strengthened by removing two wythes of brick on the interior and installing reinforced concrete applied as shotcrete. The brick was removed to keep room sizes and window recesses unchanged so original wood finishes could be reinstalled without modification. The Third Floor attic was strengthened by welding steel straps to the exposed top flanges of the steel beams in the unfinished attic to provide tensile ties in both directions of the attic slab.

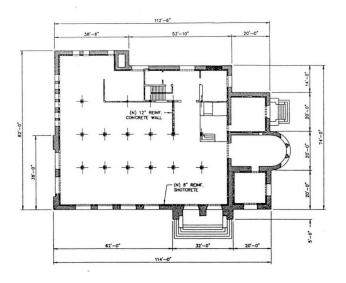
Figure 6. Proposed strengthening of San Jose Museum of Art - First Floor Plan.

A second project has completed the design phase to strengthen the remainder of the building. This is to comply with a retroactive ordinance of the City of San Jose requiring all unreinforced masonry bearing wall buildings to be strengthened or demolished in the interest of public safety. The strengthening scheme for the remainder of the building also includes reinforcing the exterior walls with reinforced concrete installed as shotcrete to strengthen those walls. Again, two wythes of brick are being removed in most places so original finishes can be restored. In addition, a new interior reinforced concrete shear wall is being added in the First Floor and Basement beneath a brick wall which forms the exterior of the reduced size Second Floor. These walls are being added to minimize horizontal stress transfers in the relatively weak Second Floor diaphragm so it does not have to be strengthened. New foundations are being constructed beneath the new walls and between the original spread footings. The strengthening work is shown on Figure 6.
