Strengthening Landmarks for Improved Seismic Performance

Loring A. WYLLIE, Jr.

Structural Engineer
H.J. Degenkolb Assoc.
San Francisco, CA, USA

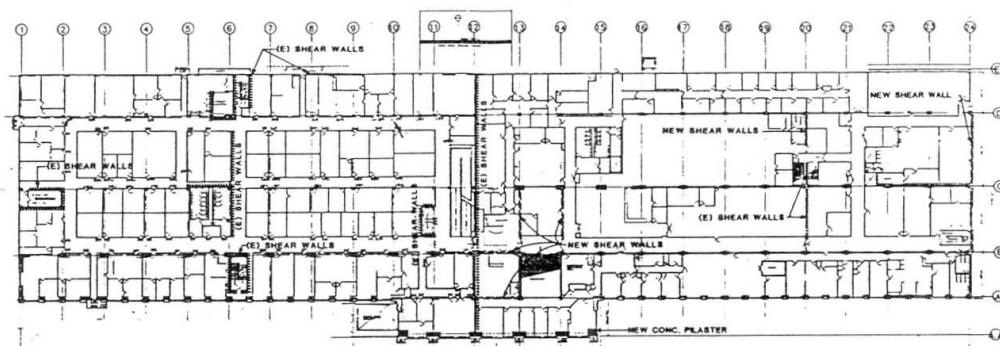
The 1989 Loma Prieta earthquake caused more damage. Several columns in the tower buckled where the X-bracing had eccentric working points. The steel flagpole atop the tower bent as it did in 1906. The front facade of the low-rise aligning with the tower was permanently displaced about 20 mm. There was various damage and cracking of the masonry walls and parapet in the south half and the end wall cracked, failed its few connecting bolts to the roof and separated about 5 mm from the roof. There was no damage in the north half which was stiffer and stronger for lateral forces.

Figure 1. Second Floor of Ferry Building showing existing and recommended locations of shear walls. The tower is between columns 12-13-A-B.

Based on a detailed analysis at the beginning of the project, we also recommended adding some additional interior reinforced concrete shear walls beneath the tower and in the south half of the building. This work is also being funded by FEMA as a reasonable measure to reduce damage in future earthquakes. Care is being taken on locating these walls to minimize their impact on the historic fabric remaining on the interior of the building.

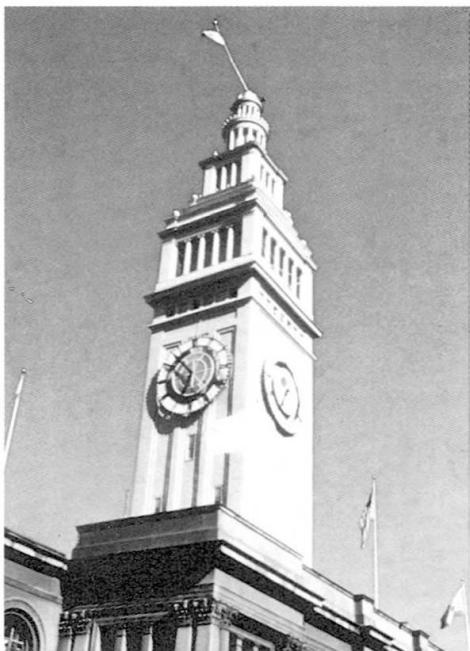
Figure 2. Photograph of Ferry Building tower after Loma Prieta earthquake with bent flagpole.

The United States federal government pays for repairs to local government buildings such as the Ferry Building through the Federal Emergency Management Agency (FEMA). Thus, the basic damage to the tower, flagpole and cracked masonry is being repaired. We were able to convince FEMA that the most suitable repair of parapet damage was to brace the parapet with reinforced concrete and steel braces. The sandstone facade in front of the tower that was permanently displaced will be left displaced but the stones will be anchored to new reinforced concrete backing. This includes the decorative facade columns which are a series of round or square stones atop each other with no steel reinforcement. The cracked and slightly leaning south wall will be reconstructed by removing two wythes of brick from the exterior (250 mm thick) and replacing it with reinforced concrete anchored to all floors and the roof. This new concrete both repairs the south wall damage, significantly strengthens the end of the building, preserves the historic interior brick and stone arched window at the Third Floor and allows us to restore previous modifications in the south wall by replicating the original arched windows and tracery. FEMA also agreed to fund these improvements as repairs.

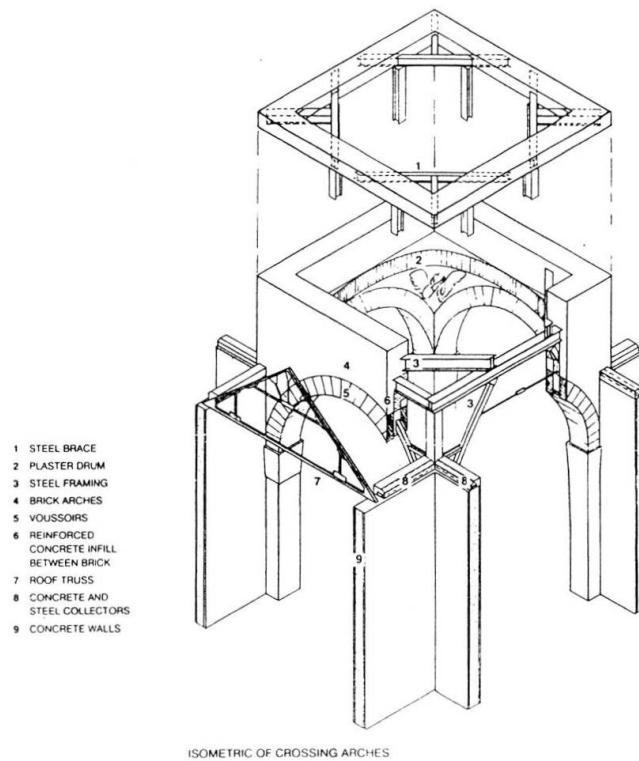
ISOMETRIC OF CROSSING ARCHES

In the 1989 Loma Prieta earthquake, the "new" concrete walls performed well but the original arches of the crossing were damaged. The arches are about 22 m high and each consists of two 1.6 m deep by 550 mm wide stone arches with carved faces. The pairs of arches support a brick wall and are separated by a void about 0.5 m wide where the structural steel for the original tower is located. In the 1989 earthquake, several of the arches moved perpendicular to their plane and caused stones near the center of the arch to crack and drop about 25 mm. At the junction of the arches, the plaster mosaics were damaged with a portion falling to the floor below.

Figure 4. Isometric of strengthening of the Crossing Arches of Stanford Memorial Church.

The damage was analyzed, the conditions determined and an analysis was completed. It was decided to strengthen the arches by filling the void in their center with some heavily reinforced concrete, to provide a diaphragm at the top of the walls above the arches consisting of a substantial reinforced concrete cap beam and steel diagonal braces. The added steel included a stiff downward cantilever to stiffen the arches against perpendicular movement. The reinforced core between the arches was also tied horizontally to the reinforced concrete walls of the four projections from the crossing to improve structural ties and the transfer of lateral forces. The wood roof diaphragms over the entire Church were strengthened with new plywood and stronger ties and connections at the concrete walls. All of this work was completed in concealed locations with no visible evidence of the repairs and strengthening. Figure 4 illustrates the strengthening scheme.

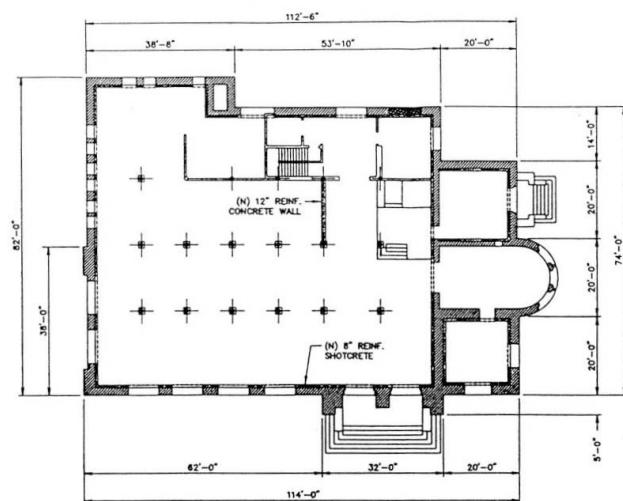
Figure 6. Proposed strengthening of San Jose Museum of Art - First Floor Plan.

A second project has completed the design phase to strengthen the remainder of the building. This is to comply with a retroactive ordinance of the City of San Jose requiring all unreinforced masonry bearing wall buildings to be strengthened or demolished in the interest of public safety. The strengthening scheme for the remainder of the building also includes reinforcing the exterior walls with reinforced concrete installed as shotcrete to strengthen those walls. Again, two wythes of brick are being removed in most places so original finishes can be restored. In addition, a new interior reinforced concrete shear wall is being added in the First Floor and Basement beneath a brick wall which forms the exterior of the reduced size Second Floor. These walls are being added to minimize horizontal stress transfers in the relatively weak Second Floor diaphragm so it does not have to be strengthened. New foundations are being constructed beneath the new walls and between the original spread footings. The strengthening work is shown on Figure 6.
