## **Strengthening Landmarks for Improved Seismic Performance**

**Loring A. WYLLIE, Jr.**

Structural Engineer  
H.J. Degenkolb Assoc.  
San Francisco, CA, USA

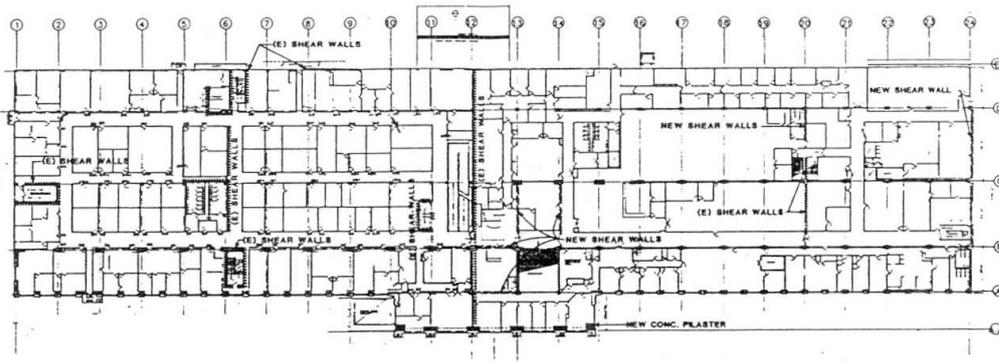
The 1989 Loma Prieta earthquake caused more damage. Several columns in the tower buckled where the X-bracing had eccentric working points. The steel flagpole atop the tower bent as it did in 1906. The front facade of the low-rise aligning with the tower was permanently displaced about 20 mm. There was various damage and cracking of the masonry walls and parapet in the south half and the end wall cracked, failed its few connecting bolts to the roof and separated about 5 mm from the roof. There was no damage in the north half which was stiffer and stronger for lateral forces.

Figure 1. Second Floor of Ferry Building showing existing and recommended locations of shear walls. The tower is between columns 12-13-A-B.

Based on a detailed analysis at the beginning of the project, we also recommended adding some additional interior reinforced concrete shear walls beneath the tower and in the south half of the building. This work is also being funded by FEMA as a reasonable measure to reduce damage in future earthquakes. Care is being taken on locating these walls to minimize their impact on the historic fabric remaining on the interior of the building.

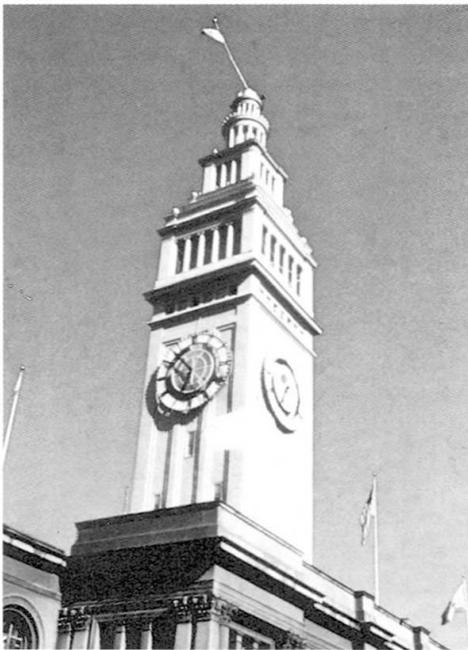
Figure 2. Photograph of Ferry Building tower after Loma Prieta earthquake with bent flagpole.

The United States federal government pays for repairs to local government buildings such as the Ferry Building through the Federal Emergency Management Agency (FEMA). Thus, the basic damage to the tower, flagpole and cracked masonry is being repaired. We were able to convince FEMA that the most suitable repair of parapet damage was to brace the parapet with reinforced concrete and steel braces. The sandstone facade in front of the tower that was permanently displaced will be left displaced but the stones will be anchored to new reinforced concrete backing. This includes the decorative facade columns which are a series of round or square stones atop each other with no steel reinforcement. The cracked and slightly leaning south wall will be reconstructed by removing two wythes of brick from the exterior (250 mm thick) and replacing it with reinforced concrete anchored to all floors and the roof. This new concrete both repairs the south wall damage, significantly strengthens the end of the building, preserves the historic interior brick and stone arched window at the Third Floor and allows us to restore previous modifications in the south wall by replicating the original arched windows and trancery. FEMA also agreed to fund these improvements as repairs.

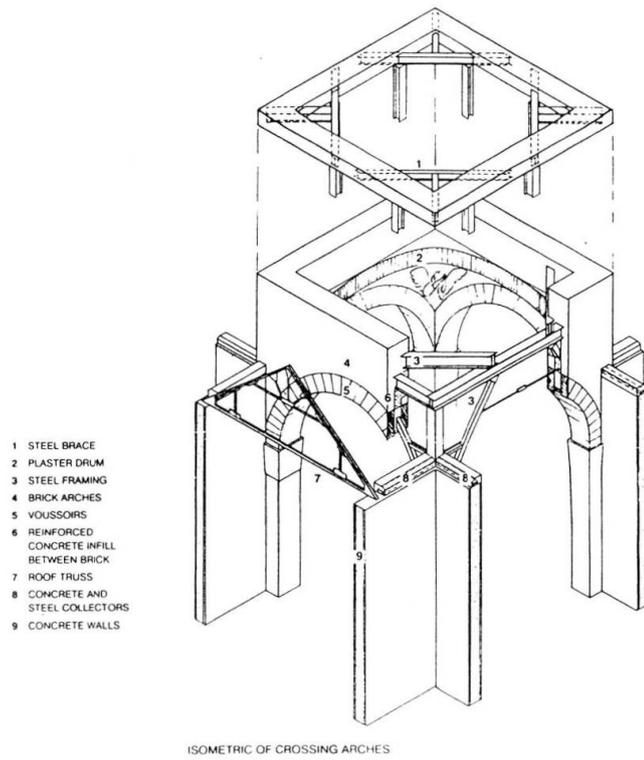
In the 1989 Loma Prieta earthquake, the "new" concrete walls performed well but the original arches of the crossing were damaged. The arches are about 22 m high and each consists of two 1.6 m deep by 550 mm wide stone arches with carved faces. The pairs of arches support a brick wall and are separated by a void about 0.5 m wide where the structural steel for the original tower is located. In the 1989 earthquake, several of the arches moved perpendicular to their plane and caused stones near the center of the arch to crack and drop about 25 mm. At the junction of the arches, the plaster mosaics were damaged with a portion falling to the floor below.

Figure 4. Isometric of strengthening of the Crossing Arches of Stanford Memorial Church.

The damage was analyzed, the conditions determined and an analysis was completed. It was decided to strengthen the arches by filling the void in their center with some heavily reinforced concrete, to provide a diaphragm at the top of the walls above the arches consisting of a substantial reinforced concrete cap beam and steel diagonal braces. The added steel included a stiff downward cantilever to stiffen the arches against perpendicular movement. The reinforced core between the arches was also tied horizontally to the reinforced concrete walls of the four projections from the crossing to improve structural ties and the transfer of lateral forces. The wood roof diaphragms over the entire Church were strengthened with new plywood and stronger ties and connections at the concrete walls. All of this work was completed in concealed locations with no visible evidence of the repairs and strengthening. Figure 4 illustrates the strengthening scheme.

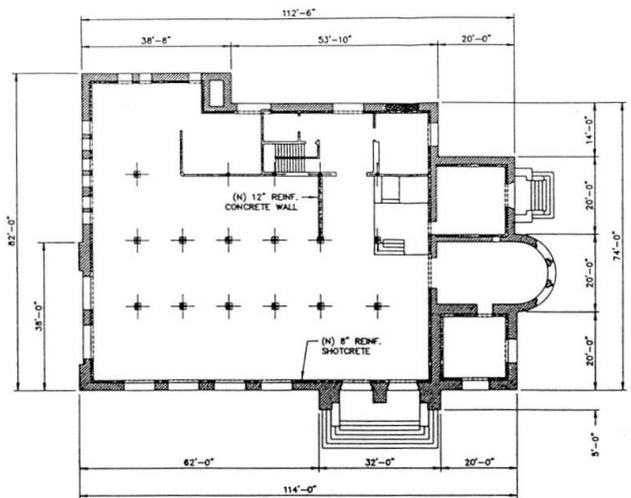
Figure 6. Proposed strengthening of San Jose Museum of Art - First Floor Plan.

A second project has completed the design phase to strengthen the remainder of the building. This is to comply with a retroactive ordinance of the City of San Jose requiring all unreinforced masonry bearing wall buildings to be strengthened or demolished in the interest of public safety. The strengthening scheme for the remainder of the building also includes reinforcing the exterior walls with reinforced concrete installed as shotcrete to strengthen those walls. Again, two wythes of brick are being removed in most places so original finishes can be restored. In addition, a new interior reinforced concrete shear wall is being added in the First Floor and Basement beneath a brick wall which forms the exterior of the reduced size Second Floor. These walls are being added to minimize horizontal stress transfers in the relatively weak Second Floor diaphragm so it does not have to be strengthened. New foundations are being constructed beneath the new walls and between the original spread footings. The strengthening work is shown on Figure 6.
