## **Strengthening Landmarks for Improved Seismic Performance**

**Loring A. WYLLIE, Jr.**

Structural Engineer  
H.J. Degenkolb Assoc.  
San Francisco, CA, USA

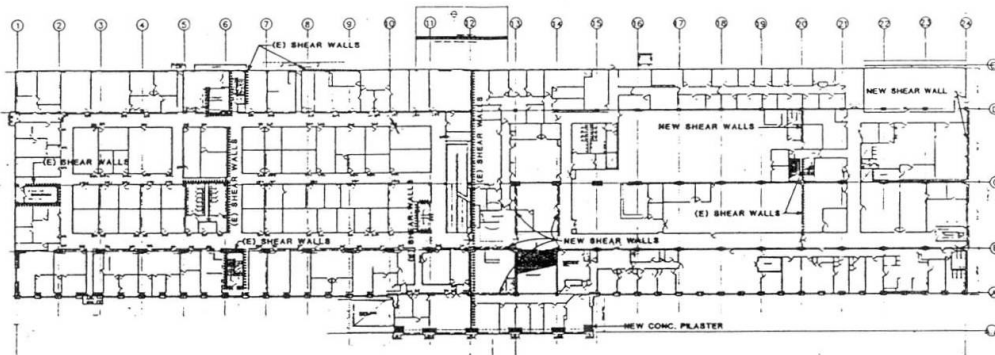
The 1989 Loma Prieta earthquake caused more damage. Several columns in the tower buckled where the X-bracing had eccentric working points. The steel flagpole atop the tower bent as it did in 1906. The front facade of the low-rise aligning with the tower was permanently displaced about 20 mm. There was various damage and cracking of the masonry walls and parapet in the south half and the end wall cracked, failed its few connecting bolts to the roof and separated about 5 mm from the roof. There was no damage in the north half which was stiffer and stronger for lateral forces.

Figure 1. Second Floor of Ferry Building showing existing and recommended locations of shear walls. The tower is between columns 12-13-A-B.

Based on a detailed analysis at the beginning of the project, we also recommended adding some additional interior reinforced concrete shear walls beneath the tower and in the south half of the building. This work is also being funded by FEMA as a reasonable measure to reduce damage in future earthquakes. Care is being taken on locating these walls to minimize their impact on the historic fabric remaining on the interior of the building.

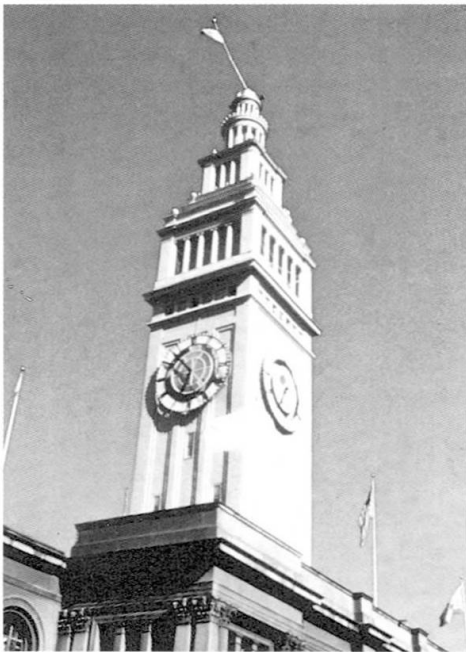
Figure 2. Photograph of Ferry Building tower after Loma Prieta earthquake with bent flagpole.

The United States federal government pays for repairs to local government buildings such as the Ferry Building through the Federal Emergency Management Agency (FEMA). Thus, the basic damage to the tower, flagpole and cracked masonry is being repaired. We were able to convince FEMA that the most suitable repair of parapet damage was to brace the parapet with reinforced concrete and steel braces. The sandstone facade in front of the tower that was permanently displaced will be left displaced but the stones will be anchored to new reinforced concrete backing. This includes the decorative facade columns which are a series of round or square stones atop each other with no steel reinforcement. The cracked and slightly leaning south wall will be reconstructed by removing two wythes of brick from the exterior (250 mm thick) and replacing it with reinforced concrete anchored to all floors and the roof. This new concrete both repairs the south wall damage, significantly strengthens the end of the building, preserves the historic interior brick and stone arched window at the Third Floor and allows us to restore previous modifications in the south wall by replicating the original arched windows and tracery. FEMA also agreed to fund these improvements as repairs.

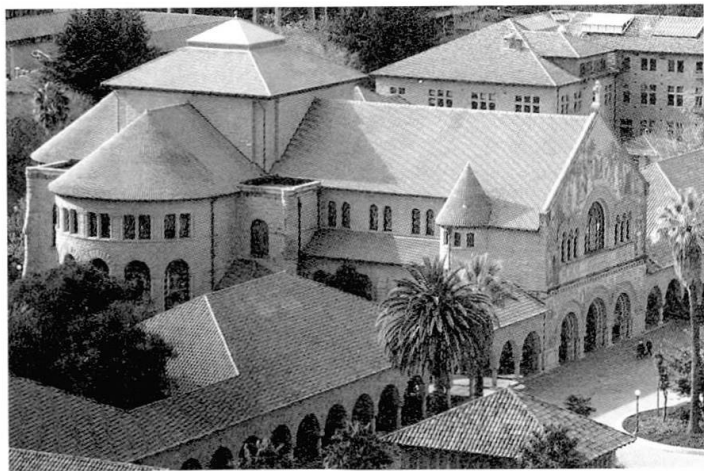
In the 1989 Loma Prieta earthquake, the "new" concrete walls performed well but the original arches of the crossing were damaged. The arches are about 22 m high and each consists of two 1.6 m deep by 550 mm wide stone arches with carved faces. The pairs of arches support a brick wall and are separated by a void about 0.5 m wide where the structural steel for the original tower is located. In the 1989 earthquake, several of the arches moved perpendicular to their plane and caused stones near the center of the arch to crack and drop about 25 mm. At the junction of the arches, the plaster mosaics were damaged with a portion falling to the floor below.

Figure 3. Stanford Memorial Church, Stanford University.

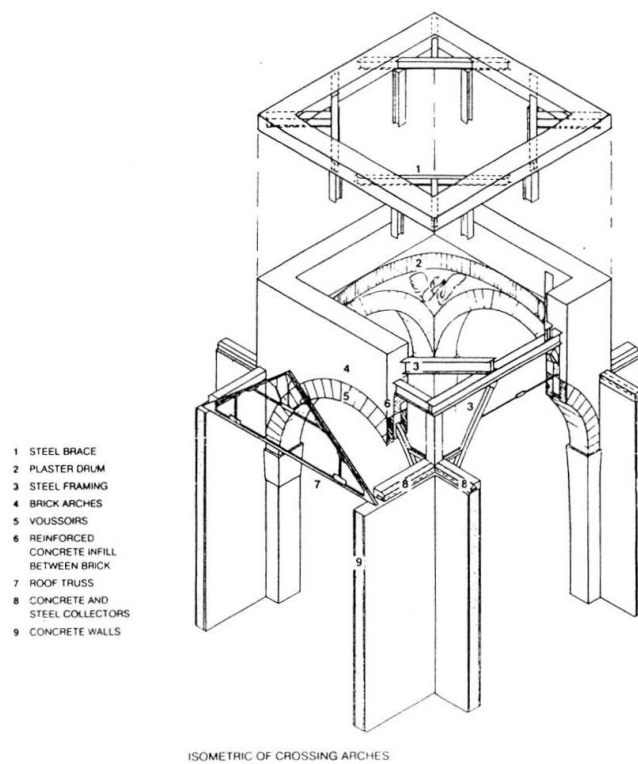
Figure 4. Isometric of strengthening of the Crossing Arches of Stanford Memorial Church.

The damage was analyzed, the conditions determined and an analysis was completed. It was decided to strengthen the arches by filling the void in their center with some heavily reinforced concrete, to provide a diaphragm at the top of the walls above the arches consisting of a substantial reinforced concrete cap beam and steel diagonal braces. The added steel included a stiff downward cantilever to stiffen the arches against perpendicular movement. The reinforced core between the arches was also tied horizontally to the reinforced concrete walls of the four projections from the crossing to improve structural ties and the transfer of lateral forces. The wood roof diaphragms over the entire Church were strengthened with new plywood and stronger ties and connections at the concrete walls. All of this work was completed in concealed locations with no visible evidence of the repairs and strengthening. Figure 4 illustrates the strengthening scheme.

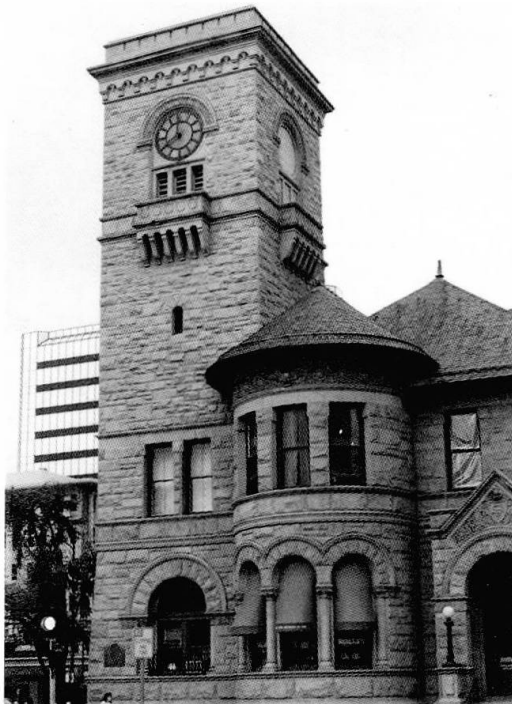
The building was extensively damaged in the 1906 San Francisco earthquake when the tower collapsed. The building was rebuilt with minor revisions to the top of the tower. In the 1989 Loma Prieta earthquake, there was minor damage consisting of cracking in the tower near the bottom of the 1906 collapse. There was no damage in the lower floors, but in a partial Third Floor attic slab, there was significant cracking at locations where the steel framing and brick arches changed directions. At those locations, there were no continuous tension ties in the floor diaphragm to prevent spreading and resist tension forces. In the lower floors, both the steel beams and the girder-to-column connections were bolted for continuity, providing tension capacity for the floors.

Figure 5. San Jose Museum of Art, formerly the United States Post Office.

The tower and Third Floor attic have been repaired by strengthening, again funded by FEMA. The tower was strengthened by removing two wythes of brick on the interior and installing reinforced concrete applied as shotcrete. The brick was removed to keep room sizes and window recesses unchanged so original wood finishes could be reinstalled without modification. The Third Floor attic was strengthened by welding steel straps to the exposed top flanges of the steel beams in the unfinished attic to provide tensile ties in both directions of the attic slab.

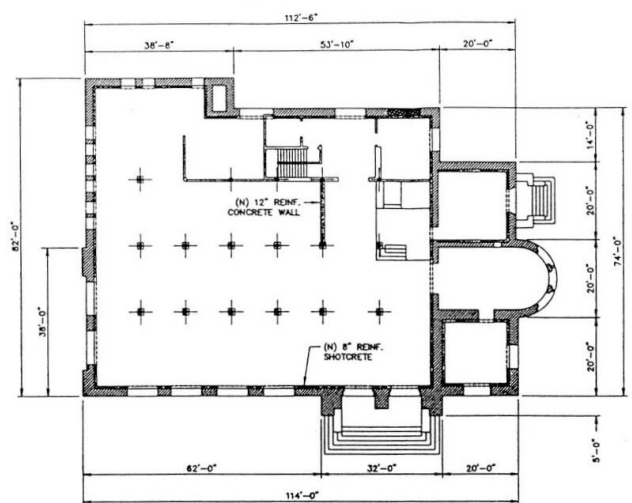
Figure 6. Proposed strengthening of San Jose Museum of Art - First Floor Plan.

A second project has completed the design phase to strengthen the remainder of the building. This is to comply with a retroactive ordinance of the City of San Jose requiring all unreinforced masonry bearing wall buildings to be strengthened or demolished in the interest of public safety. The strengthening scheme for the remainder of the building also includes reinforcing the exterior walls with reinforced concrete installed as shotcrete to strengthen those walls. Again, two wythes of brick are being removed in most places so original finishes can be restored. In addition, a new interior reinforced concrete shear wall is being added in the First Floor and Basement beneath a brick wall which forms the exterior of the reduced size Second Floor. These walls are being added to minimize horizontal stress transfers in the relatively weak Second Floor diaphragm so it does not have to be strengthened. New foundations are being constructed beneath the new walls and between the original spread footings. The strengthening work is shown on Figure 6.
